## FATIGUE OF COMMERCIALLY PURE TITANIUM DENTAL IMPLANTS

**Abstract.** Failure of two commercially pure titanium dental implants was analysed. The implants fractured at the abutments after only three years use. One abutment failed at the junction of the threaded and unthreaded areas, the other failed within the threaded area. Both failures were by reversed bending fatigue, whereby fatigue cracks began from relatively coarse machining marks on the abutments. The final fracture areas were less than 10 % of the total fracture surfaces, indicating that the abutments had not been abnormally loaded. However, bone resorption would have increased the abutment bending stresses by causing an increased moment arm of the acting forces and misalignment of the abutments in the maxilla. The effect of misalignment was investigated by finite element modelling, which showed that even a slight misalignment could double the bending stresses. This unanticipated large effect, combined with the coarse machining marks, explains the premature failure of the implants.

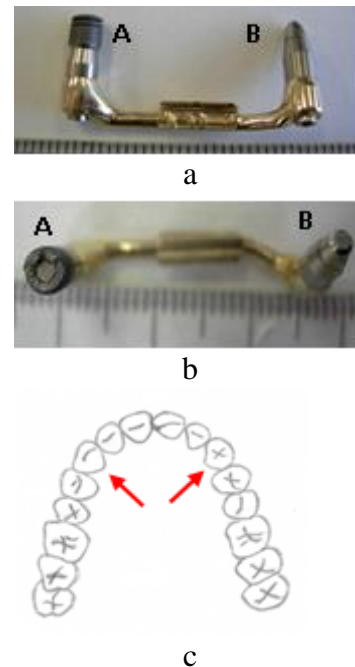
**Fig. 2.** Side (a) and top (b) views of the failed implants and (c) a schematic of the implant locations at the upper canines (cuspid). A full upper denture was attached to the implants. Note that part of the fixture for abutment A was present as well.

Figure 2 shows the parts of the failed implants made available for investigation and their locations with respect to the upper jaw and a full denture attached to them. Both failures were in the abutments and occurred after about 3 years of service. Abutment A failed within the threaded area, abutment B failed at the junction of the threaded and unthreaded areas. Another difference was that abutment B was longer than abutment A by about 1.5mm, and therefore its fixture was implanted deeper into the jaw.

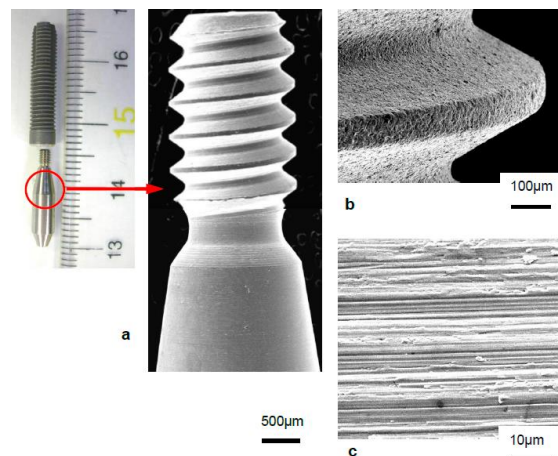
**4.1. Surface Finishes.** Figure 3 shows (a) the fixture and abutment from the *unused* implant, (b) the fixture thread surface, indicative of high-intensity shot peening, and (c) a detail of the abutment thread surface showing coarse machining grooves. The broken fixture in Fig. 2 had also been shot blasted; the remaining thread on the broken abutment A also showed coarse machining grooves; and abutment B had coarse machining on its surface, see Figure 6. Therefore it is reasonable to assume that both the fixtures from the failed implants had been shot peened and both the broken abutments (A and B) had screw threads with coarse machining grooves.

**Fig. 3.** Macroscopic and microscopic images showing (a) the unused fixture and abutment, (b) the shot-peened finish on the fixture, and (c) coarse machining grooves on the abutment screw threads.

A corrective measure could be as simple as shot peening the surfaces of the abutments, especially near the areas of highest stress. Shot peening tends to flatten and smooth out the machining marks and introduces beneficial compressive residual stresses at and near the surfaces. These compressive stresses inhibit or delay fatigue cracking. Shot peening is commonly used for dental implants, especially the fixtures, and has been shown to improve the fatigue resistance of dental titanium [39].

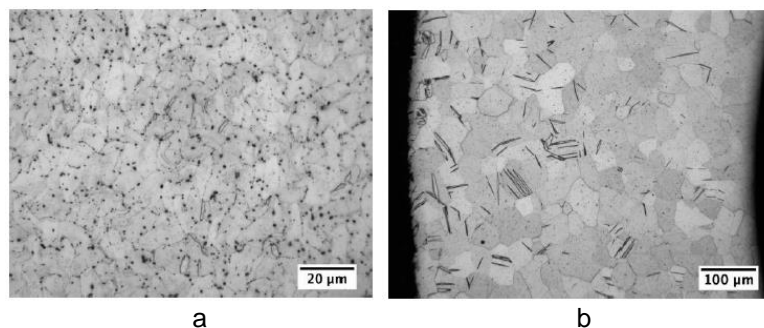
**4.2. Metallography.** Figure 4 gives etched metallographic cross-sections of abutment A and its fixture. The abutment microstructure consisted primarily of equiaxed grains with sizes  $\sim 10 \mu\text{m}$ . There were, however, numerous constituent particles, which is unusual for titanium alloys, and occasional deformation twins. The fixture had a relatively coarse grain size, 30 – 50  $\mu\text{m}$ , and there were numerous deformation twins, especially near the external surface, but also deep within the fixture. This twin distribution is consistent with high-intensity shot peening of the external surface.

**Fig. 4.** Microstructures of (a) abutment A and (b) its fixture: Kroll's etch.

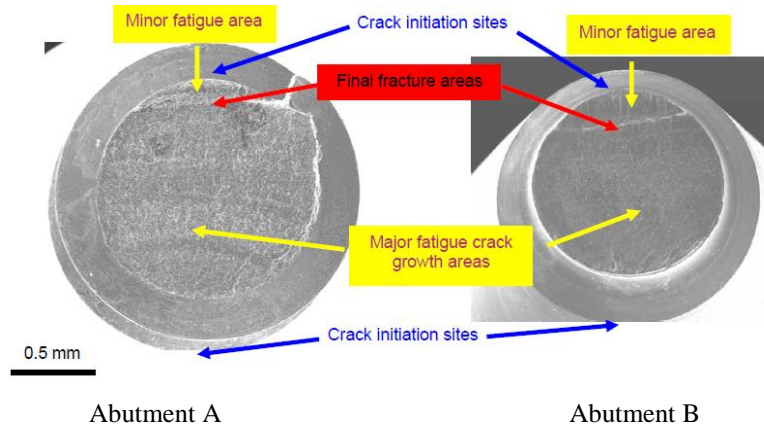
**4.3. Fractography.** Figure 5 gives overviews of the abutment fracture surfaces. Abutment A fractured at the second thread while abutment B fractured at the junction of the threaded and unthreaded areas. In both cases fatigue began on opposite sides of the abutments.

This indicates fatigue by reversed bending, although the relative amounts of fatigue-cracked areas and the positions of the final fracture areas show that the bending stresses must have been much higher on the sides from which the larger areas of fatigue commenced. Even so, the final fracture areas were less than 10 % of the total fracture surfaces, indicating that the abutments had not been abnormally loaded.

**Fig. 5.** SEM overviews of the abutment fracture surfaces.

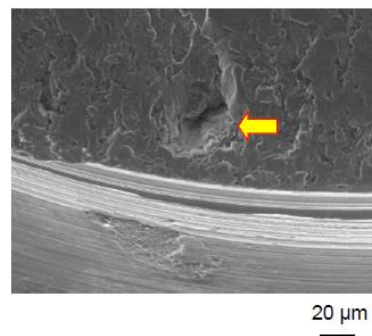
The fatigue cracks most probably began directly from coarse machining grooves on the abutment screw threads (abutment A) and just at the beginning of the screw threads (abutment B). Figure 6 shows coarse machining grooves directly associated with the beginning of the major fatigue crack in abutment B.

**Fig. 6.** SEM detail of the major fatigue crack initiation site in abutment B, showing coarse machining grooves on the abutment surface. The arrow points to a dent (incidental post-fracture damage). This dent is also visible in Fig. 5, just above the blue arrowhead.

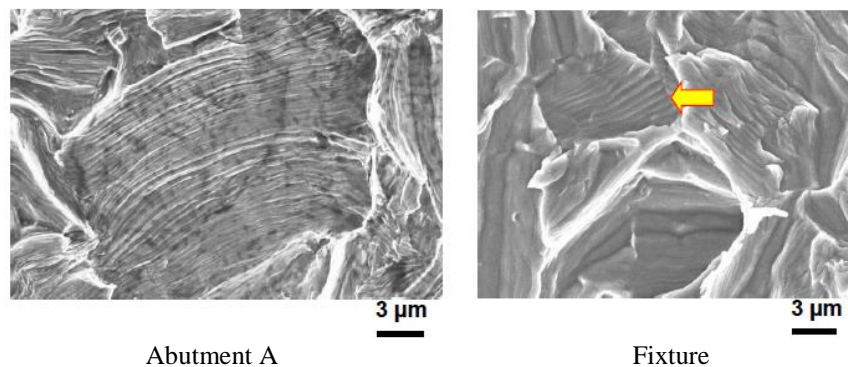
**Fig. 7.** SEM details of the fatigue fracture surfaces of abutment A and its fixture. The arrow points to an isolated patch of coarse striations.

Figure 7 shows details of the fatigue fracture surface of abutment A, and also evidence of fatigue on the fracture surface of its fixture. The abutment had large areas of fatigue striations, whose spacings were typically  $0.3\text{--}0.5\mu\text{m}$ . However, striations on the fatigue fracture surface of the fixture were coarser and in isolated patches between large microvoids. This shows that the fixture failed under (very) high stresses after, and owing to, complete failure of the abutment.

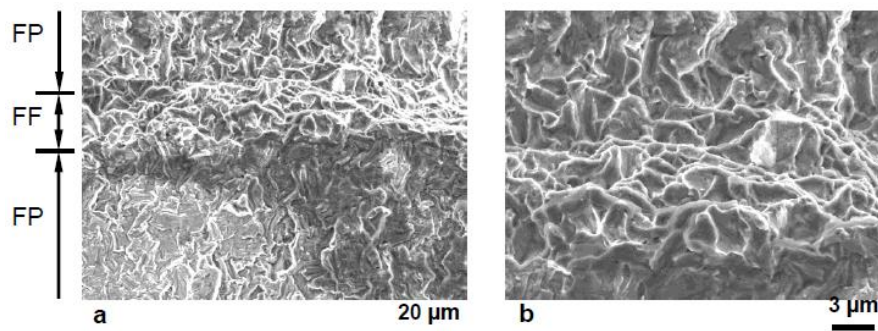
Figure 8 identifies the small region of final overload failure bounded by the two areas of fatigue crack growth in abutment A. The detail in figure 8b shows irregular microvoid coalescence characteristic of overload failure.

**Fig. 8.** SEM fractographs identifying final overload failure in abutment A: (a) the transition area between fatigue propagation and final fracture area bounded by the two fatigue areas; (b) typical microvoid coalescence characteristic of overload. FP = fatigue propagation; FF = final fracture.

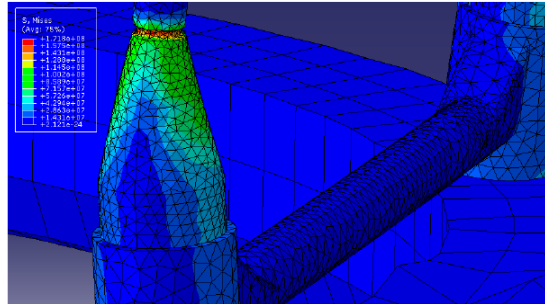
stresses were near the notches where fatigue actually initiated. For the perfectly vertical case the maximum von Mises stress was approximately 80 MPa on the notch surface of abutment A. For the misaligned case the maximum von Mises stress was approximately 172 MPa in a very similar location, i.e. a misalignment of only about  $10^\circ$  more than doubled the maximum stress. This is shown in Fig. 10.

**Fig. 10.** The stress concentration on abutment A for the misaligned implant case. The maximum stress on the abutment surface is about 172 MPa. Note that the fixture has been hidden in this image.

For a simple vertical loading case the finite element model showed semi-quantitatively that a slight ( $10^\circ$  from vertical) misalignment of the implants more than doubled the maximum stress at the stress concentration of an abutment. The main reason for this large effect is a significant increase of the moment arm of the vertical force. Some additional contribution could be due to stresses induced by interaction between the two coupled implants. It is unknown whether the misalignment in the present case was present initially, or that it occurred mainly owing to bone resorption, which seems more likely. If bone resorption was the main culprit, then it could have been self-perpetuating. In other words, the higher loads and stresses on the implants, and hence the surrounding bone, could have caused an increased resorption rate [11].

A finite element model using a simple but common loading scenario showed that a slight misalignment of the implants contributed to much higher stress levels at critical locations in the abutments. This indicates that great care be taken in aligning the implants during insertion, and that any misalignment due to bone resorption can be problematic. Whether or not implant misalignments occur during service, it is also recommended to pay special attention to the surface finish of the abutments. In the present case their fatigue lives could have been extended by providing a (much) better surface quality, e.g. by finishing with shot peening. This would have smoothed out the coarse machining grooves and introduced beneficial compressive residual stresses at and near the abutment surfaces.
