# FATIGUE OF COMMERCIALY PURE TITANIUM DENTAL IMPLANTS

**Abstract.** Failure of two commercially pure titanium dental implants was analysed. The implants fractured at the abutments after only three years use. One abutment failed at the junction of the threaded and unthreaded areas, the other failed within the threaded area. Both failures were by reversed bending fatigue, whereby fatigue cracks began from relatively coarse machining marks on the abutments. The final fracture areas were less than 10 % of the total fracture surfaces, indicating that the abutments had not been abnormally loaded. However, bone resorption would have increased the abutment bending stresses by causing an increased moment arm of the acting forces and misalignment of the abutments in the maxilla. The effect of misalignment was investigated by finite element modelling, which showed that even a slight misalignment could double the bending stresses. This unanticipated large effect, combined with the coarse machining marks, explains the premature failure of the implants.

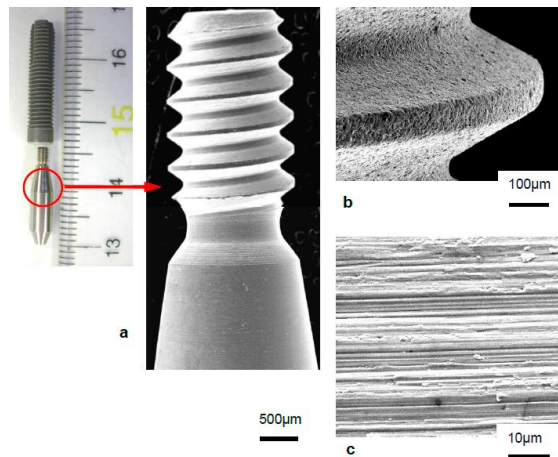
**4.1. Surface Finishes.** Figure 3 shows (a) the fixture and abutment from the *unused* implant, (b) the fixture thread surface, indicative of high-intensity shot peening, and (c) a detail of the abutment thread surface showing coarse machining grooves. The broken fixture in Fig. 2 had also been shot blasted; the remaining thread on the broken abutment A also showed coarse machining grooves; and abutment B had coarse machining on its surface, see Figure 6. Therefore it is reasonable to assume that both the fixtures from the failed implants had been shot peened and both the broken abutments (A and B) had screw threads with coarse machining grooves.

**Fig. 3.** Macroscopic and microscopic images showing (a) the unused fixture and abutment, (b) the shot-peened finish on the fixture, and (c) coarse machining grooves on the abutment screw threads.

A corrective measure could be as simple as shot peening the surfaces of the abutments, especially near the areas of highest stress. Shot peening tends to flatten and smooth out the machining marks and introduces beneficial compressive residual stresses at and near the surfaces. These compressive stresses inhibit or delay fatigue cracking. Shot peening is commonly used for dental implants, especially the fixtures, and has been shown to improve the fatigue resistance of dental titanium [39].

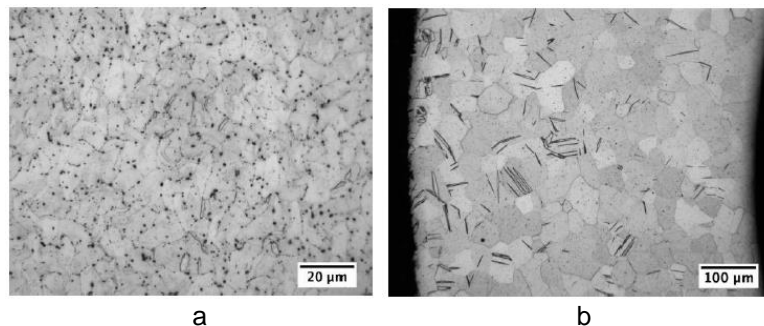
**4.2. Metallography.** Figure 4 gives etched metallographic cross-sections of abutment A and its fixture. The abutment microstructure consisted primarily of equiaxed grains with sizes  $\sim 10 \mu\text{m}$ . There were, however, numerous constituent particles, which is unusual for titanium alloys, and occasional deformation twins. The fixture had a relatively coarse grain size, 30 – 50  $\mu\text{m}$ , and there were numerous deformation twins, especially near the external surface, but also deep within the fixture. This twin distribution is consistent with high-intensity shot peening of the external surface.

**Fig. 4.** Microstructures of (a) abutment A and (b) its fixture: Kroll's etch.

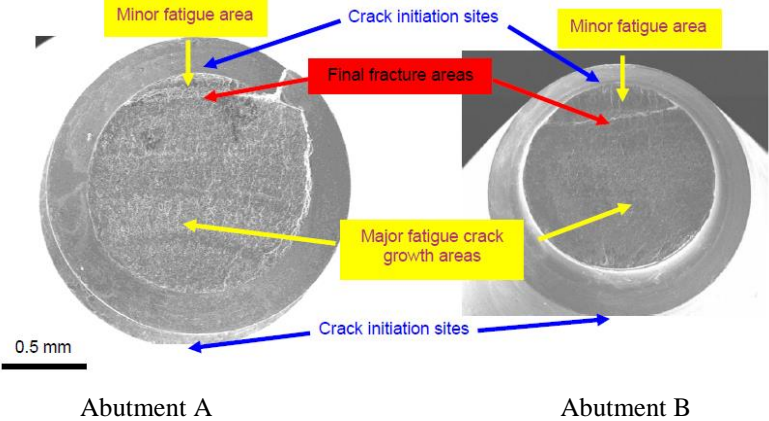
**4.3. Fractography.** Figure 5 gives overviews of the abutment fracture surfaces. Abutment A fractured at the second thread while abutment B fractured at the junction of the threaded and unthreaded areas. In both cases fatigue began on opposite sides of the abutments.

This indicates fatigue by reversed bending, although the relative amounts of fatigue-cracked areas and the positions of the final fracture areas show that the bending stresses must have been much higher on the sides from which the larger areas of fatigue commenced. Even so, the final fracture areas were less than 10 % of the total fracture surfaces, indicating that the abutments had not been abnormally loaded.

**Fig. 5.** SEM overviews of the abutment fracture surfaces.

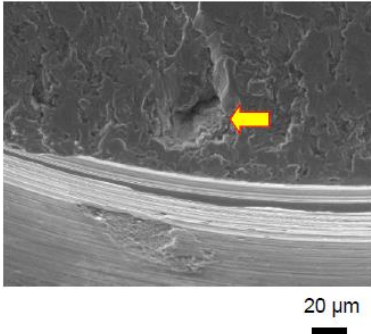
The fatigue cracks most probably began directly from coarse machining grooves on the abutment screw threads (abutment A) and just at the beginning of the screw threads (abutment B). Figure 6 shows coarse machining grooves directly associated with the beginning of the major fatigue crack in abutment B.

**Fig. 6.** SEM detail of the major fatigue crack initiation site in abutment B, showing coarse machining grooves on the abutment surface. The arrow points to a dent (incidental post-fracture damage). This dent is also visible in Fig. 5, just above the blue arrowhead.

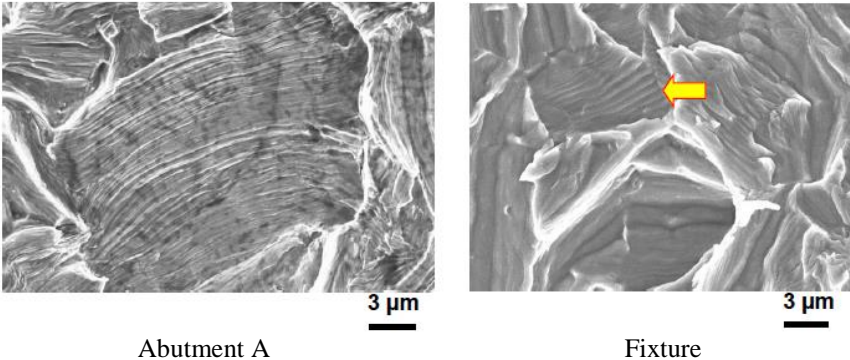
**Fig. 7.** SEM details of the fatigue fracture surfaces of abutment A and its fixture. The arrow points to an isolated patch of coarse striations.

Figure 7 shows details of the fatigue fracture surface of abutment A, and also evidence of fatigue on the fracture surface of its fixture. The abutment had large areas of fatigue striations, whose spacings were typically 0.3-0.5 $\mu\text{m}$ . However, striations on the fatigue fracture surface of the fixture were coarser and in isolated patches between large microvoids. This shows that the fixture failed under (very) high stresses after, and owing to, complete failure of the abutment.

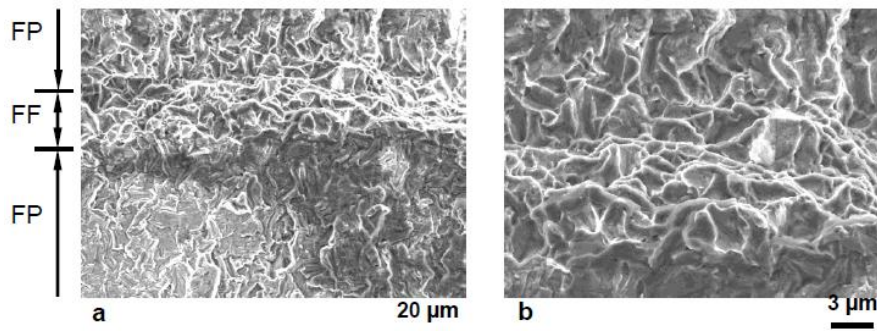
Figure 8 identifies the small region of final overload failure bounded by the two areas of fatigue crack growth in abutment A. The detail in figure 8b shows irregular microvoid coalescence characteristic of overload failure.

**Fig. 8.** SEM fractographs identifying final overload failure in abutment A: (a) the transition area between fatigue propagation and final fracture area bounded by the two fatigue areas; (b) typical microvoid coalescence characteristic of overload. FP = fatigue propagation; FF = final fracture.
