Seismic Response of Rocking Precast Concrete Cladding System in a Full-Scale Three-Storey Building

ABSTRACT

Low-damage connection; rocking cladding system; shake table test; component acceleration amplification factor; damage states

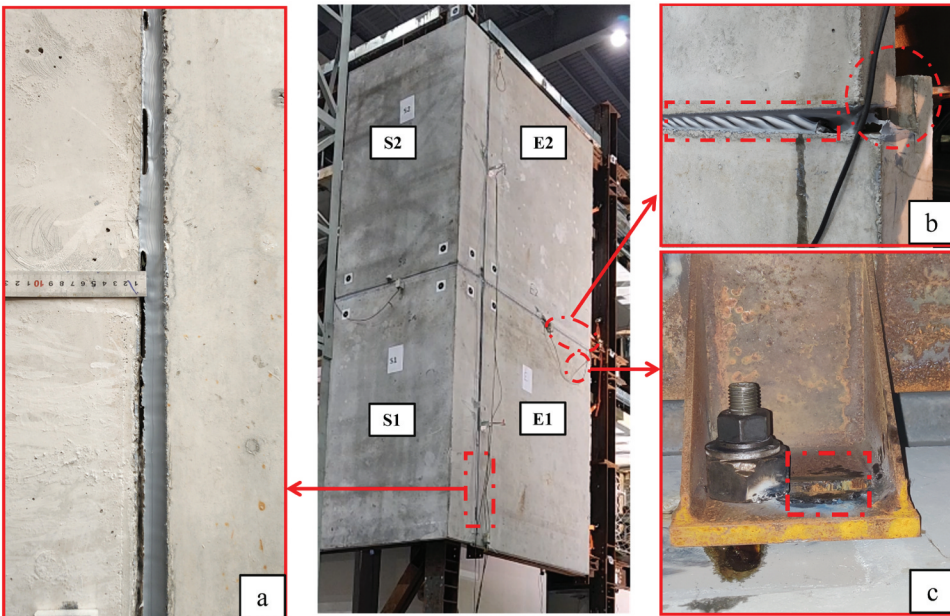
Minor damage was initially observed at a PIDR of 0.51%, characterised by the sealant detachment at the vertical joint between cladding panels E1 and S1 (Fig. 8a). This is an adhesive failure caused by lateral sliding forces in the flat panels during shaking in the longitudinal (NS/X) direction exceeding the adhesive bond strength (Klosowski and Wolf 2016). This was attributed to dust embedded between the sealant and concrete surfaces due to insufficient cleaning, drying, and preparation of the panel edges before sealant application. Such damage was also reported in previous studies by Xue, Tan, and Sha (2020) and Bhatta, Dhakal, and Sullivan (2023a). Wrinkles in the sealant were also first observed at the horizontal joint between panels W1 and W2 at 1.00% PIDR and between panels E1 and E2 at 1.16% PIDR. This response indicates the post-elastic nonlinear behaviour of the sealant when the shear displacement becomes larger. Dal Lago et al. (2017) defined this as the formation of inclined ties, which occurred at 0.90% drift under the cyclic test. Sealant tearing at the vertical joint between the east and south elevation was expected to occur at a PIDR of 1.25%. However, the tearing was not observed because sealant detachment occurred before reaching the expected drift level. For the west and north elevation panels, the maximum PIDR remained below the design drift corresponding to sealant tearing.

Figure 8. Damage observed in the east elevation cladding panels: (a) sealant detachment at the vertical joint between panels E1 and S1 at 0.51% PIDR (0.20 g shaking in the longitudinal (NS/X) direction); (b) horizontal shifting of cladding panel E1 and appearance of sealant wrinkles after 1.41% PIDR (0.60 g shaking in the longitudinal (NS/X) direction); (c) failure of tack-weld.

With increased shaking intensity, the east elevation panels sustained further damage. On panels E1 and E2, the tack-welded connections between the two top horizontally slotted steel angles and the nuts failed as shown in Fig. 8c during 0.60 g longitudinal direction (NS/X) shaking (PIDRs of 1.41% and 1.26% on the second and third storeys), resulting in horizontal panel movement (Fig. 8b). As these tack-welds were applied without a specific design, their failure was likely due to increased force demands during stronger shaking. Therefore, tack-welds should be designed to resist the required horizontal force in accordance with SNZ TS 1170.5 (2025), considering the specific connection configurations. Such tack-weld failure widened the gap between the east and south elevation panels, leading to the complete detachment of the sealant at the vertical joint. Although this could compromise the weather tightness and thermal insulation of the cladding system, it can be considered as a minor repair damage state since this damage was associated with the failure of the tack-weld. This damage requires repair actions such as repositioning the panels through the slotted steel angles, re-welding the nut-to-plate connections, and resealing the joints. As there was no immediate risk of panel detachment, the test was continued without repairing the specimens, so that a comprehensive evaluation of the performance of the cladding system under extreme seismic conditions could be made.

Additional observations included the breakage and dislodgement of backer rods behind the sealant in the horizontal joints between panels E1 and E2 after 1.16% PIDR. This damage is attributed to repeated panel sliding and the frictional forces developed between the concrete and backer rod, as also reported in a previous study by Bhatta, Dhakal, and Sullivan (2023b). Bolt loosening was also noted during inspections and required retightening to control out-of-plane movement and reduce the risk of panel detachment in subsequent shaking. No other damage, such as loosening and yielding of steel-embeds, cracking, and crushing of panels, was observed during the inspections throughout the test.
