ASSESSING THE ENGINEERING PROPERTIES AND PERFORMANCE OF
LIMESTONE COMPARED TO CONTRACT SPECIFICATIONS AS ROAD
CONSTRUCTION AGGREGATE IN THE KINGDOM OF TONGA

A thesis submitted
in fulfilment of the requirements for the degree of
Master of Engineering (Civil)

Department of Engineering
School of Engineering
AUT University of Auckland

2018

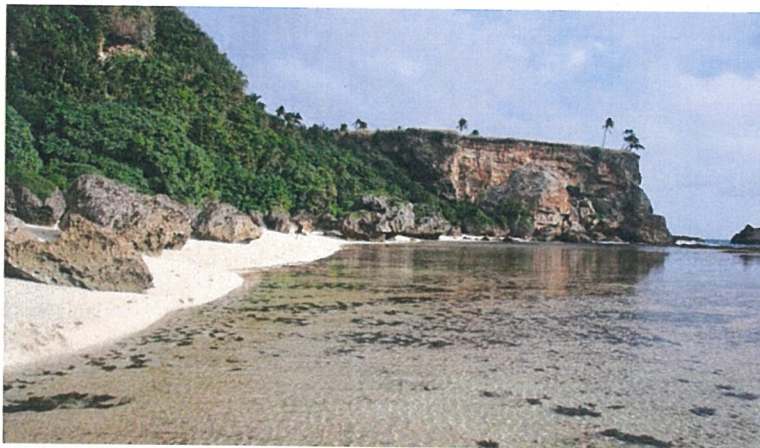
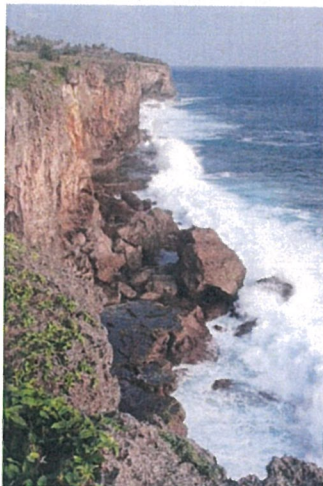
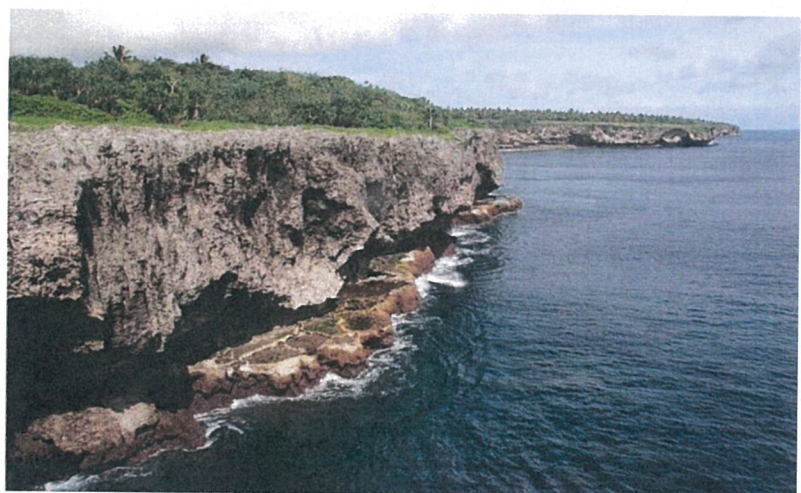
The following photos are from the southern coast of Tongatapu above, refer Figure. 2.6 marked B, illustrating height above sea level of the seaside cliffs and weathered limestone rock faces (Source: www.panoramio.com, 2015).

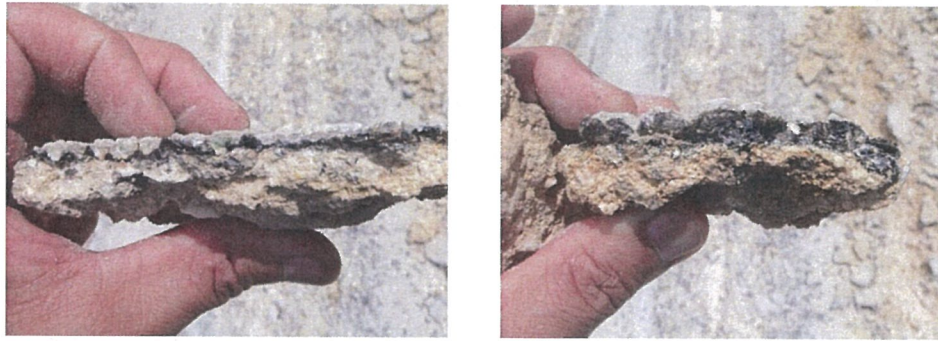
Figure. 3.6. Typical chipseal surfacing depth sample excavated during the 2013 reconstruction near Nuku'alofa CBD (Source: Hiliau, 2014)

In Figure. 3.6 illustrates the typical chipseal depth observed in Tonga obtained during site visits, when existing surfacing were scarified to be renewed as part of Tonga road improvement project 2014. Depths varied between 5mm – 10mm. Excessive amount of fine dusty particles can be observed between crushed aggregate.

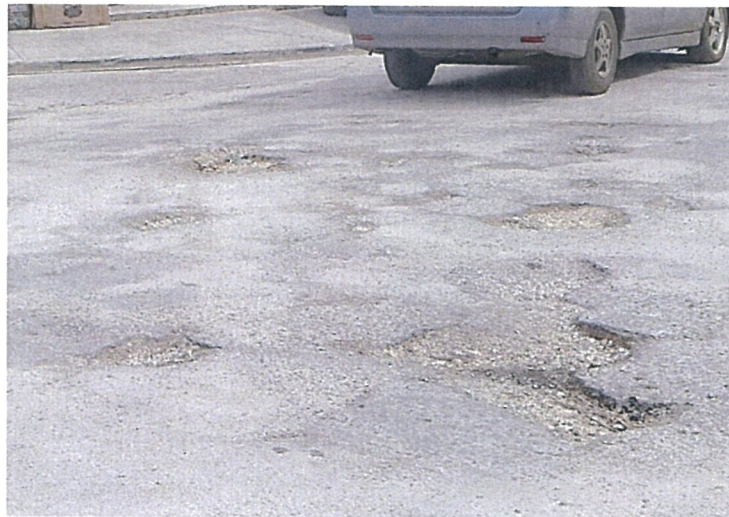
Figure. 3.7. Typical asphaltic concrete potholes in and around Nuku'alofa CBD (Source: Hiliau, 2014)

AC resurfacing work did not occur at the time of research site visits hence no physical AC samples were available. However, numerous AC potholes located throughout Tongatapu shown in Figure. 3.7. Typically, a depth of 50mm were specified in previous AC surfacing projects in Tonga which will form part of the discussions in Chapter 4.

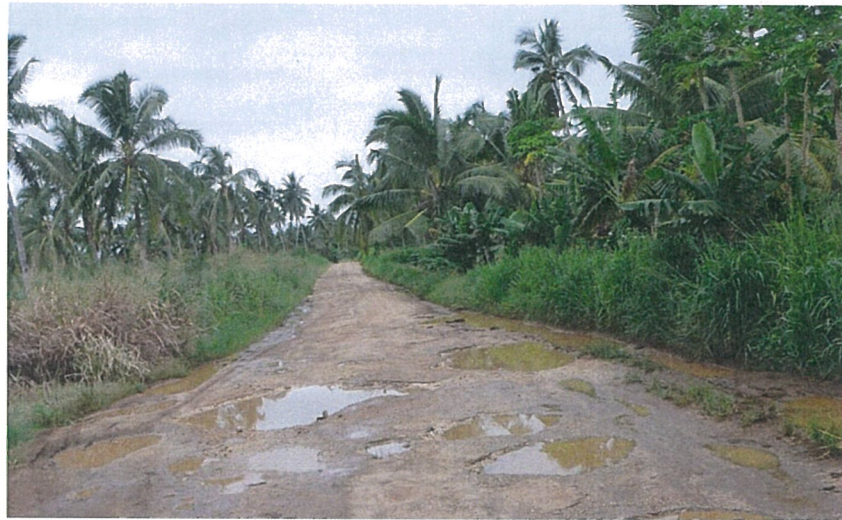
Figure. 4.4. Chipseal Highway Roads around the coast of Tongatapu had been left to deteriorate for some time due to lack of maintenance (Source: Hiliau, 2014)

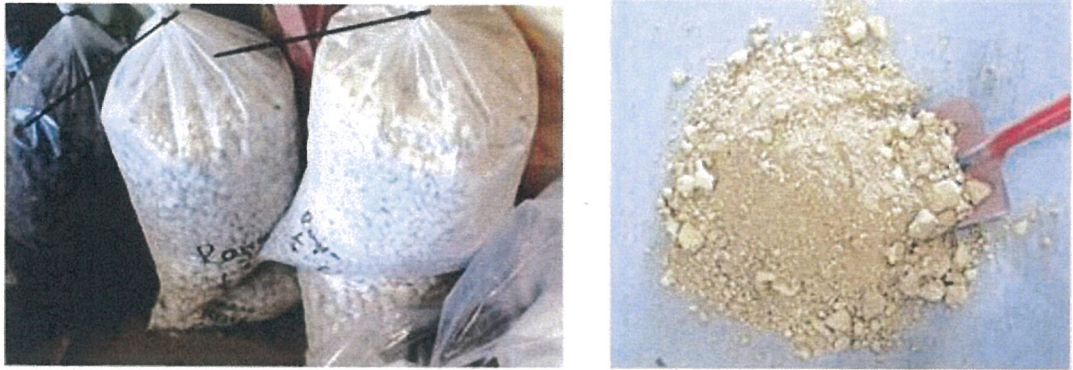
Fig. 7.1. Samples storage and then being mixed for sieving at OPUS laboratory, Albany, Auckland.

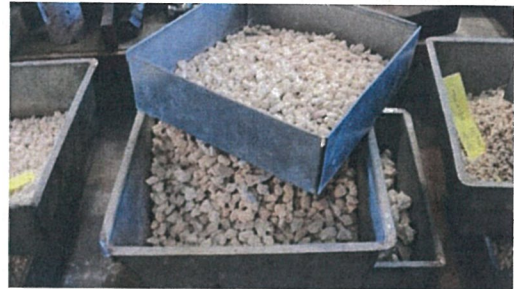
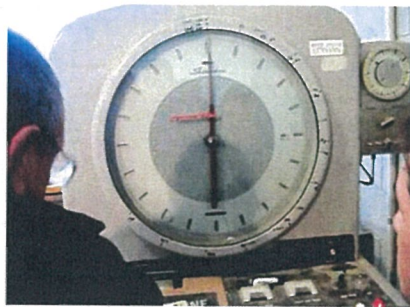
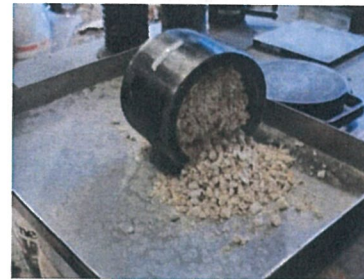
The laboratory apparatus used for the crushing vlaue testing is illustrated below.
