An Investigation Into The Surface Finish of Laterally Face Milled
Cobalt-Chromium-Molybdenum Alloys

A thesis

Master of Engineering

**School of Engineering, Computer, and Mathematical Sciences,
Auckland University of Technology**

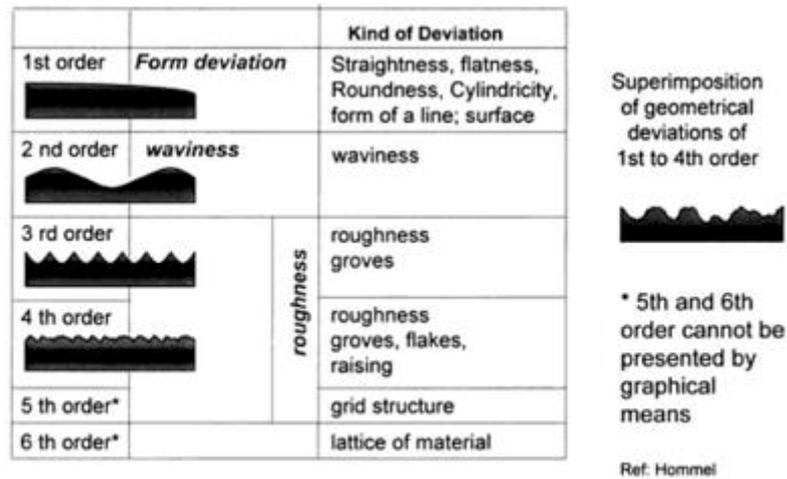
Figure 1 Classification of geometrical properties according to DIN 4760 (45).

As shown in Figure 1, roughness is defined as the third, fourth and fifth order of deviation from the nominal surface wavelength. The first order of deviation refers to form: straightness, flatness, roundness, etc. The second order of deviation refers to waviness. The most common causes of waviness are vibrations, machining chatter, residual stress, work deflections or heat treatment (42). First and second order deviations are due to set-up or machine errors such as poor alignment, material being not properly clamped/restrained, tool and/or machine vibrations, material deflection, material inhomogeneity and tool errors. Third and fourth order deviations are due to irregularities such as grooves, flaking, raising and cracks. Such irregularities are directly related to the tool cutting surface, tool shape, tool condition, the chip formation mechanism and kinematics during machining (43–45). The fifth and sixth order of deviation cannot be represented graphically but are due to the material structure of the workpiece. The material structure is heavily connected to physical-chemical mechanisms acting on a grain and lattice scale (slip, diffusion, oxidation, residual stress, etc.) (43). Figure 1 also shows the first to fourth order superimposed to allow an insight into a sample surface wavelength.

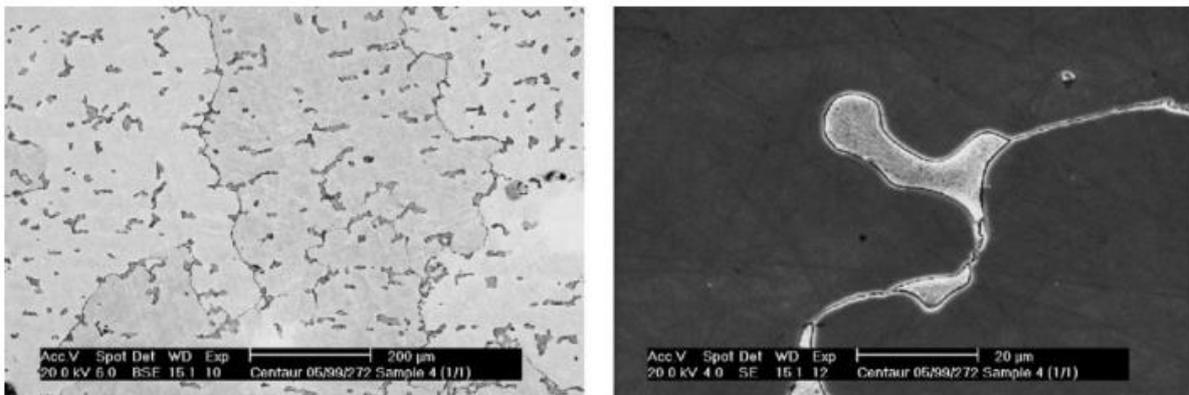
Figure 2 SEM micrographs of the as-cast (AC) CoCrMo sample (grain boundary etched and carbide stained). J. Cawley et al. (8).

Shown in Figures 2 and 3 are the comparative microstructures of as-cast (AC) and heat-treated (HT) CoCrMo samples with the grain boundaries etched and the carbides stained. Figure 2 shows the AC sample with its large, irregular, and blocky carbide morphology, and Figure 3 shows the HT sample with the finely dispersed agglomeration of particulate carbides.

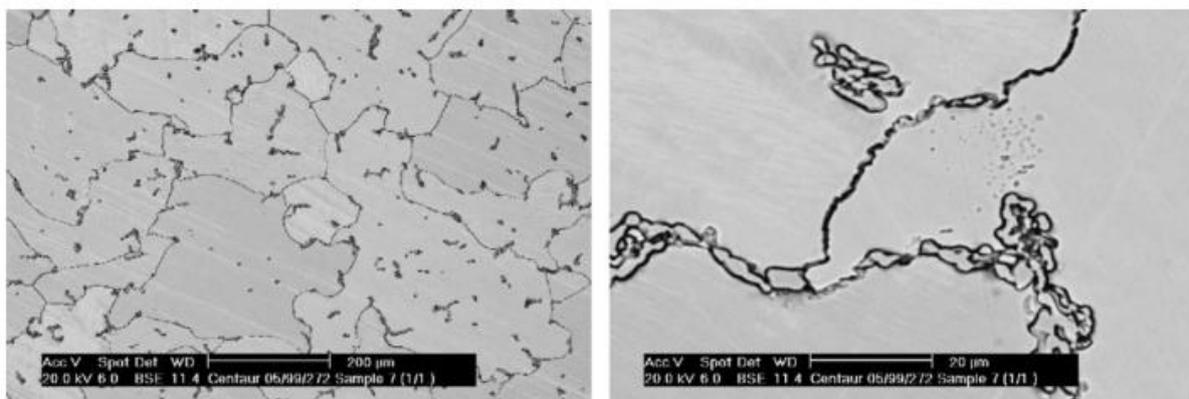
Figure 3 SEM micrographs of the heat-treated (HT) CoCrMo sample (grain boundary etched and carbide stained) J. Cawley et al. (8).

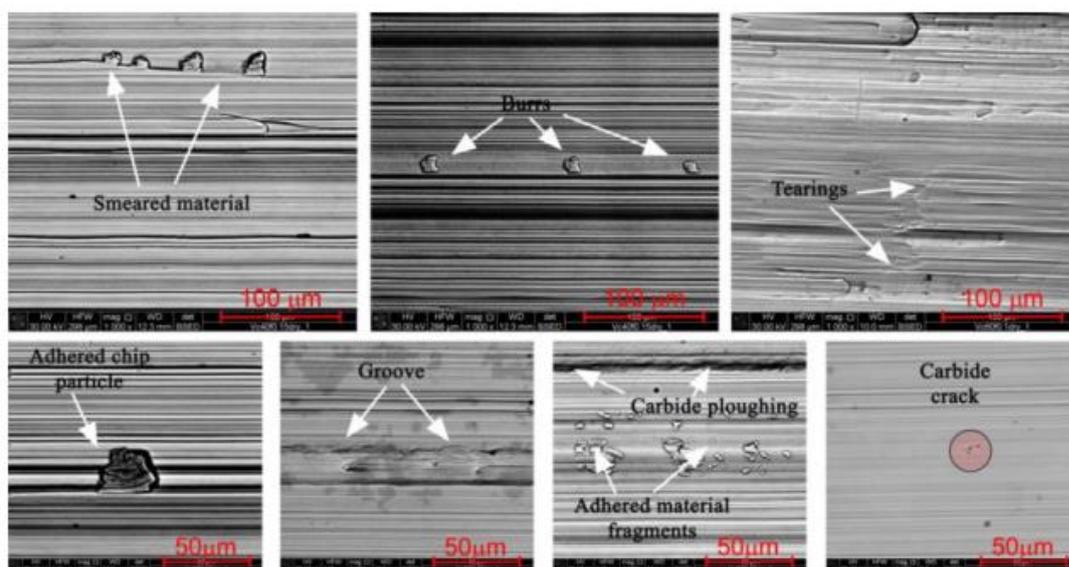
Figure 4 SEM images of surface defects found in dry turning of ASTM F1537 CoCrMo (7).

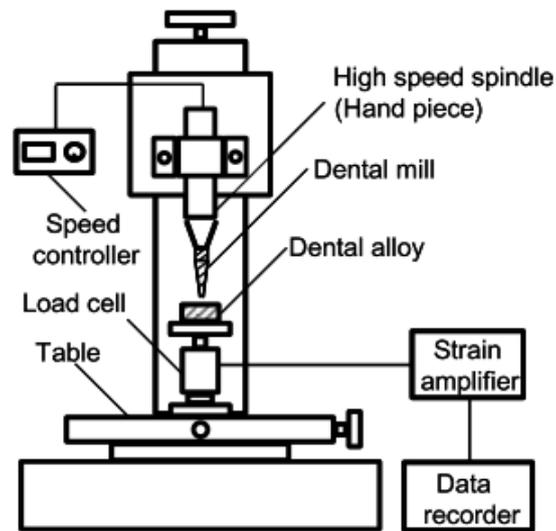
Figure 5 Experimental setup for investigating milling operations. M. Takahashi et al. (29).

The setup used allowed repeatability and removed many factors that could influence the results. Spindle speeds were varied from 10,000 RPM to 35,000 RPM, in increments of 5000 RPM, with the feed rate held constant at 0.15mm/second (29). During central slot milling of CoCr it was found that lower speeds had generally higher cutting forces with speeds of 12,000 RPM to 20,000 RPM experiencing greater forces than speeds of 24,000 RPM to 30,000 RPM. Some instability occurred at lower speeds, but forces were relatively stable at speeds ranging between 25,000 RPM to 30,000 RPM (29). The DLC coated mill did not show significantly lower forces during milling; though it was believed, and later shown under SEM, that the coating was rapidly worn off. There is a lack of data regarding the central milling experiments with CoCrTi. Two of the mills were not used at any speeds, while two more were used for low speed passes only. Extreme mill wear, failure and machining heat led to the abandonment of these experiments, however they did show that CoCrTi had a much lower machinability than CoCr (29). Lateral milling cutting forces were lower than those of central slot milling for both alloys, cutting forces being generally relatively high at low speeds of 10,000 RPM but decreased at higher speeds and stabilised (29). At higher speeds, multiple mills were having slipping issues where the spindle would loosen on the mill during milling. The DLC coated drill did not have this issue, possibly due to its lowered coefficient of friction (29). SEM analysis of the milled surfaces in both central slot milling and side milling showed that re-welded chips were a leading cause of poor surface quality. It is recommended that the use of cooling fluid during machining is likely to reduce the problem of chip re-welding and abrasion issues (29).

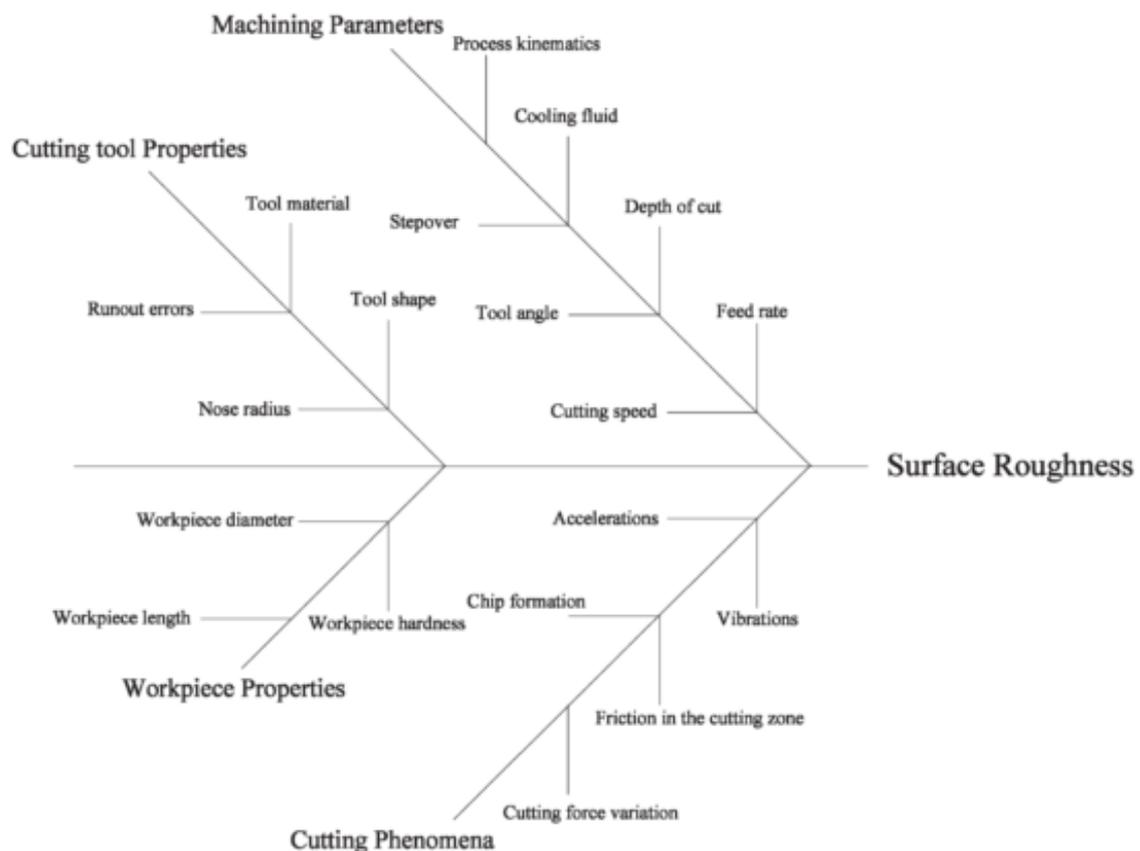
Figure 6 Fishbone diagram listing parameters that affect surface roughness. P G Benardos (43).

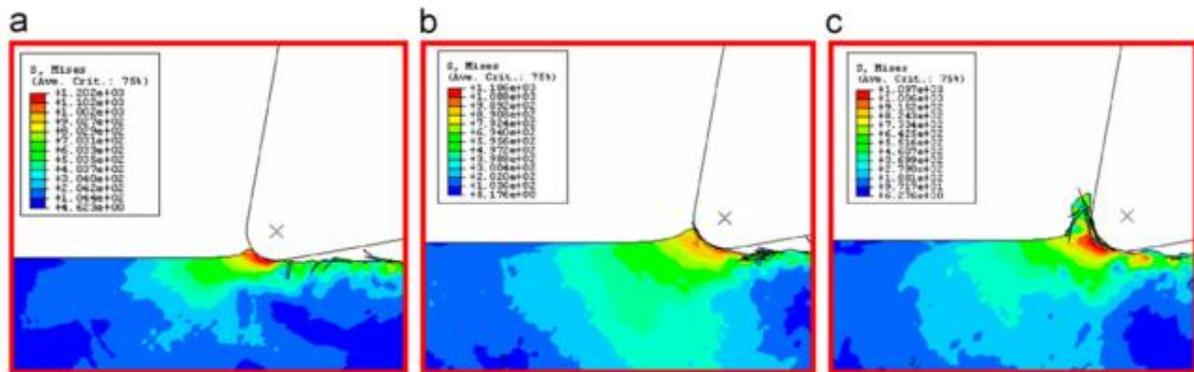
Figure 7 Chip formation process. (a) $h = 0.1R$ (0.2mm); (b) $h = 0.2R$ (0.4mm); (c) $h = 0.3R$ (0.6mm). X. Lai et al. (35).

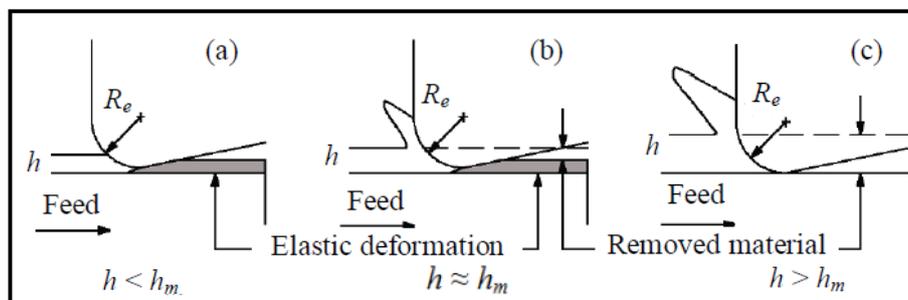
Figure 10 Schematic representation of the minimum chip thickness in orthogonal cutting; r : edge radius of cutting tool, h : depth of cut, h_m : minimum chip thickness. F. Ducobu et al. (34).

The study tested eight ratios of h/r ranging from 14 to 0.05. It was found that for values where $h/r < 0.25$ no chip was formed. In this region the material seemed not to be sheared but

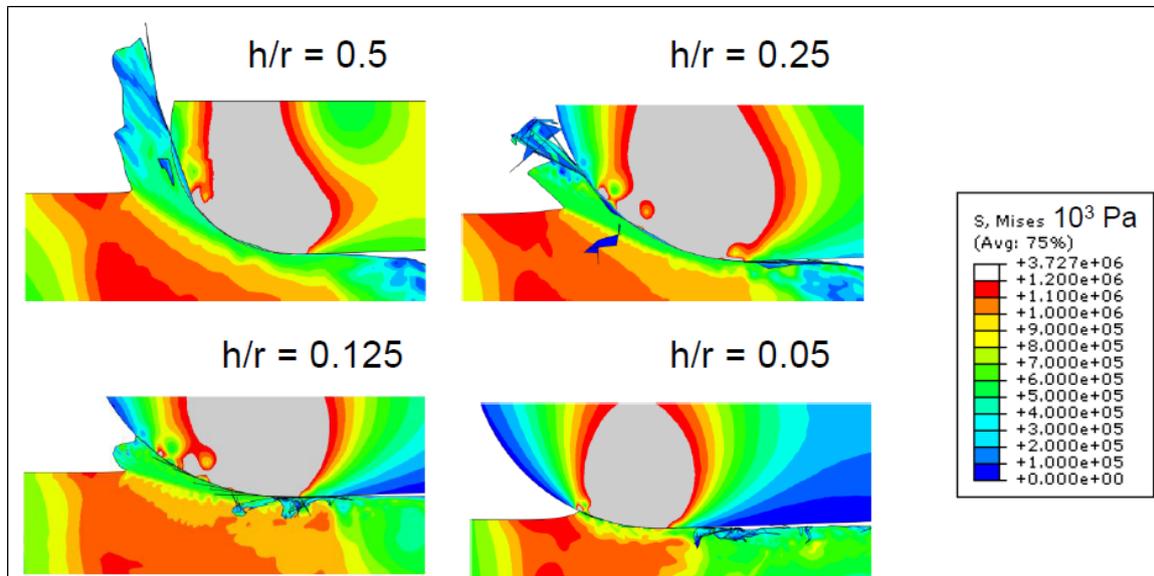
Figure 11 Chip morphologies for h/r values ranging from 0.5 to 0.05. F. Ducobu et al. (34).

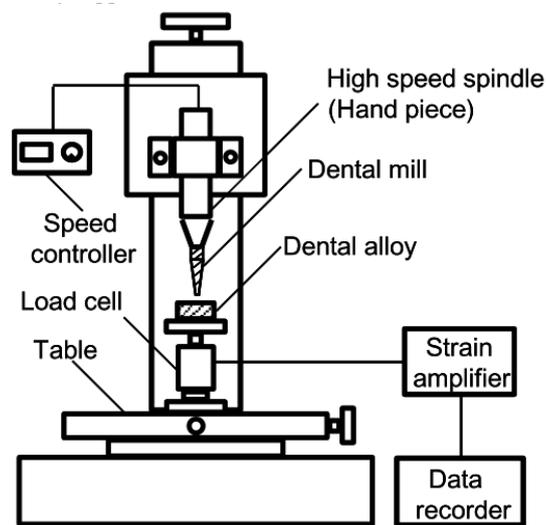
Figure 12 Experimental milling setup. M. Takahashi et al. (29).

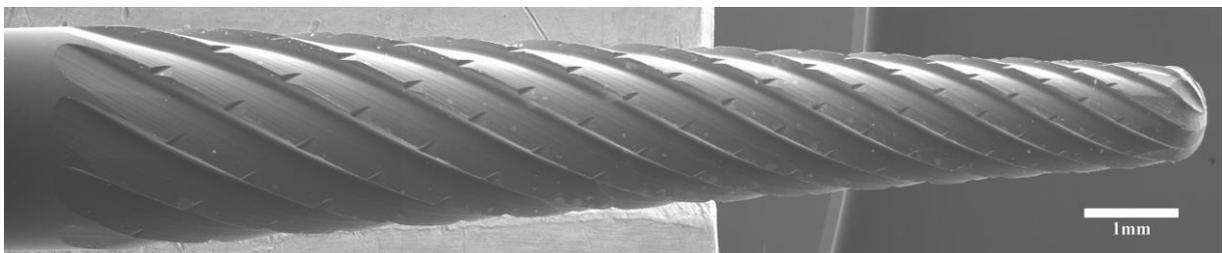
Figure 16 Dental Mills; A, B, C and D respectively in unused condition.

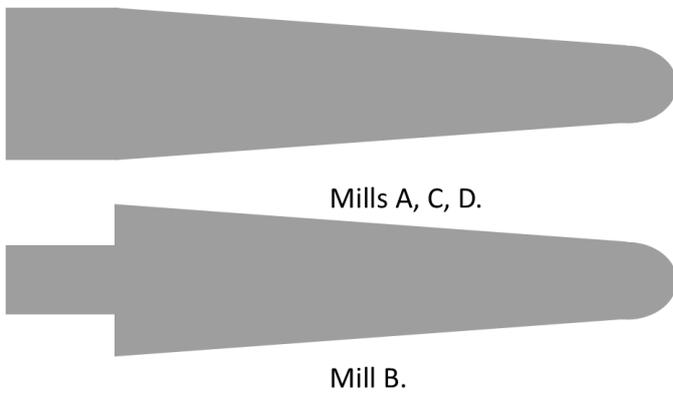
Figure 17 Dental Mill Shapes.

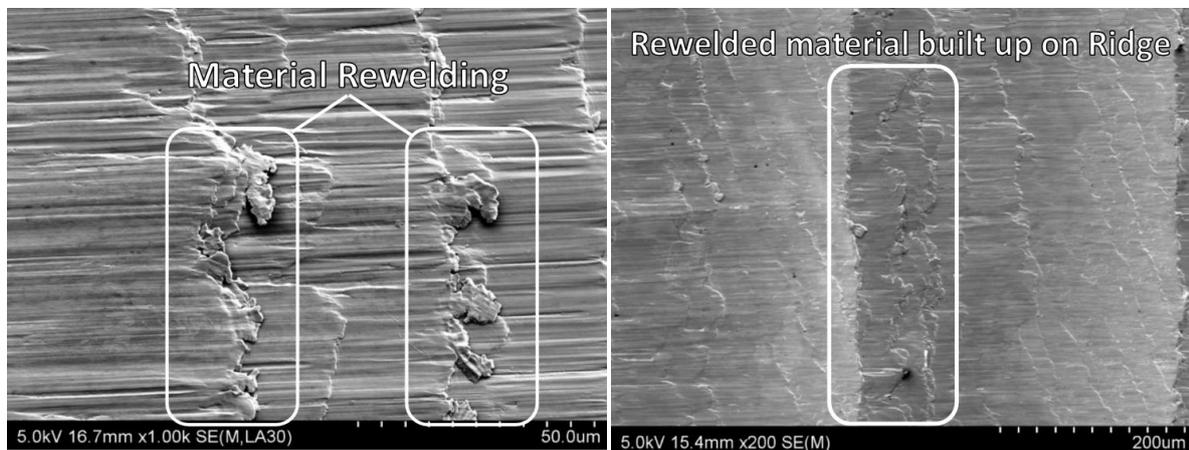
Figure 18 Examples of rewelded material on the milled surface.

These images were evaluated on the occurrence of common defects and overall surface quality with common points of interest including waviness, tearing, craters, gouging (due to ploughing) and rewelded chips/material on the milled surface. As the literature review suggested, frictionally rewelded chips/material are expected to be one of the most detrimental phenomena to the surface finish. The rewelding occurs as chips and severed BUE chunks are frictionally rewelded to the material behind the milling tool, examples of which are shown in Figure 18.

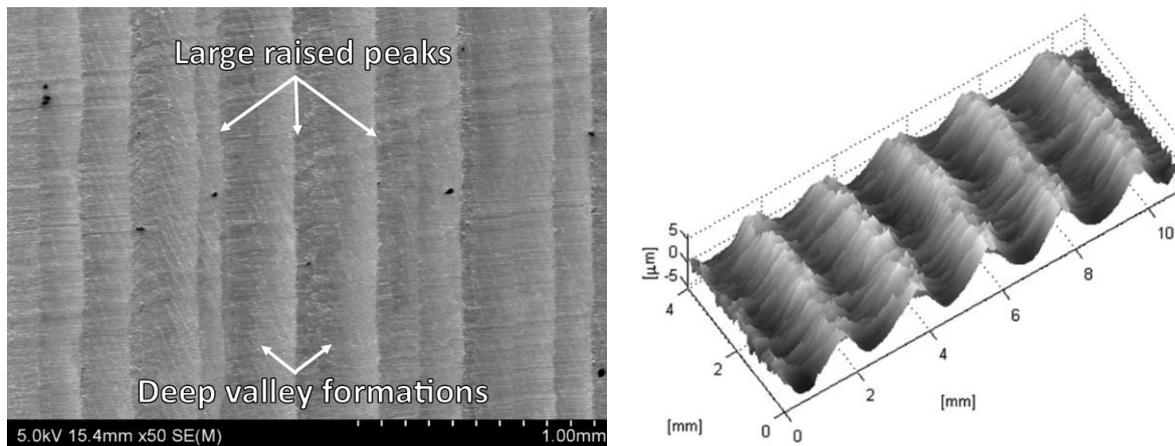
Figure 19 Left: SEM image of surface waviness. Right: A 3D scan of surface waviness. www.mdpi.com (56).

formations. Examples of waviness are shown in Figure 19, showing both an SEM image and a 3D representation of waviness.

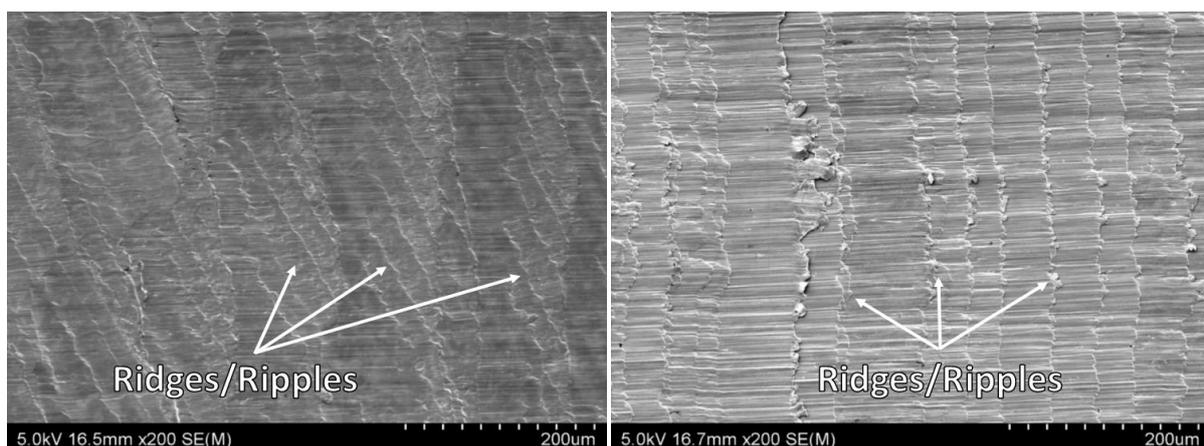
Figure 20 Examples of ridges/ripples on the milled surface.

As well as the large ridges occurring due to the waviness formations, there are also smaller ridge/ripple formations shown on the surface of these milled specimens. The height and nature of these ridges (clean edge vs fractured edge) plays a significant role in the surface finish quality of the specimens. These ridges are generated due to the chip forming mechanism and often attract large amounts of rewelded material, further offering a place for bacteria to breed if used in dental implants. As such these ridges/ripples are detrimental to surface finish. Examples of these are shown in Figure 20.

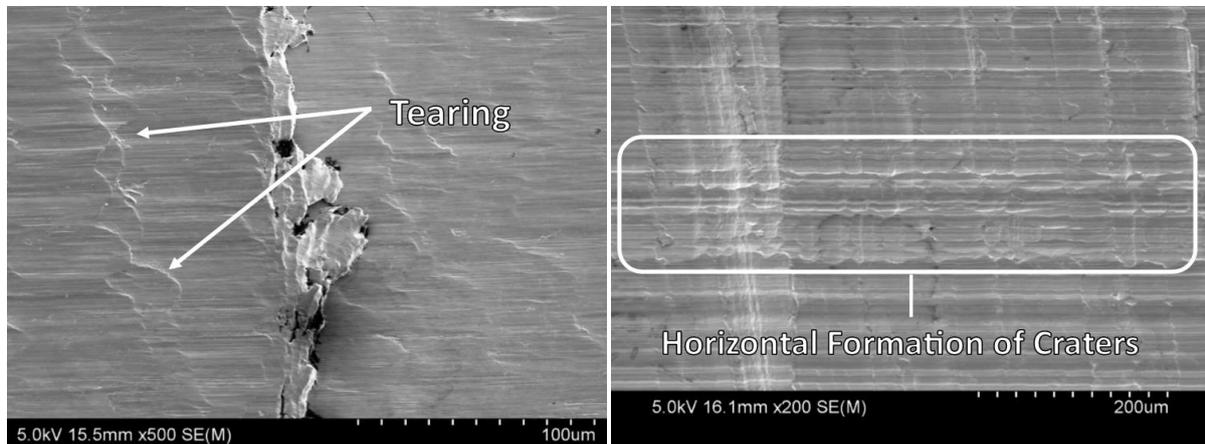
Figure 21 Tearing and craters on the milled surfaces.

horizontal bands of crater formations seen to occur in this study, though worn cutting edges, BUE on the tool and mill vibrations are thought to be likely causations. Examples are shown in Figure 21.

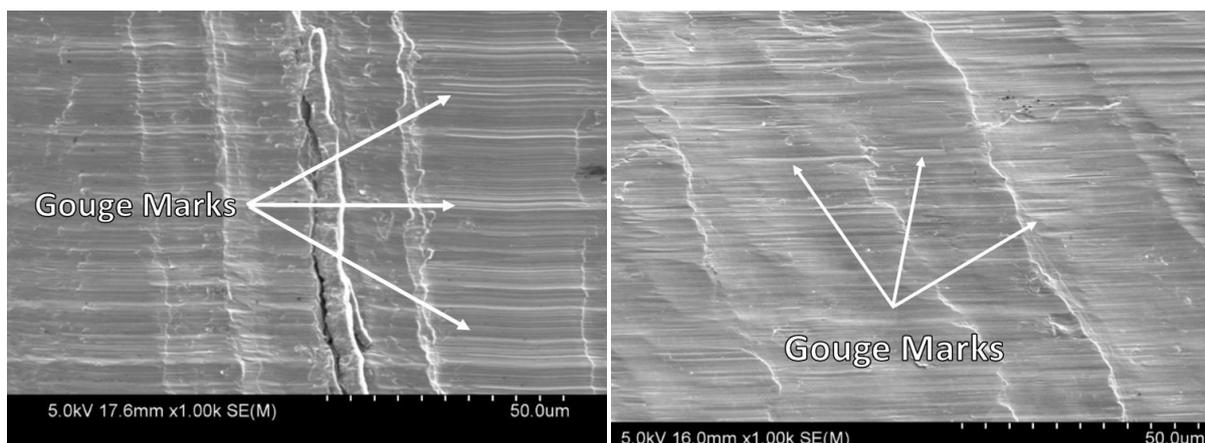
Figure 22 Gouge marks on the milled surface.

The final major surface defect is gouging, these defects appearing as horizontal grooves gouged into the material. Gouges can be caused by a number of factors, however BUE on the mill cutting edge that is then dragged across the surface owing to the ploughing mechanism is strongly suspected as the main cause in this study. It can be summarised that ploughing is therefore the cause of the defect, with the defect being the gouge marks. An example of gouge marks on the milled surface is shown in Figure 22.

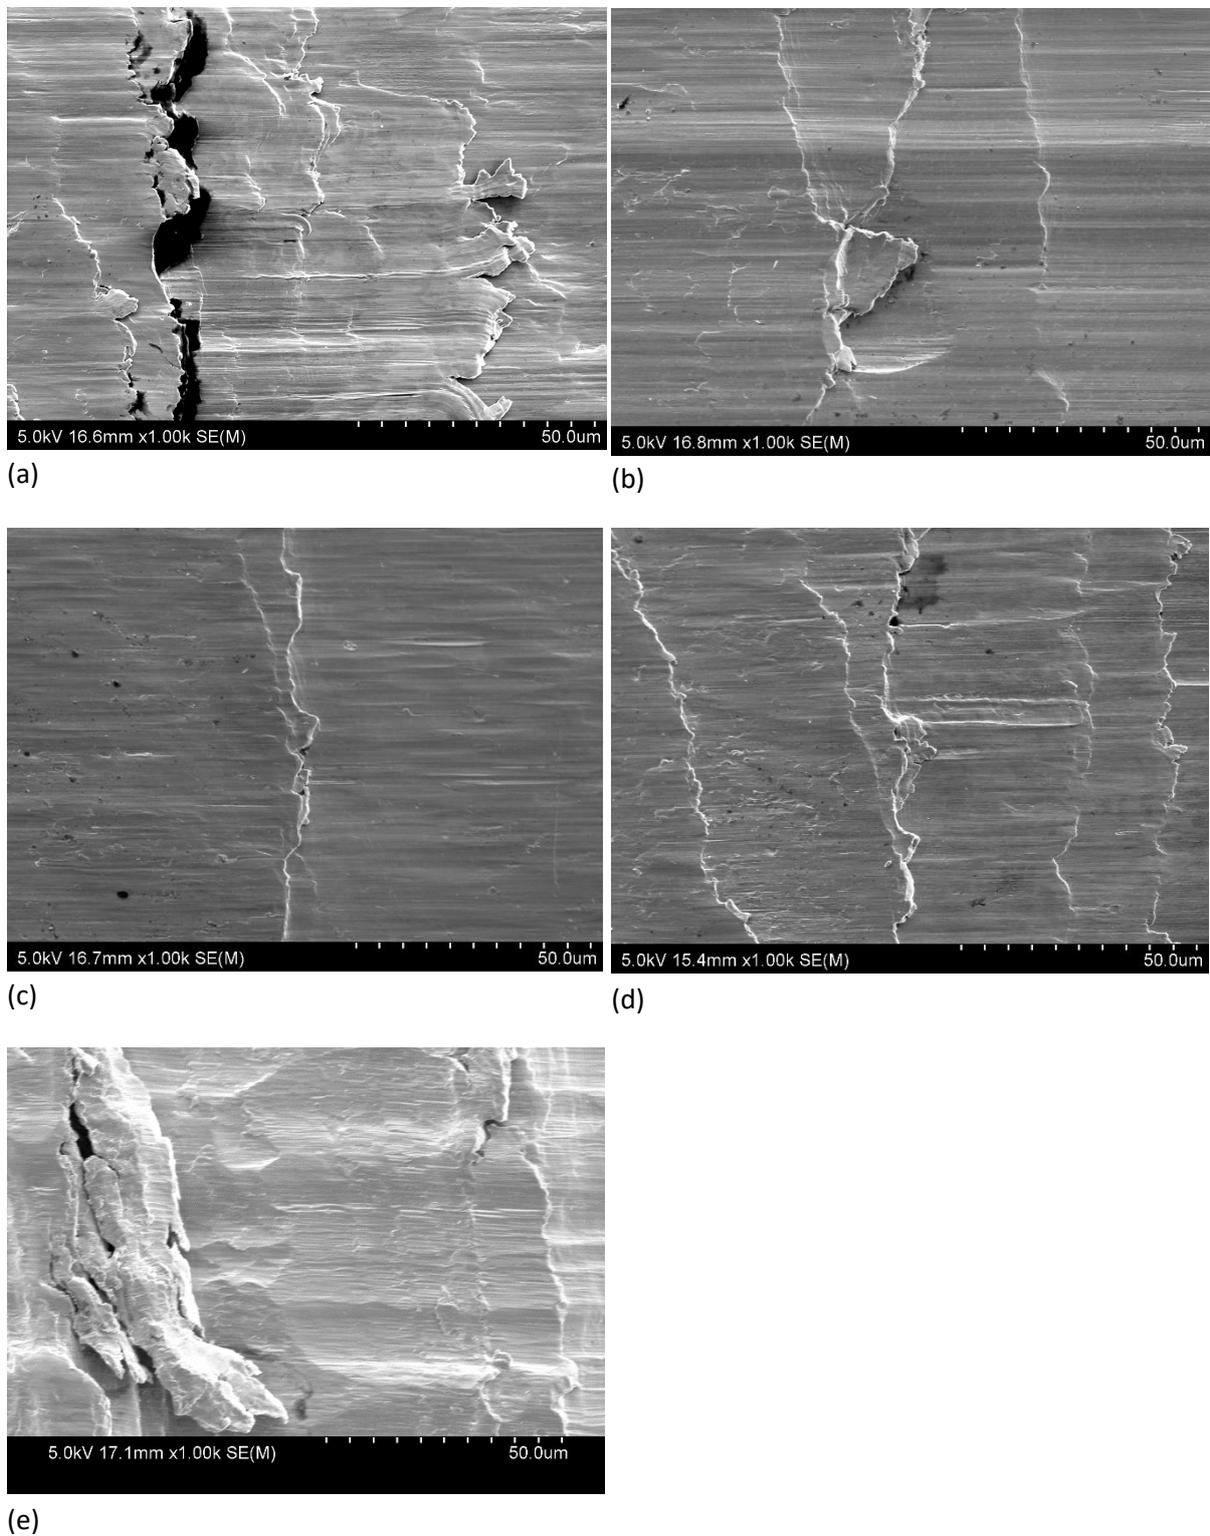
Figure 29 1000x magnification SEM images of specimens laterally face milled at 15,000 RPM showing; (a) as-received CoCrMo milled with Mill A, (b) as-received CoCrMo milled with Mill B, (c) as-received CoCrMo milled with Mill C, (d) as-received CoCrMo milled with Mill D and (e) HT4H CoCrMo milled with Mill B.

certainly has not been shown to occur with the AR CoCrMo specimen milled using Mill B. Images of these magnifications are shown in Figure 29 (a-e).

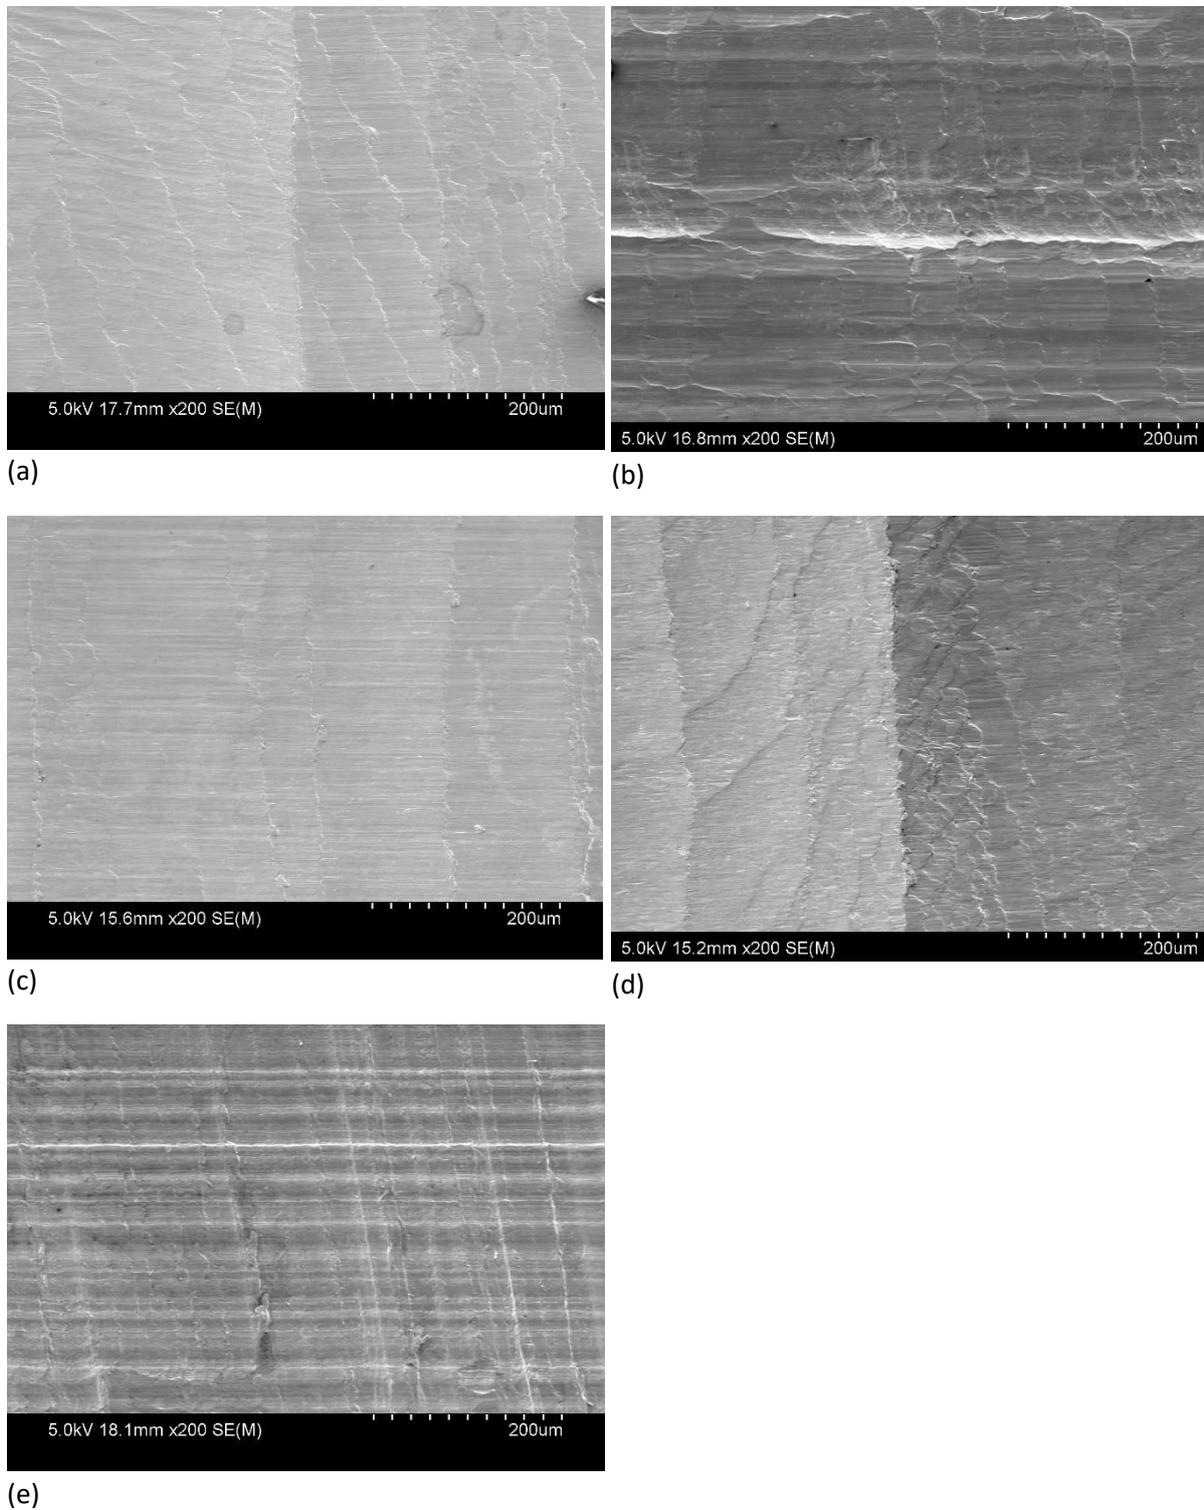
Figure 34 200x magnification SEM images of specimens laterally face milled at 25,000 RPM showing; (a) as-received CoCrMo milled with Mill A, (b) as-received CoCrMo milled with Mill B, (c) as-received CoCrMo milled with Mill C, (d) as-received CoCrMo milled with Mill D and (e) HT4H CoCrMo milled with Mill B.

exhibited a much less rugged and fractured nature. These images are shown in Figure 34 (a-e).

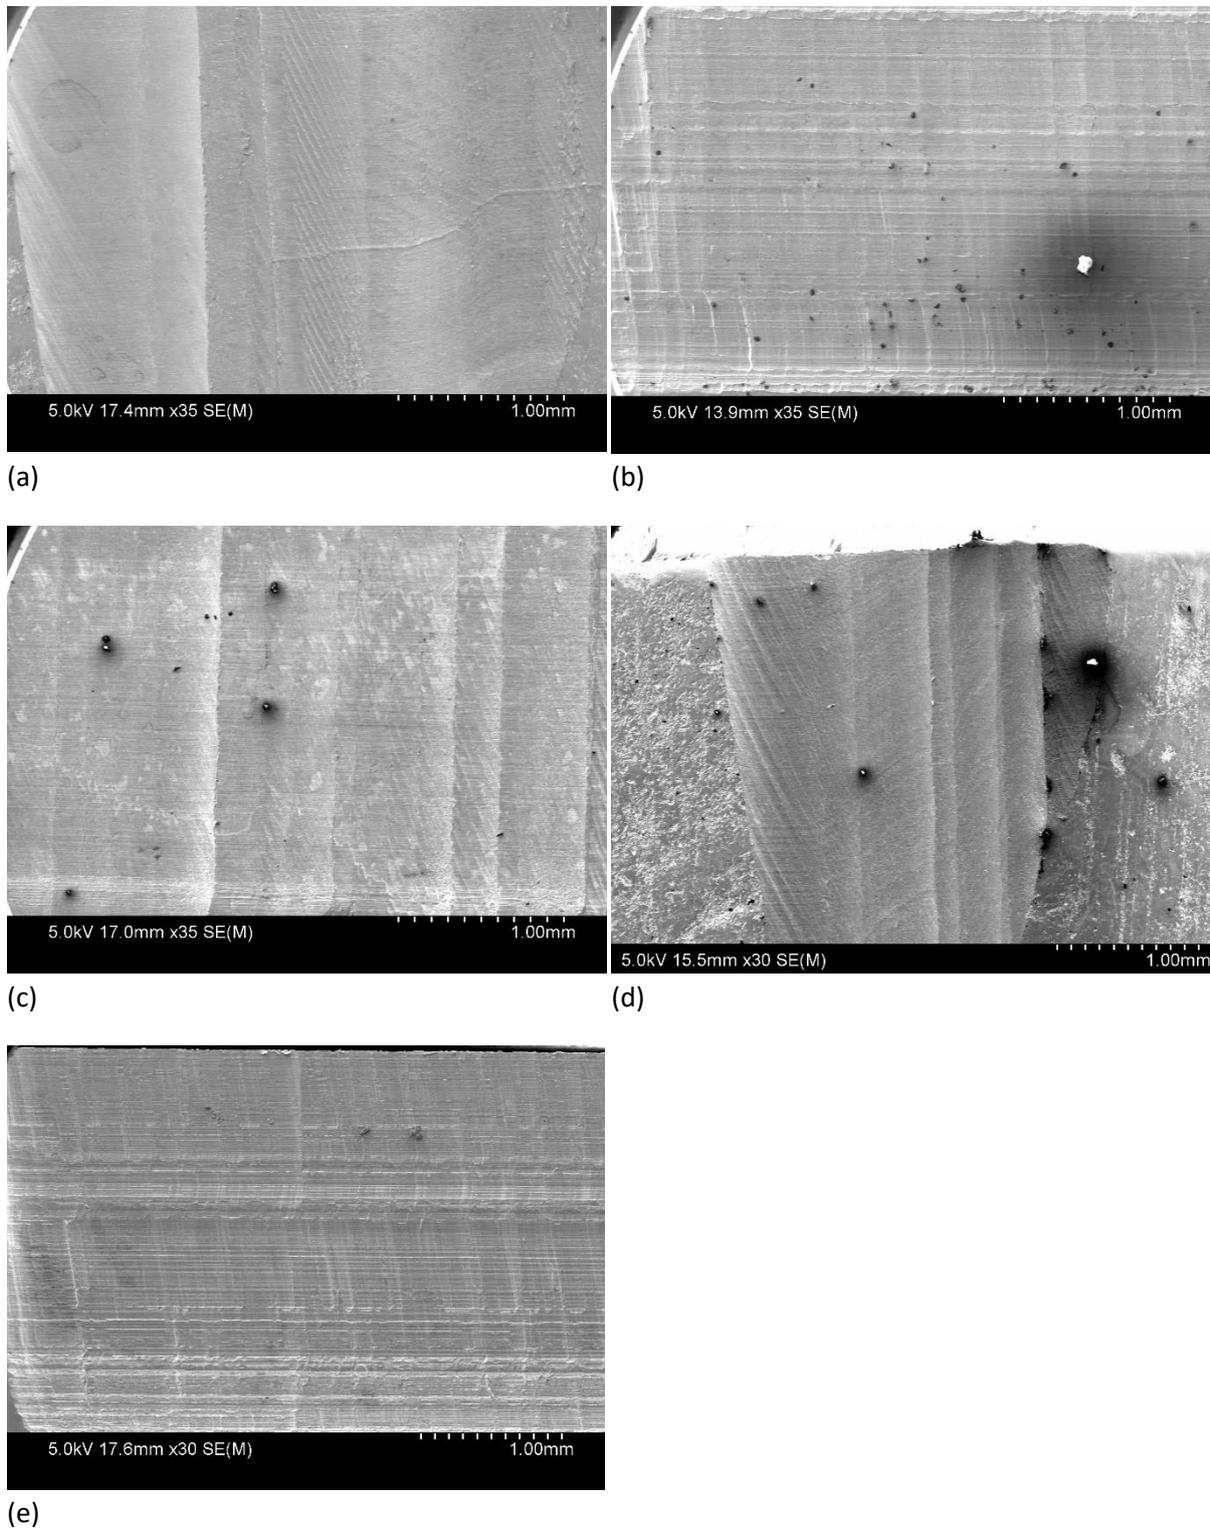
Figure 36 Low magnification SEM images of specimens laterally face milled at 30,000 RPM showing; (a) as-received CoCrMo milled with Mill A, (b) as-received CoCrMo milled with Mill B, (c) as-received CoCrMo milled with Mill C, (d) as-received CoCrMo milled with Mill D and (e) HT4H CoCrMo milled with Mill B.

Images of all five milled surfaces at low magnification are shown in Figure 36 (a-e).

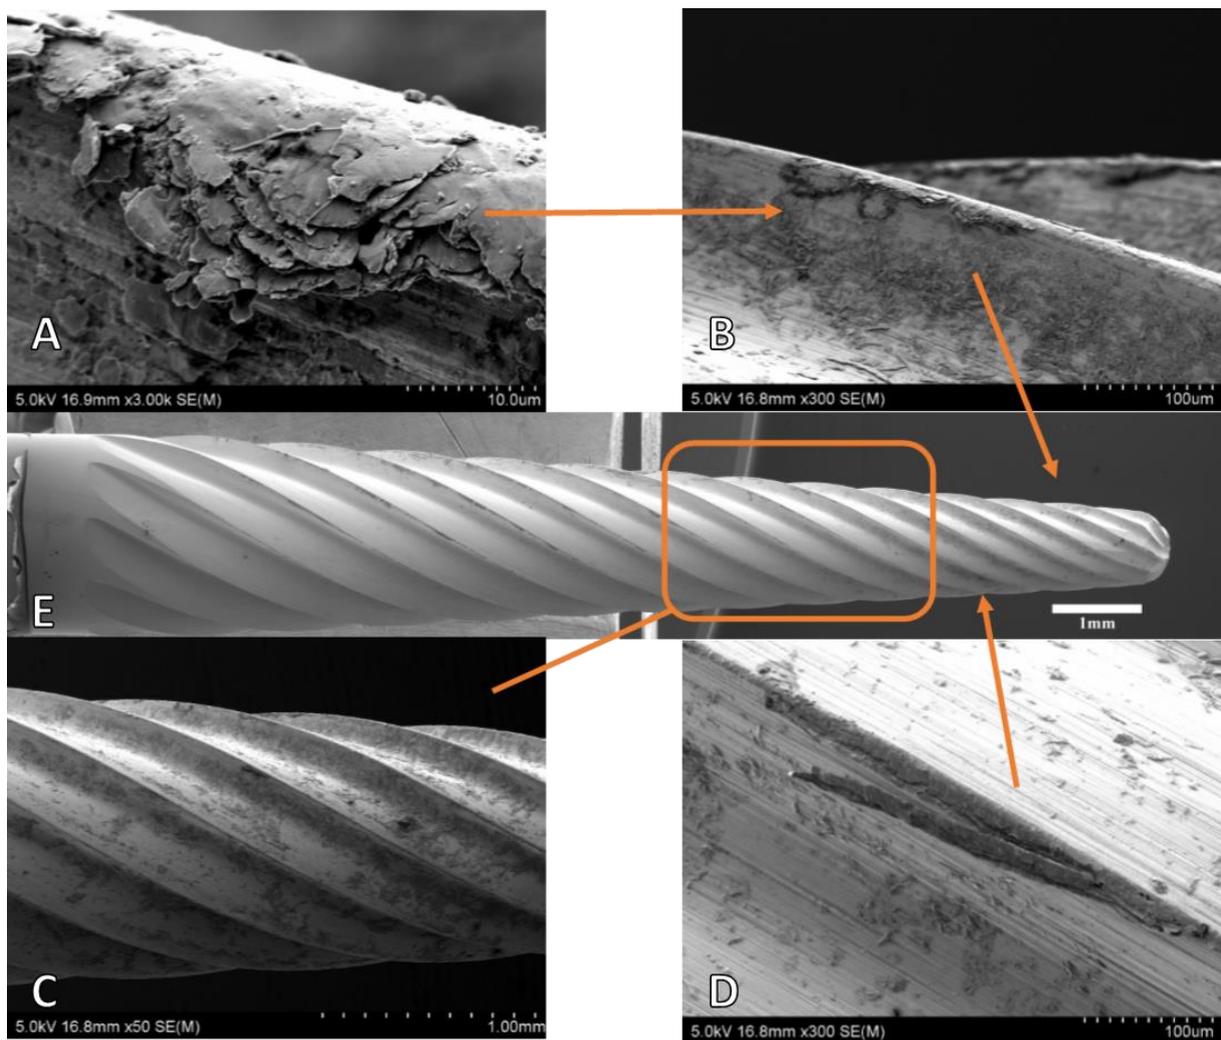
Figure 42 SEM images of Mill A: Meisinger HM23LR after milling As-received CoCrMo.

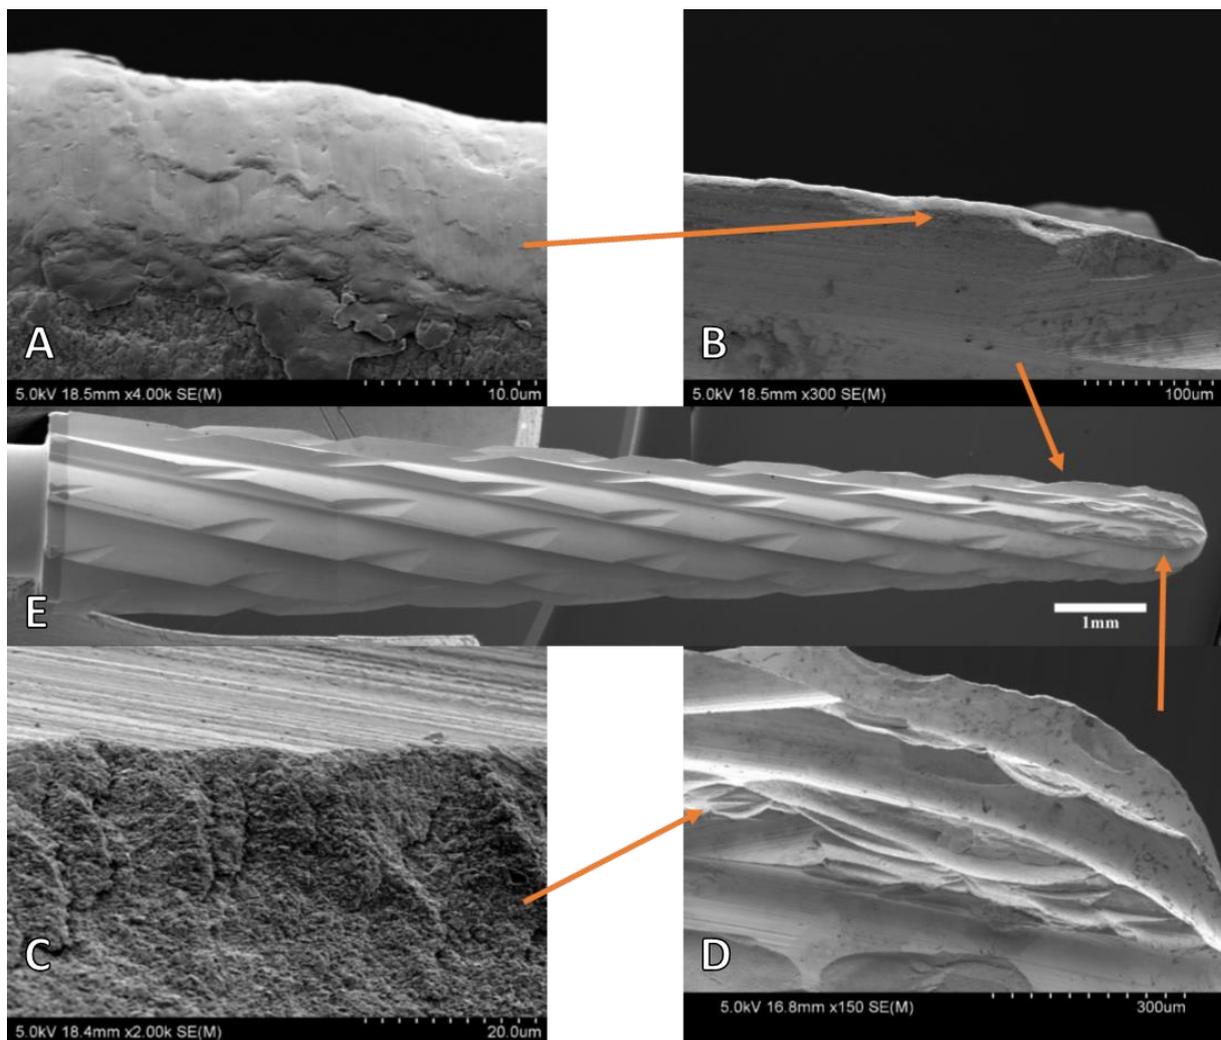
Figure 43 SEM images of Mill B: Shofu 21N after milling As-received CoCrMo.

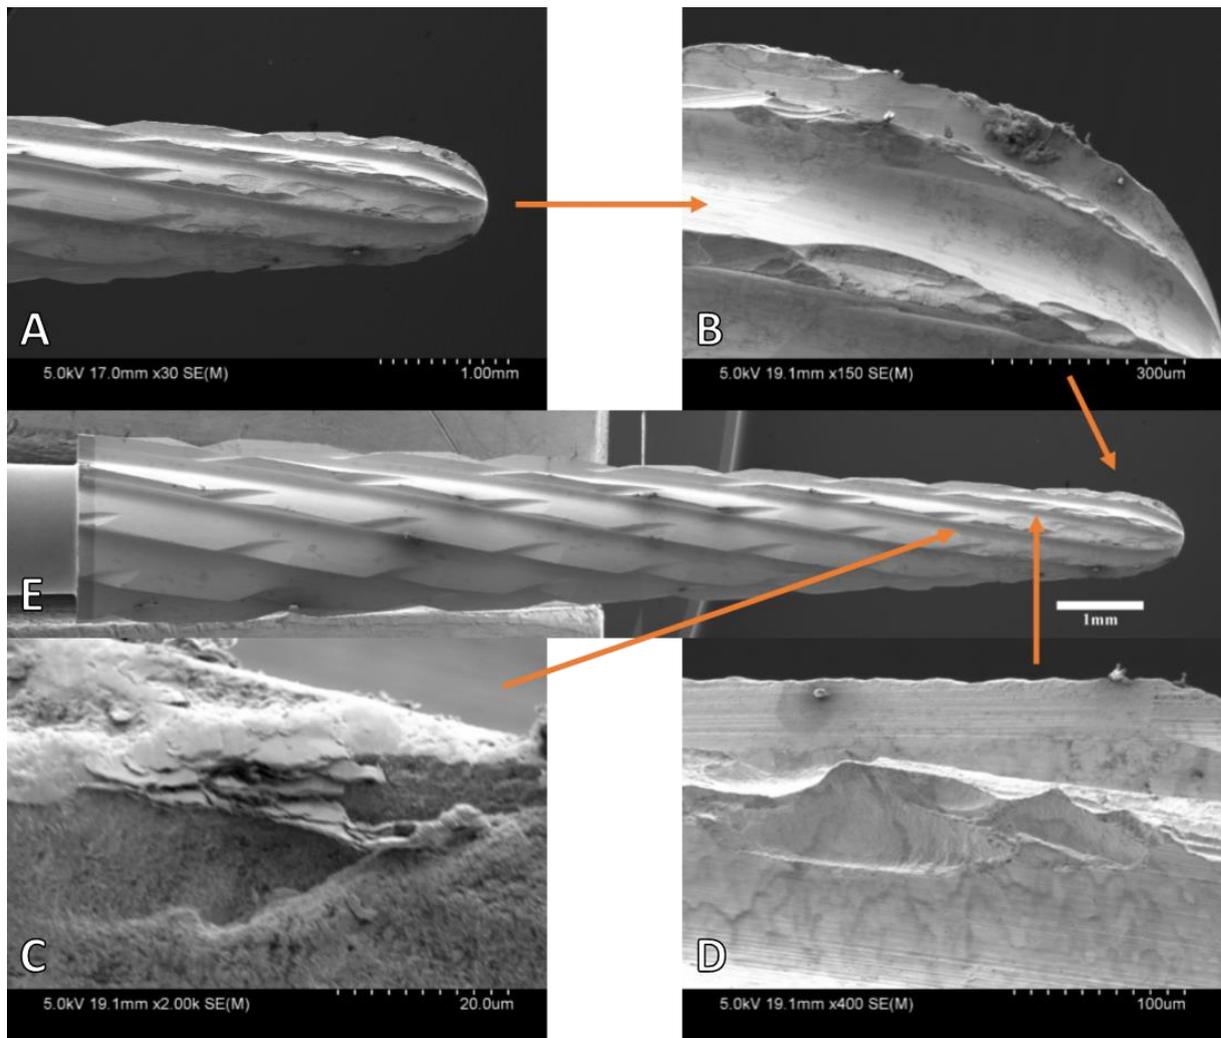
Figure 44 SEM images of Mill B: Shofu 21N after milling HT4H CoCrMo.

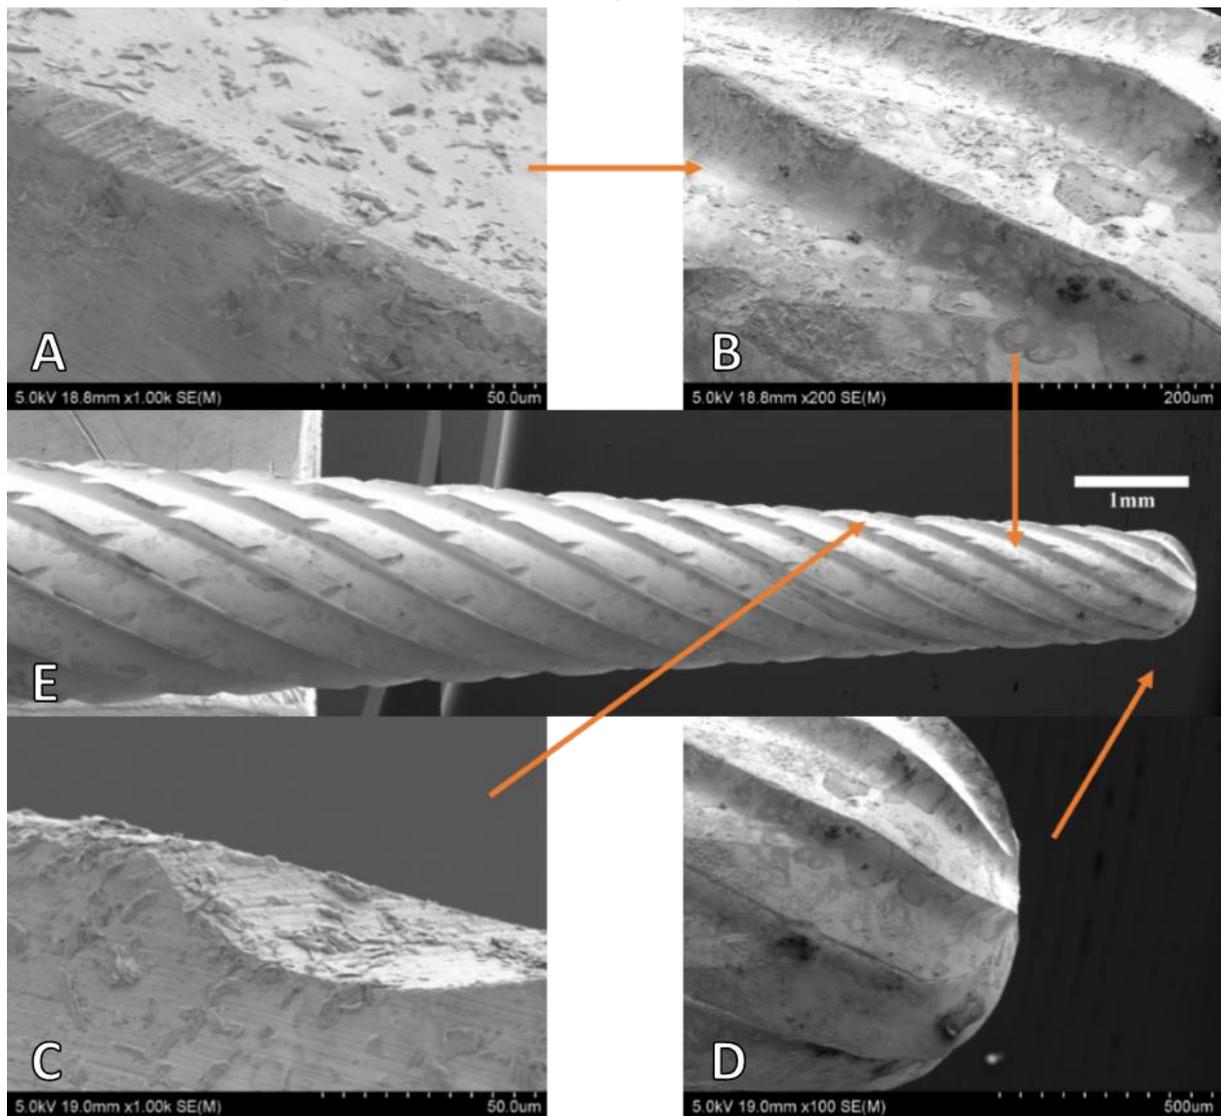
Figure 45 SEM images of Mill C: Meisinger HM23GX after milling As-received CoCrMo.

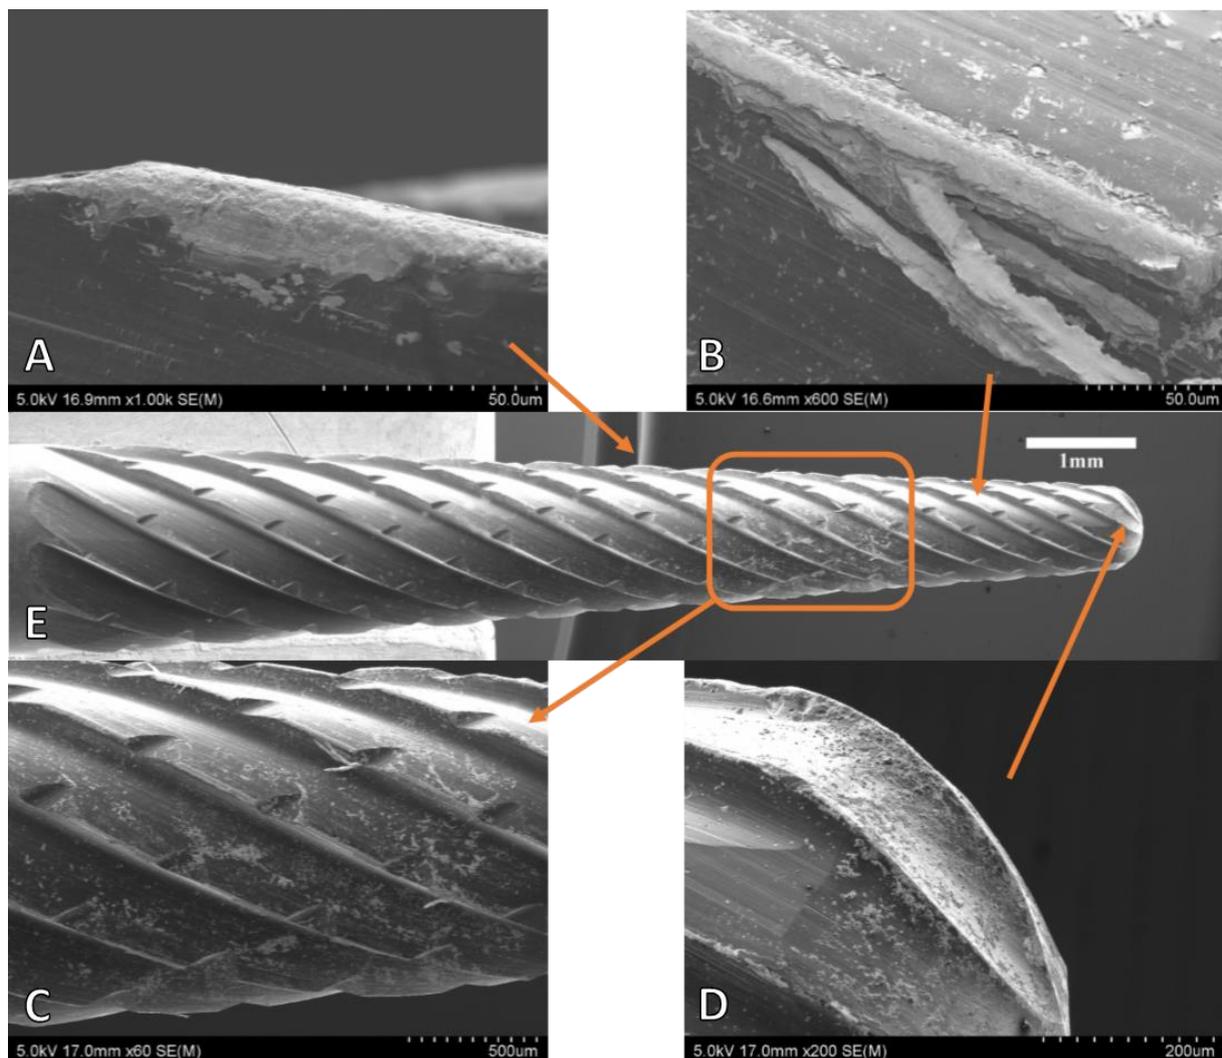
Figure 48 SEM images of Mill D: Meisinger HMB23G after milling As-received CoCrMo.
