An Investigation Into The Surface Finish of Laterally Face Milled
Cobalt-Chromium-Molybdenum Alloys

A thesis

Master of Engineering

**School of Engineering, Computer, and Mathematical Sciences,
Auckland University of Technology**

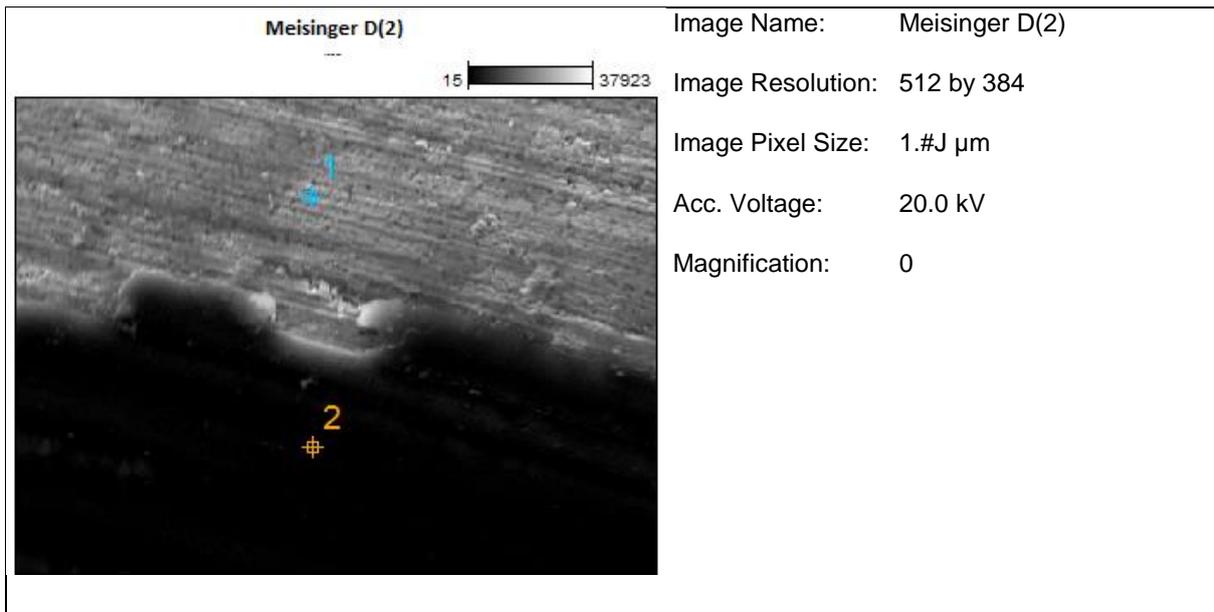
Figure 49 Mill D, DLC layer two point EDS test.

In order to verify the DLC coating had been worn on the tool edges, and that the eroded edges were what was believed to be shown in the previous images, an energy-dispersive X-ray spectroscopy (EDS) investigation was undertaken on the used mill. Two tests were undertaken with the used mill in this investigation. First, a two point, standard less, analysis scan was taken with one point on the exposed tungsten carbide (WC) surface, the other on the DLC layer. Secondly, a window scan was taken over an area showing the eroded tool edge and flute body where the DLC layer had not been delaminated. This scan was then mapped into the five key elements to show where the counts were found. Shown first is the two point test in Figures 49 and 50 and Table 12.

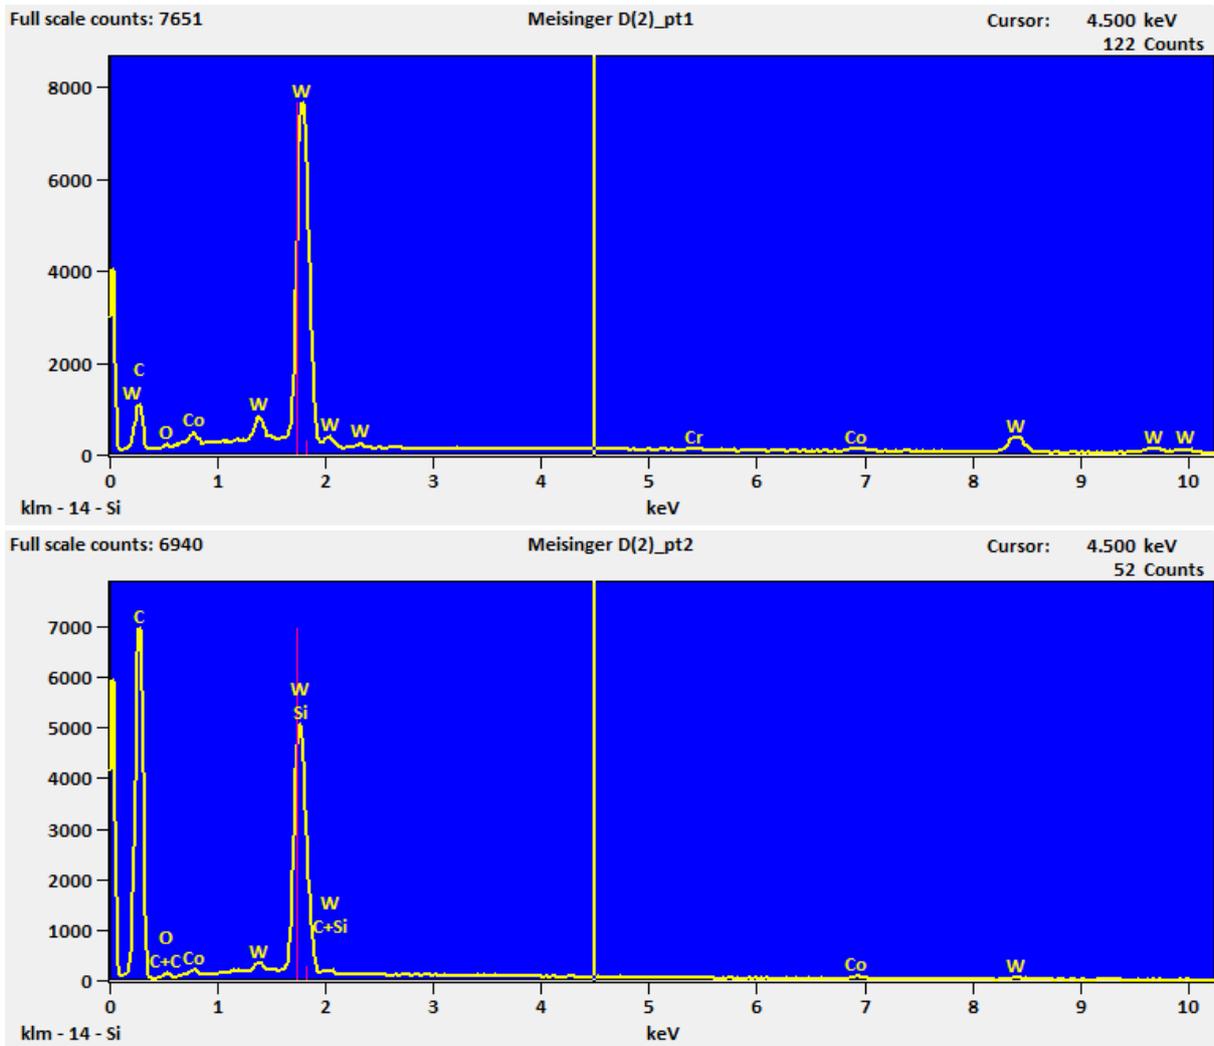
Figure 50 Mill D, DLC layer two point EDS test counts.

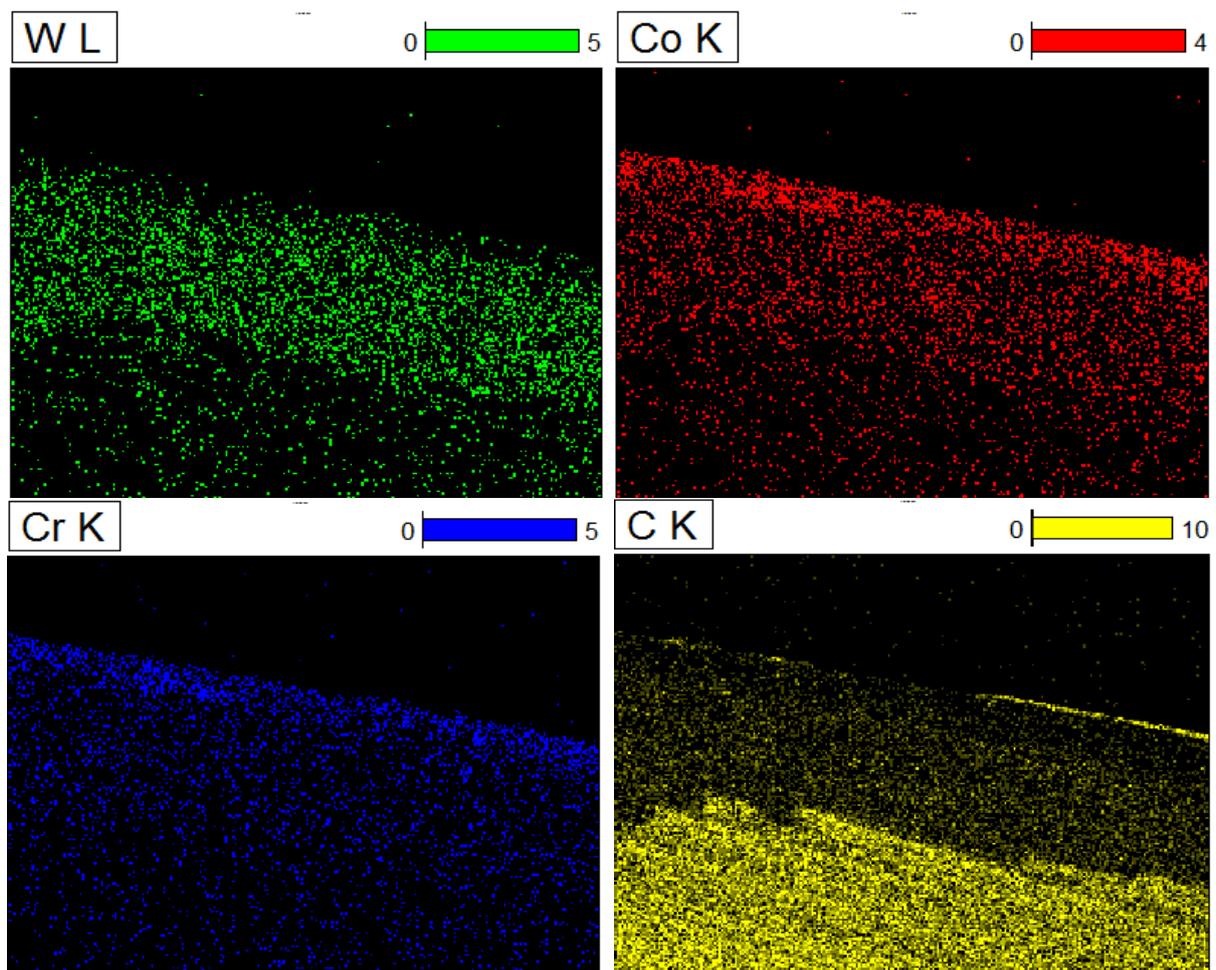
Figure 52 Mill D, DLC layer EDS window scan maps.

Figure 52 displays the mapped images of the data obtained from the EDS window scan shown in Figure 51. The four elements plotted were Tungsten (W), Cobalt (Co), Chromium (Cr), and Carbon (C). The light grey area in Figure 51 is believed to be the exposed cemented tungsten carbide (WC), with the dark black area below this being the DLC layer. The W and Co maps show the majority of these element counts occurring in the light grey area of the mill, with the Cr map showing this to a less defined extent. Co and Cr elements present on the mill would be due to the contact between the workpiece and tool during milling, therefore it is logical that the eroded area would show higher concentrations of these elements. Furthermore, since the majority of W in Table 12 was found in the mill composition, it is expected these element counts would appear on the light grey area (mill body). Most convincing is the map of C, showing the counts of C in a highly defined shape mimicking the dark area from Figure 51. Since DLC consists mainly of carbon, this leads to the conclusion that by using EDS analysis it can be definitively shown that the light grey area seen on the tool flutes is the tungsten carbide material of the mill where the DLC layer has been delaminated.

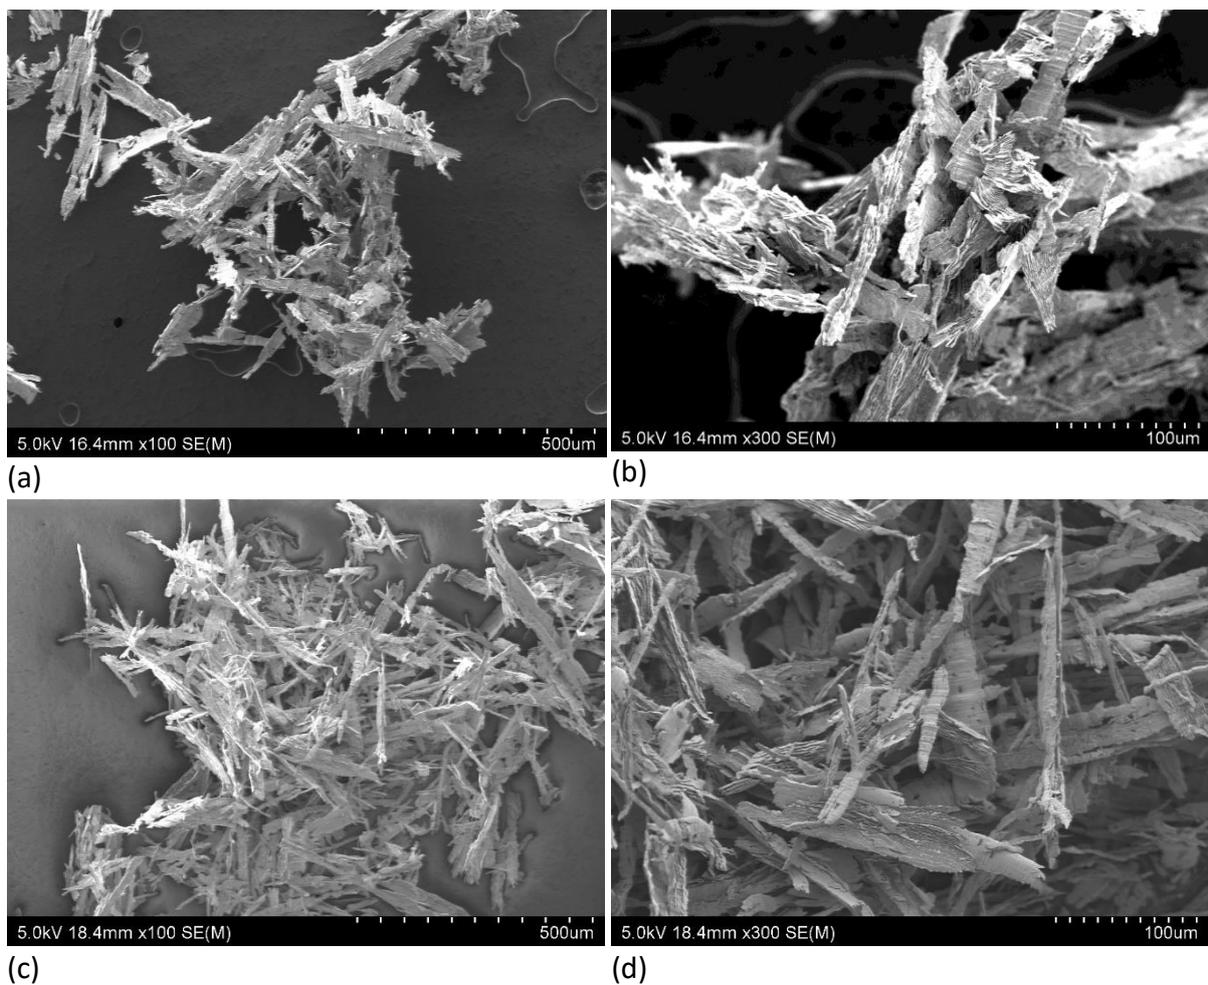
Figure 53 SEM images of chips obtained from AR CoCrMo milled at 25,000 RPM. (a, and b) chips from Mill A, (c, and d) chips from Mill B.

Samples of the machined chips were collected after milling to be viewed and analysed. These chips were mounted on carbon paper and viewed using SEM to see if there were any noticeable differences between chips from differing mills and/or spindle speeds. The author was unable to see any definitive differences between chips obtained from differing conditions (further analysis is recommended to be carried out). In order to illustrate this, five sets of chips from a spindle speed of 25,000 RPM are displayed, including chips collected from AR CoCrMo milled with Mill A, Figure 53 (a, b); Mill B, Figure 53 (c, d); Mill C Figure 54 (a, b); Mill D, Figure 54 (c, d) and HT4H CoCrMo milled with Mill B, Figure 54 (e, f). Images displaying the chips from AR CoCrMo milled with Mills A and B are shown with 300x and 100x magnifications, while the rest of the images are displayed with 100x and 30x magnifications. These images are shown in Figures 53 and 54.

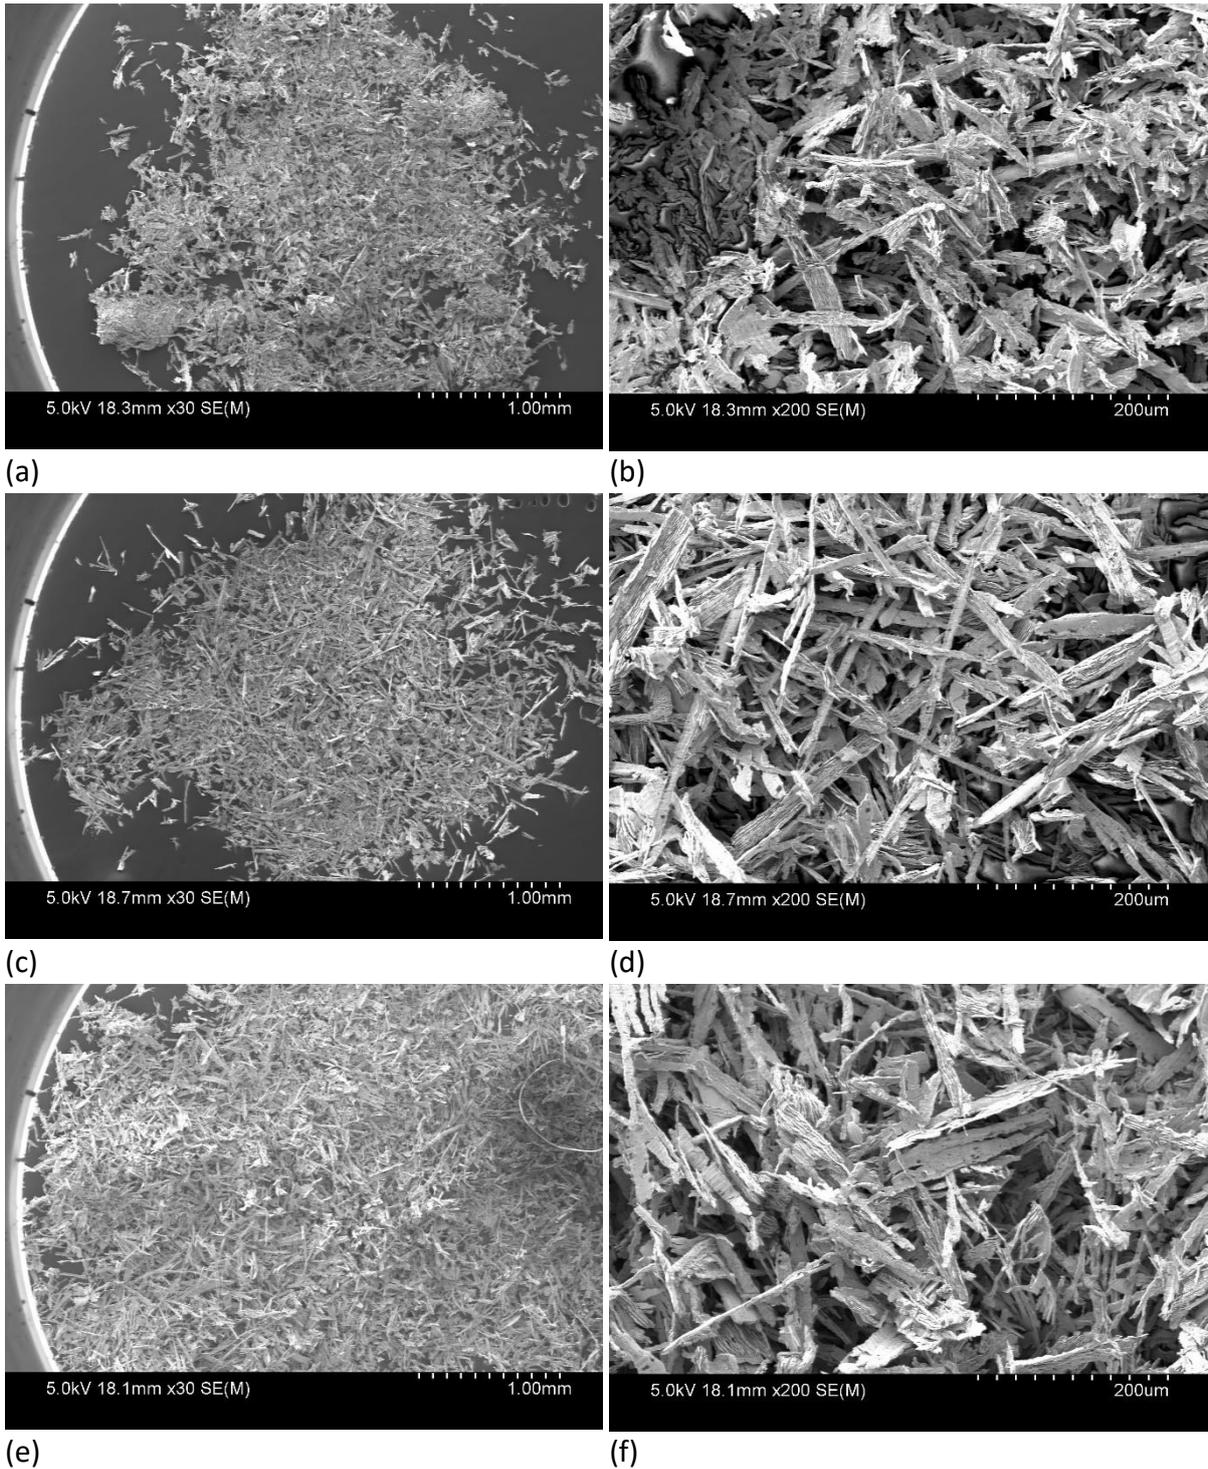
Figure 54 SEM images of chips obtained from milling; AR CoCrMo milled with Mill C (a, b), AR CoCrMo milled with Mill D (c, d) and HT4H CoCrMo milled with Mill B (e, f). All milling was undertaken at a spindle speed of 25,000 RPM.

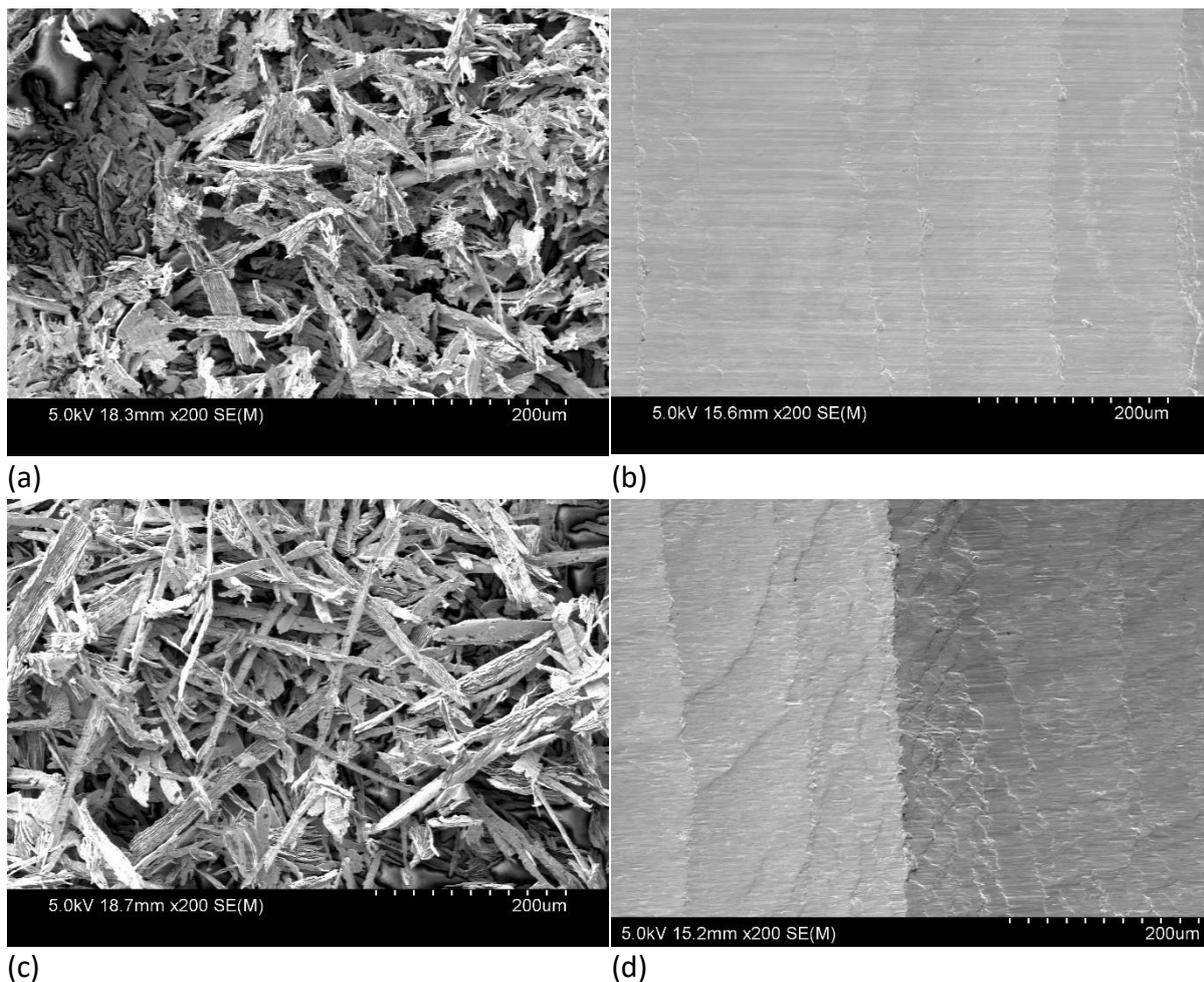
Figure 55 Chips vs corresponding surface finish for AR CoCrMo milled with Mills C, and D at 25,000 RPM.

undertaken at 25,000 RPM. At this spindle speed major variances in surface finish were shown, with Mill C producing a relatively good surface finish, and Mill D producing a poor surface finish exhibiting high amounts of waviness and rewelded material. However, looking at Figure 54 (c, d) and (e, f) very little difference can be seen between chips obtained from these passes. This further backs up one of the underlying theories of this study that states mill vibrations, BUEs, and ploughing (related to the minimum chip thickness theory), are the main detriments to surface finish, rather than the tool geometry and related chip forming mechanism. To further illustrate this point, Figure 55 shows the surface finish and chips obtained from each test for Mill C, and Mill D milling AR CoCrMo at 25,000 RPM. It is apparent that Figure 55 (a) does appear to show slightly thicker and shorter chips than Figure 55 (c). However, this is only a small sample of the chips collected and despite these differences the author sees very little possibility that such minor differences in chip geometry could lead to such differing surfaces as shown in Figure 55 (b, and d).

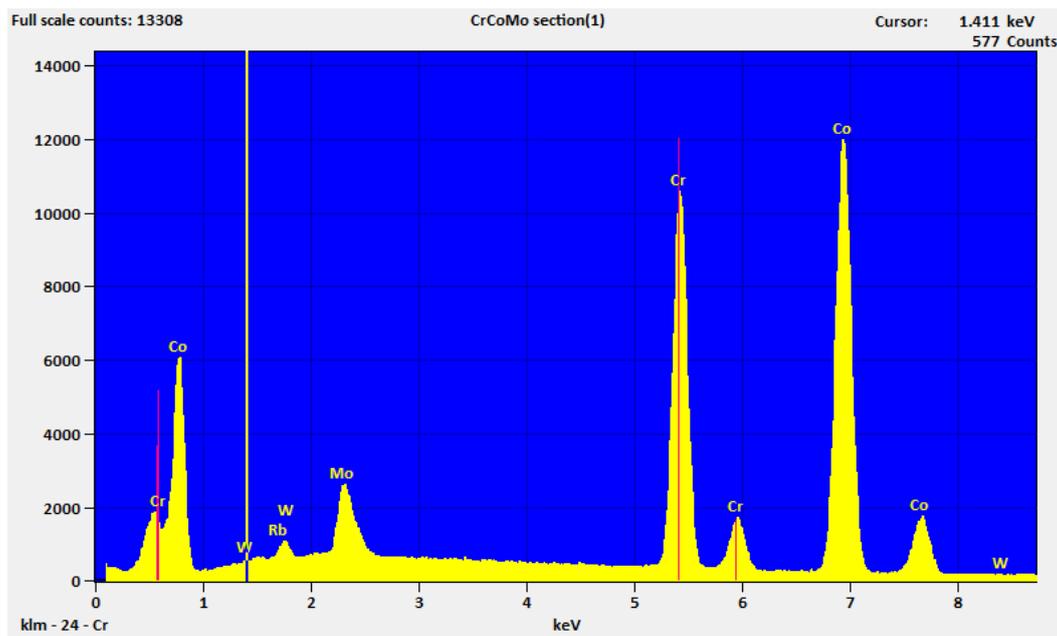
Figure 56 EDS composition scan of AR CoCrMo specimen.

respectively. Aside from the mystery peak, the EDS showed a slightly higher Cr reading, and a slightly lower Mo reading, while the Co reading was fairly identical to the manufacturer's specifications. Furthermore, small trace elements like Ni, Fe, C, N, and Mn were not found in the obtained data, however due to the relative quickness of the test and it being standard less, the SEM technician recommended it was reasonable to conclude that the composition of the specimen is in line with the manufacturer's specifications and it can be confirmed to be CoCrMo.

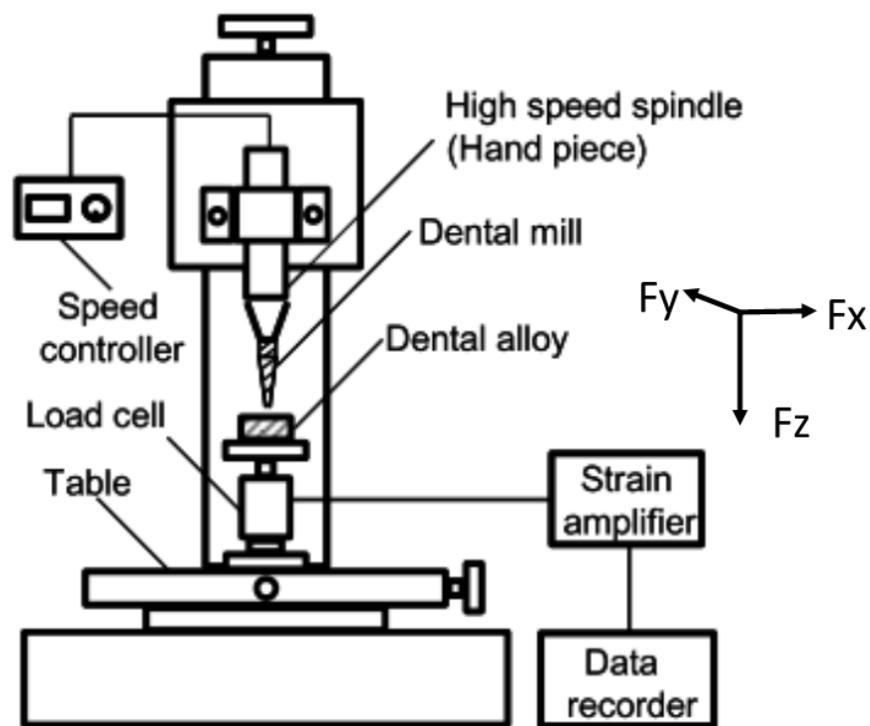
Figure 62 Milling diagram with force directions. M. Takahashi et al. (29)

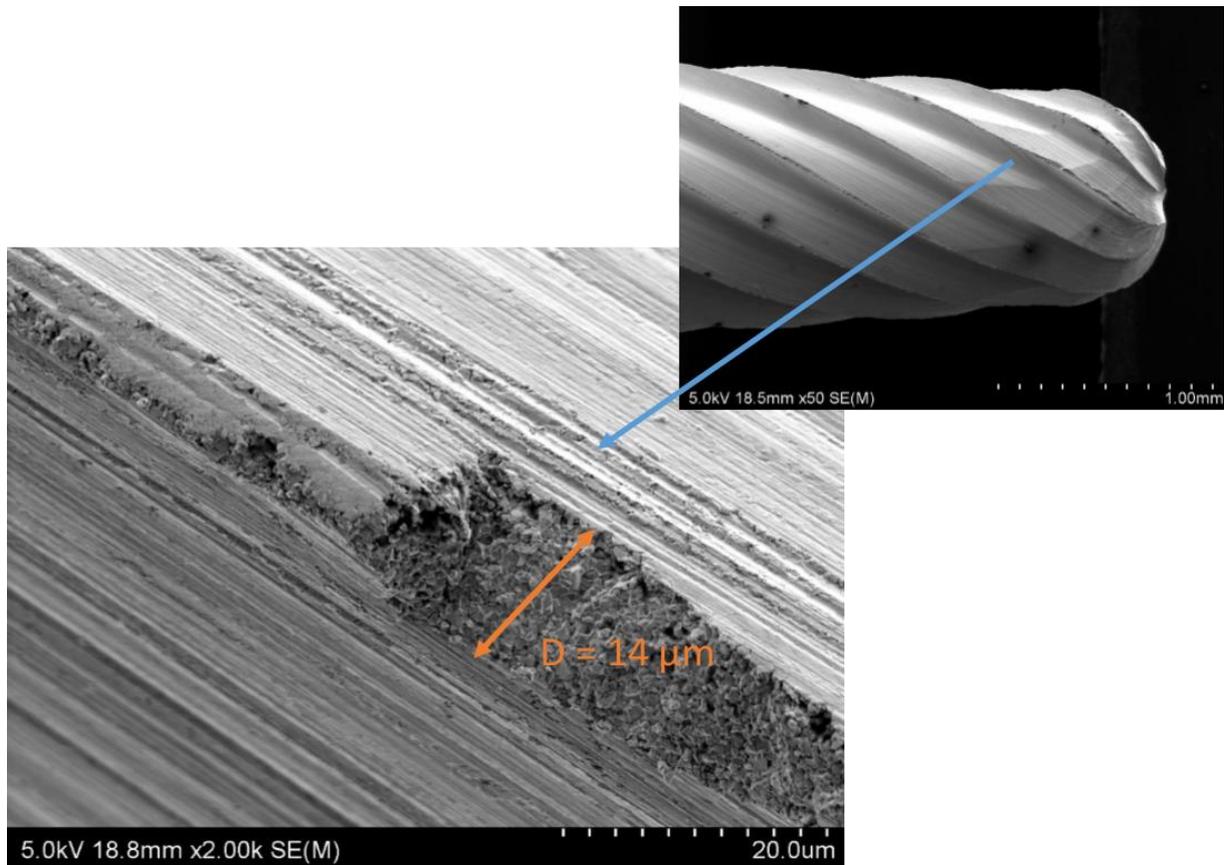
Figure 63 Mill A: Meisinger HM23LR cutting edge radius (r).

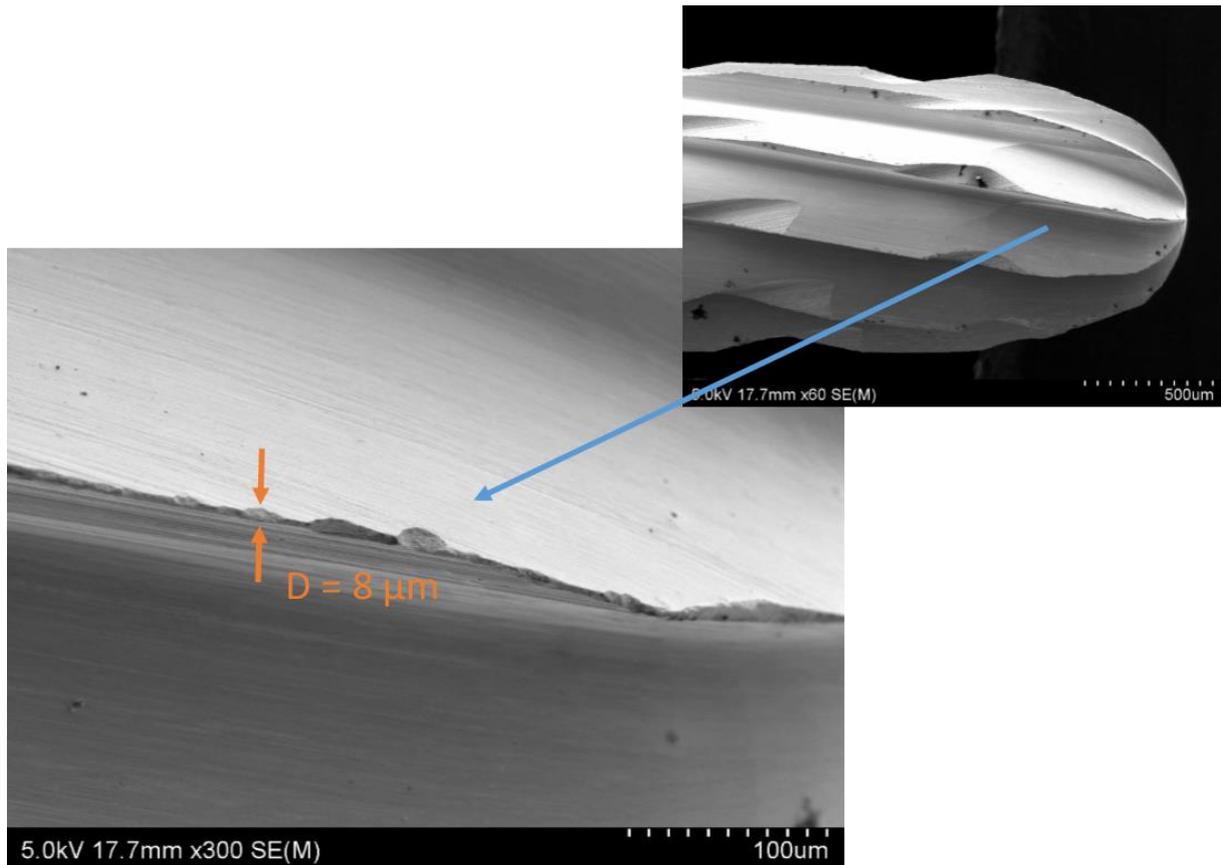
Figure 64 Mill B: Shofu 21N cutting edge radius (r).

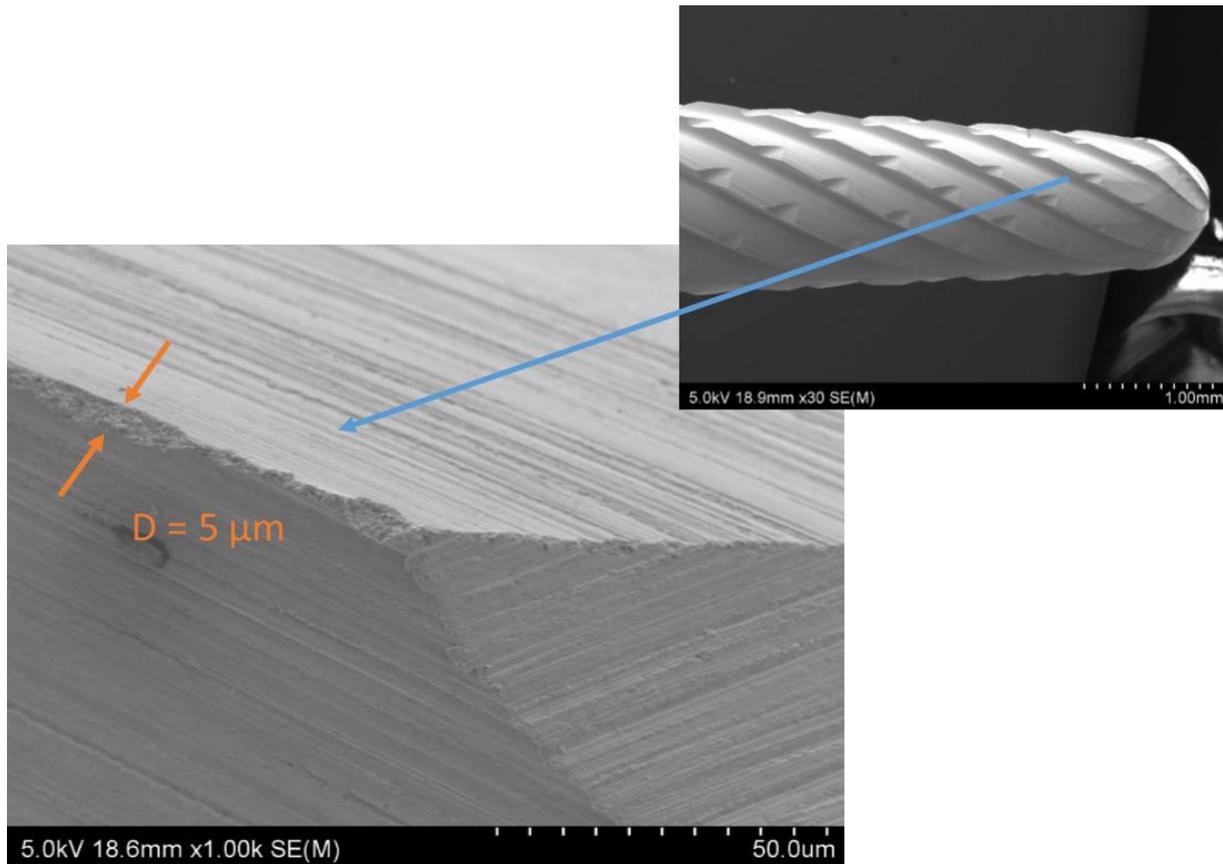
Figure 65 Mill C: HM23GX cutting edge radius (r).

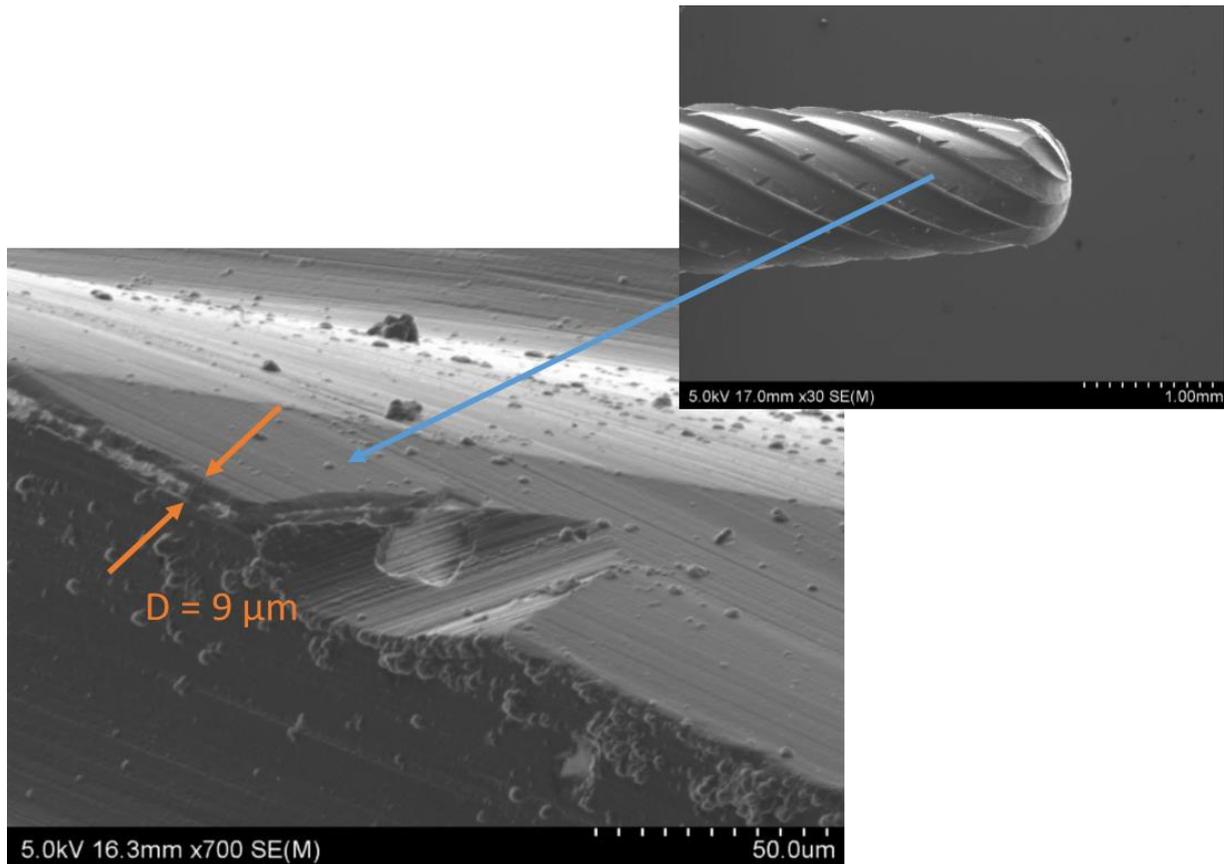
Figure 66 Mill D: HMB23G cutting edge radius (r).

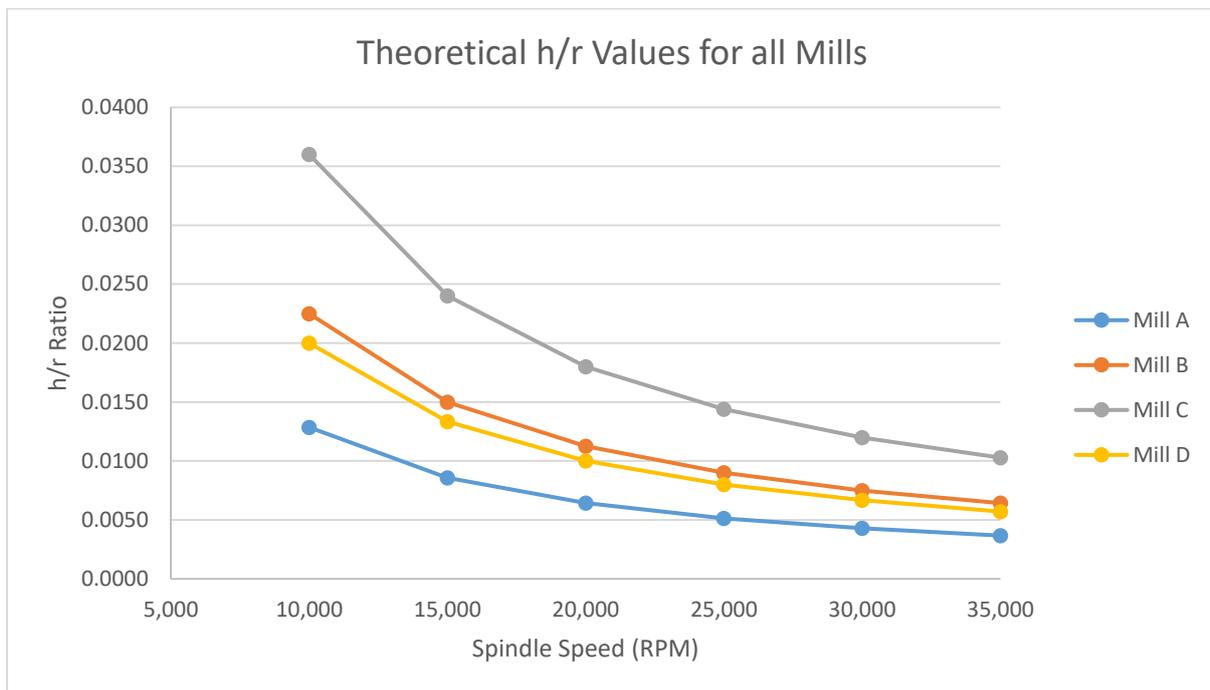
Figure 67 Theoretical h/r Values vs spindle speed (RPM) for all mills.

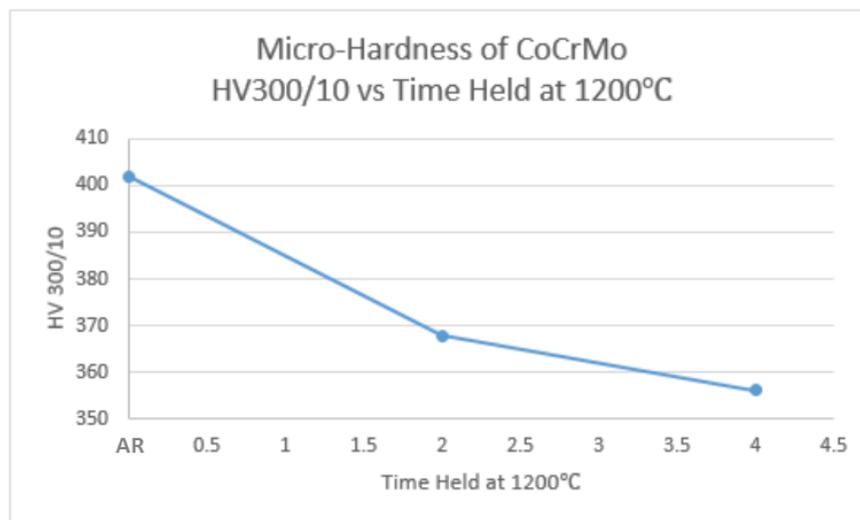
Figure 68 Micro-hardness of CoCrMo vs annealing time.

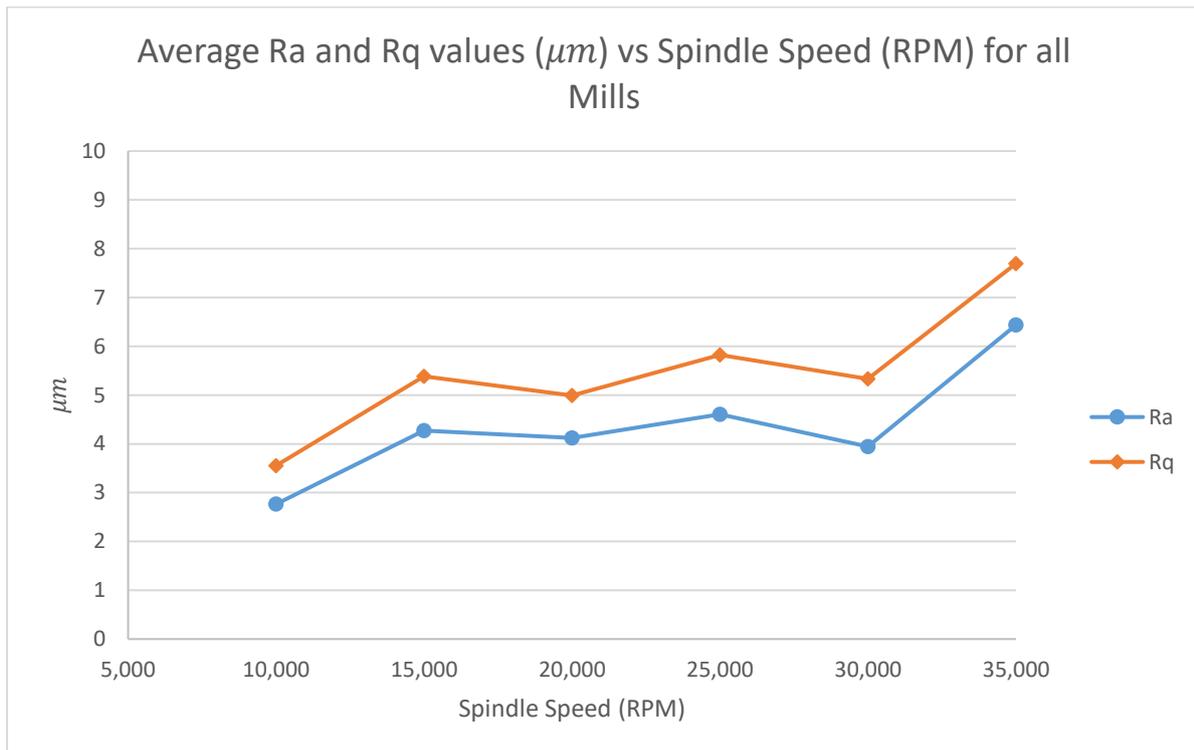
Figure 70 Average Ra and Rq values (μm) vs Spindle Speed (RPM) for all mills.

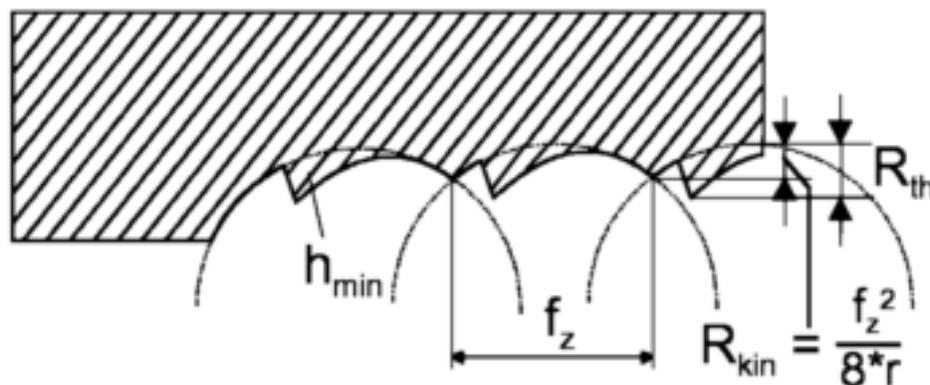
Figure 72 Saw tooth profile typical of the minimum chip thickness effect. V. Huntrup et al. (53).

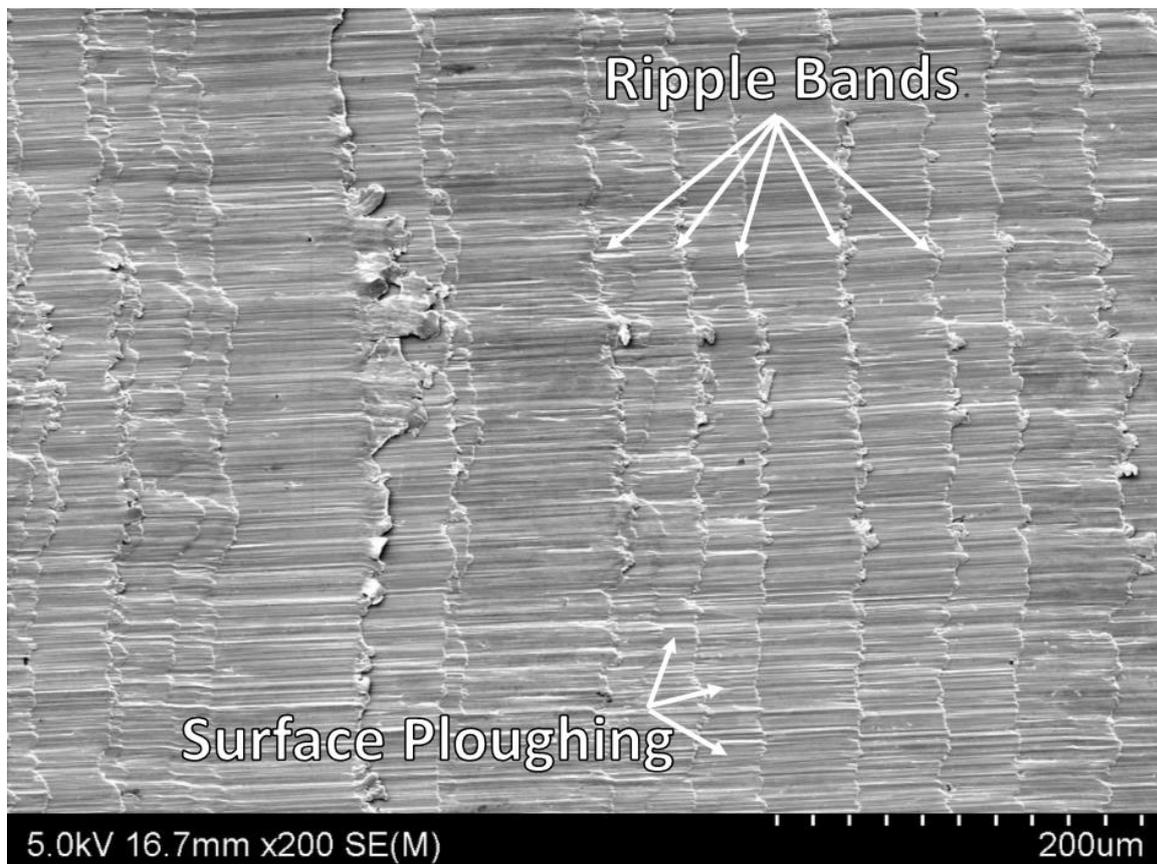
Figure 73 Minimum chip thickness analysis of the surface milled by Mill A at 10,000 RPM.

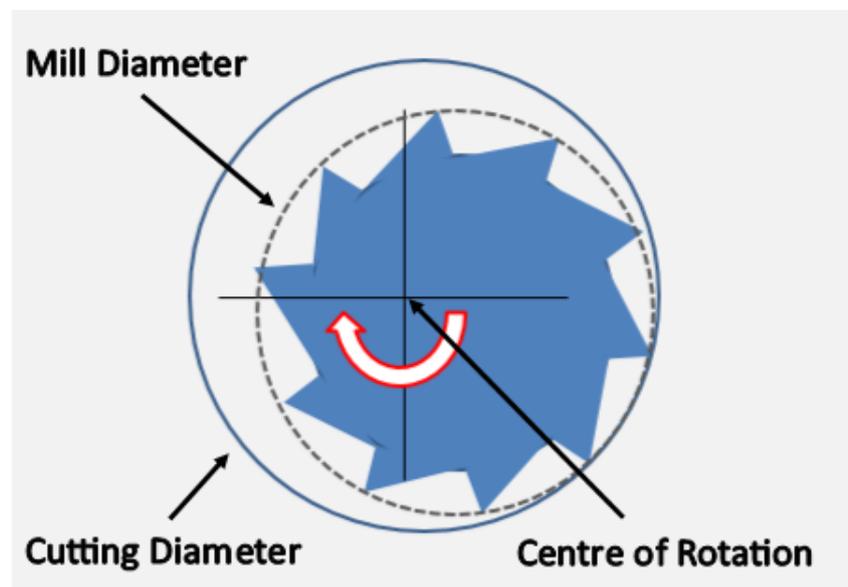
Figure 74 Run-out deviation diagram. P. Connor et al (57)

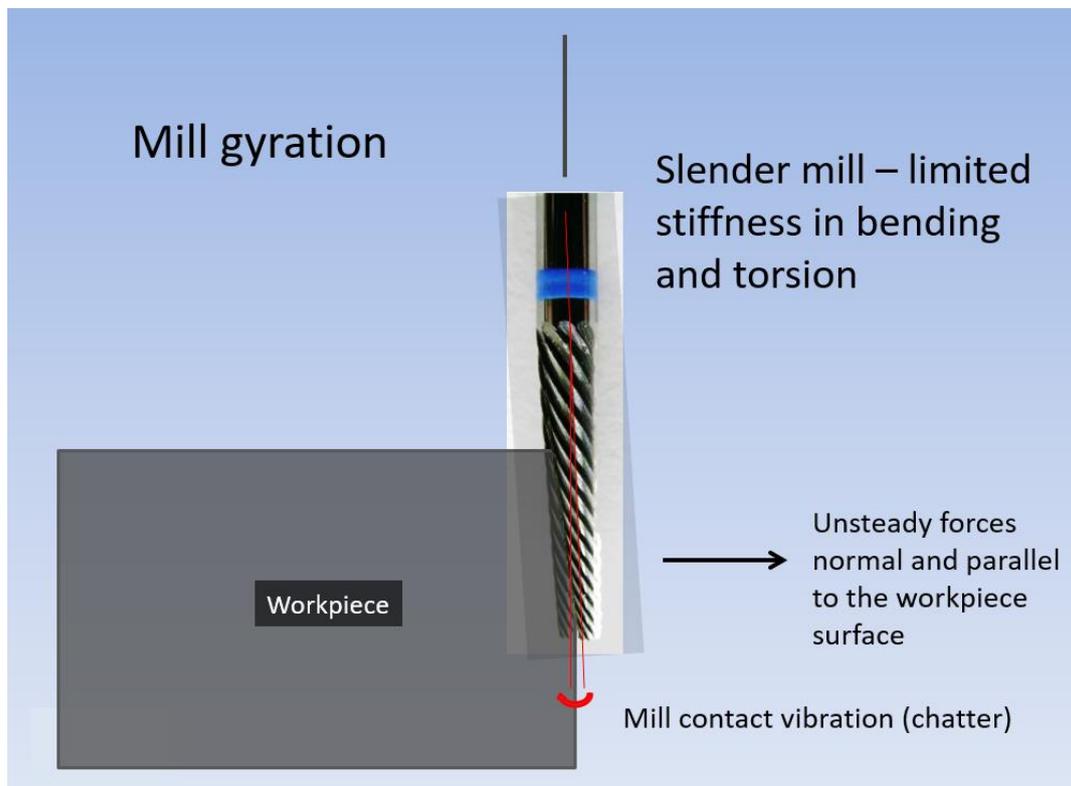
Figure 75 Mill gyration diagram. P. Connor et al. (57)
