# Integrating energy retrofit with seismic upgrades to future-proof built heritage: Case studies of unreinforced masonry buildings in Aotearoa New Zealand

Energy retrofit  
Unreinforced masonry buildings  
Integrated retrofit  
Seismic strengthening  
Heritage adaptation  
New Zealand heritage

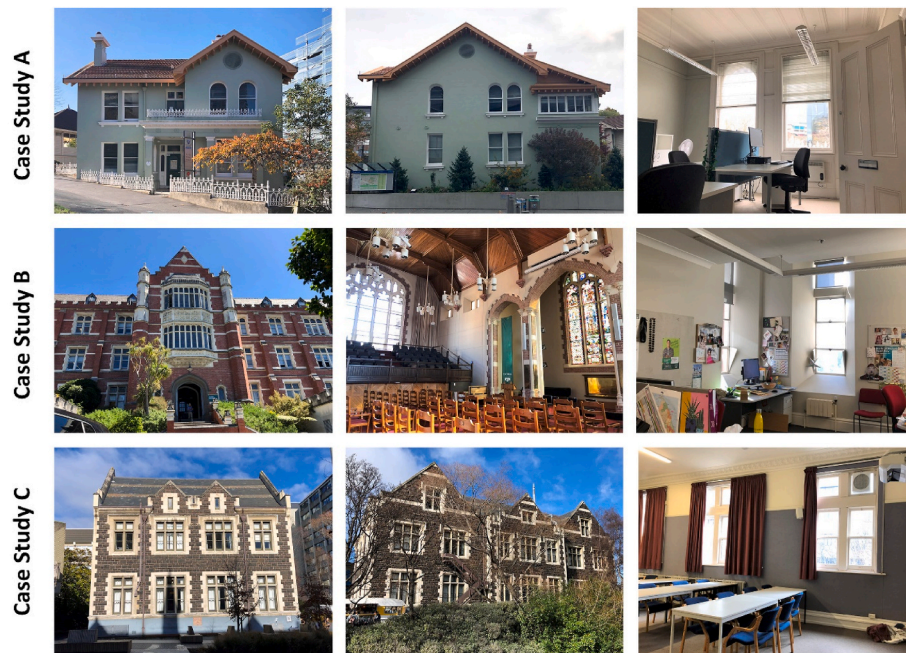
Fig. 1. External and internal photos of case study buildings A, B, and C.

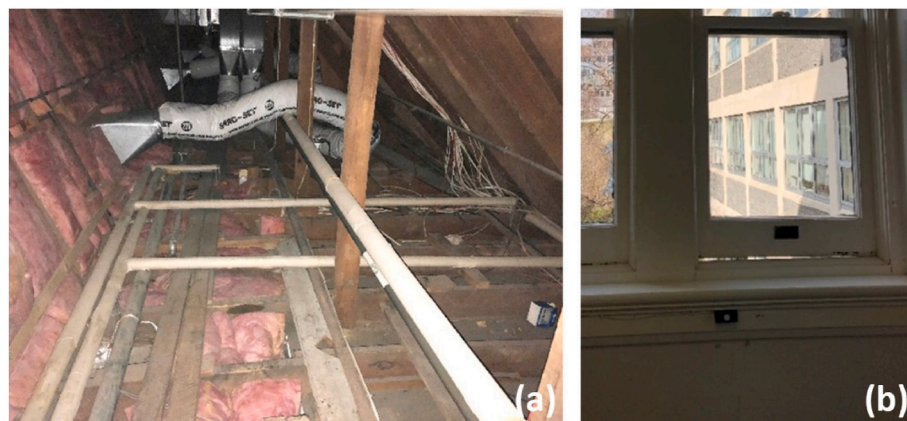
Fig. 4. Photos of case study C showing key issues. Photo credit: Priscila Besen.

Visual inspection was documented with photographs of critical aspects found in the three buildings. The main findings were related to decay, lack of maintenance, modifications, and occupants' preferences. Following the identification of issues in ceiling insulation through thermography in case study C, an inspection of roof space revealed that insulation was only installed in half of the ceiling space: Fig. 4 (a) shows that the areas on the right-hand side remain uninsulated, causing significant heat losses. Also, air draughts through windows were common in all buildings due to lack of maintenance, as per Fig. 4 (b) showing how the original sash windows do not close properly and leave a visible gap at the bottom in building C.

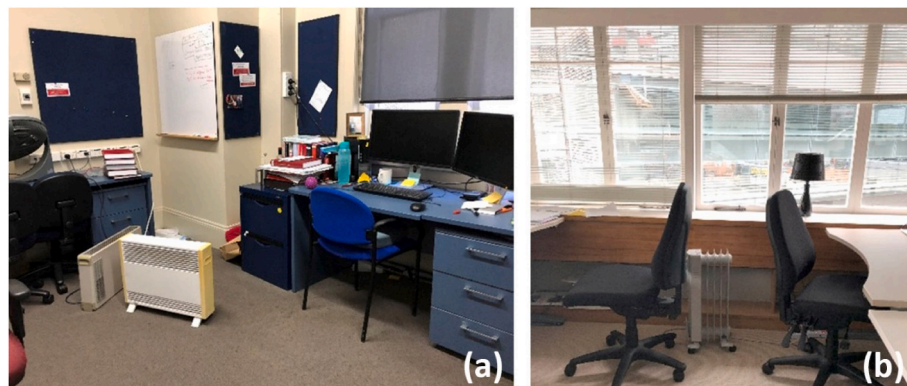
Fig. 5. Use of personal portable heaters by building occupants in case studies C (a) and A (b). Photo credit: Priscila Besen.

To maintain building occupants' thermal comfort, many portable electric heaters were used in office spaces, which were brought from home by the occupants (Fig. 5). This practice, found in all case studies, clearly indicates that the fixed heating devices installed in the buildings are not enough to ensure comfortable conditions in winter.

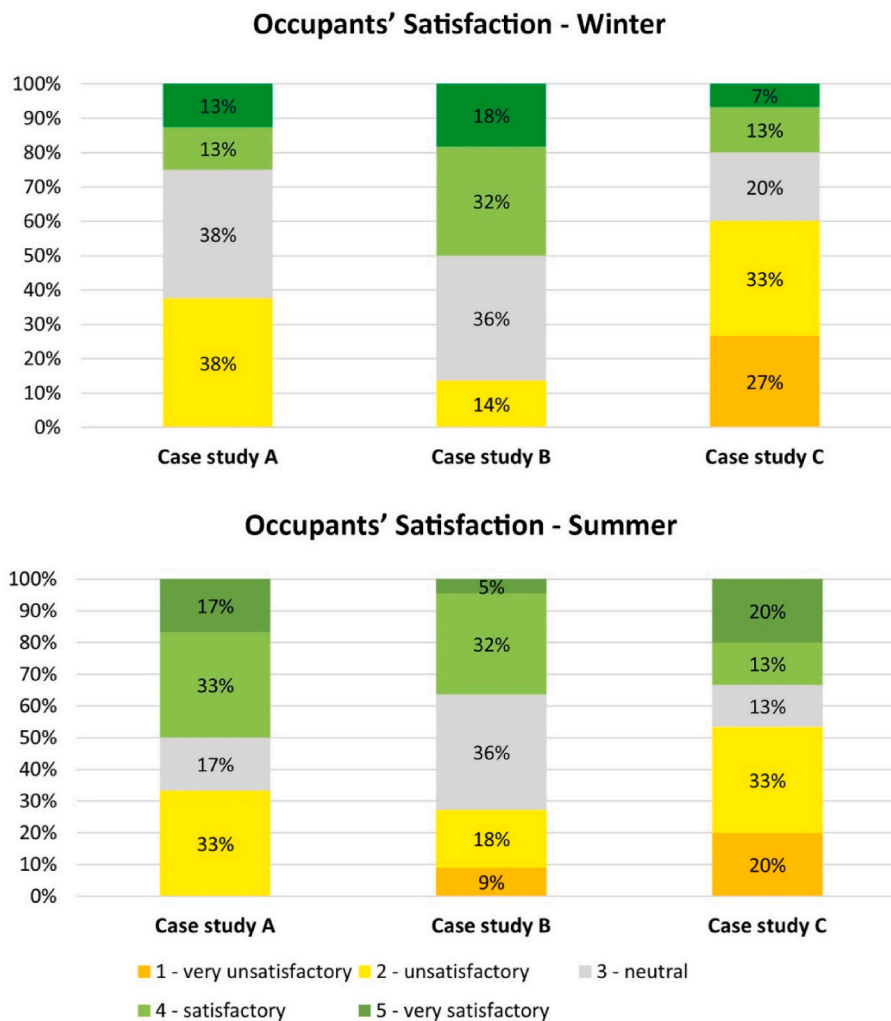
Fig. 6. Level of satisfaction with indoor temperatures in the case studies in winter and summer.

Overall, there was dissatisfaction with indoor temperatures both in winter and in summer. In case study C, located in the coldest climate, 60% of respondents revealed dissatisfaction in winter. In summer, dissatisfaction was also high: 53% of participating building occupants were dissatisfied or very dissatisfied with indoor temperatures. In Case study A, located in the warmest of the three climate zones, the level of dissatisfaction was higher in winter than in summer. Auckland is usually known as a "mild climate", but the lack of insulation, the use of single glazing, and the orientation of the building contributed to cold indoor temperatures. Although case study B showed higher percentages of satisfaction and neutrality regarding indoor temperatures, the open-ended questions revealed many issues in the building, due to its construction techniques. Table 3 shows selected comments from open-ended questions related to indoor comfort in the three case studies.

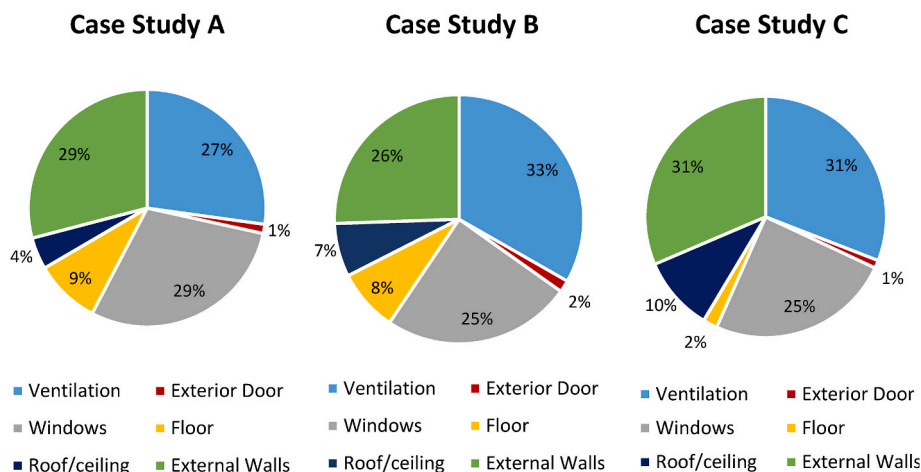
**Fig. 7.** Heat losses (%) in baseline models as calculated by PHPP.

Ventilation, external walls, and fenestration were found to be the main sources of heat losses in the buildings, with some variations between the three buildings due to the building form and construction configurations. Ventilation is a high source of heat loss, due to the draughts in junctions, windows, and doors. Although contributing to solar heat gains, windows undergo high rates of heat losses due to single glazing and timber frames providing low levels of insulation. External

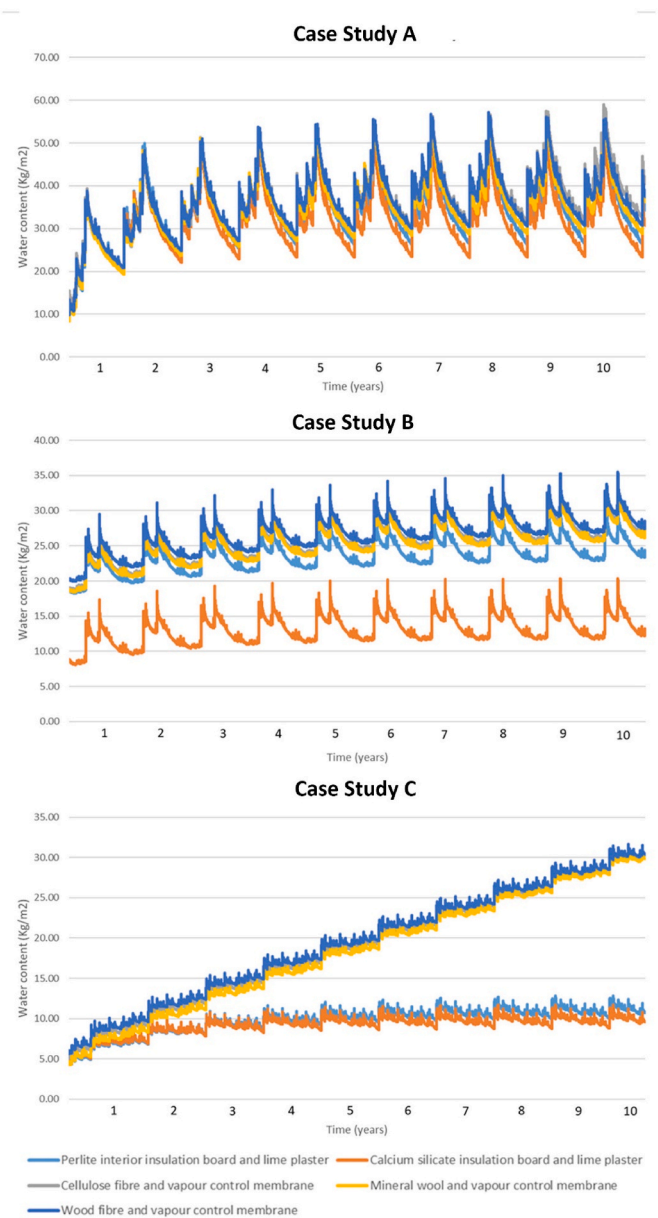
Fig. 11. Total water content in wall assembly over time for various internal insulation materials.

In buildings A and B, calcium silicate boards obtained the best results. Overall, it is predicted that total moisture content will achieve a balance and show stable values after the initial period with all the proposed material types, while mineral wool, cellulose insulation, and wood fibre are unlikely to present satisfactory results. Although vapour control membranes were integrated to the wall assemblies in the models to help obtain better results, issues are likely to remain.

Given the hygrothermal evaluation results, calcium silicate boards were chosen for internal wall insulation in all case studies. This material is commonly known as being a suitable type of capillary active insulation. Therefore, the proposed internal wall insulation consists of 80 mm rigid calcium silicate boards in case studies A and B, and 100 mm in case study C. Lime plaster will be applied as a finishing surface, which is airtight but vapour permeable, allowing possible moisture build-up from the wall to dry towards the interior environment. The insulation material can be attached to the existing masonry walls with a clay-based mortar, which can improve the potential for reversing this

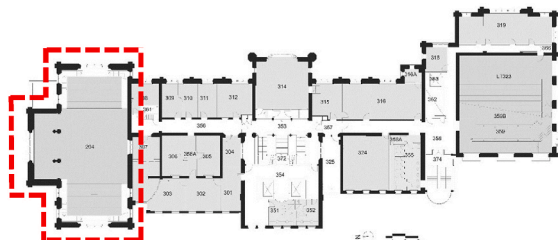
Fig. 10. Case study B: Floor plan and photo showing the Council Chambers room, which will be subject to minimal energy retrofit interventions due to its heritage significance.

Values shown for building B do not apply to the Council Chamber room, as it needed to be carefully assessed for retrofit. This room is a triple-height space that is utilised for occasional events. There is significant original detailing in the timber, walls, and ceilings, and heritage significant stained glass windows, which are a memorial for staff and students who died in the world wars. These windows had already been upgraded with secondary glazing applied to the outside to provide protection from decay. The addition of secondary internal glazing and wall insulation would have a significant impact on this important space. The ceiling and floor of the room could possibly be insulated, if insulation could be added to existing cavities (this would be subject to confirmation through further investigations such as through the use of endoscope cameras). Therefore, given its heritage significance and its occasional occupancy pattern, no interventions are proposed for this room because any changes could have a significant visual impact. In addition, there are no significant requirements from occupants' comfort point of view since it is only used for occasional short meetings and gatherings. Fig. 10 shows the location of the Council Chamber room and the extent of the building that will be excluded from retrofit interventions, as well as an internal view of the configuration of the space and the stained-glass memorial windows.

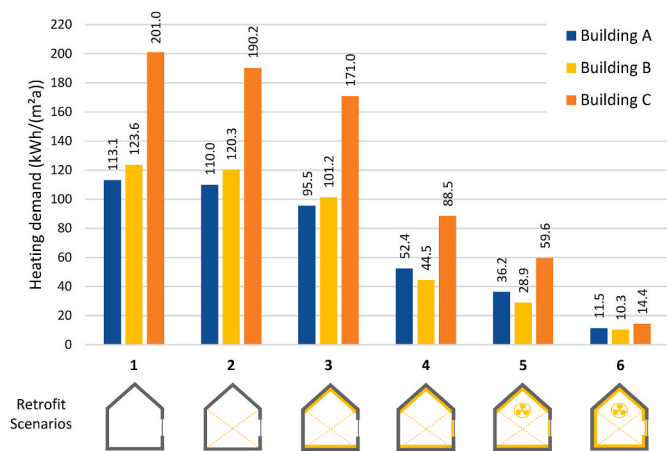
Fig. 12. Cumulative retrofit scenarios 1–6: heating demand results for case studies A (Auckland), B (Wellington), and C (Dunedin).

Fig. 12 shows the results from energy simulation, demonstrating the effect of the proposed retrofit scenarios on heating demand, while

In all case studies, wall insulation has the greatest impact on heating demand, reducing it by over a third when compared to the previous retrofit scenario (number 5). Airtightness and window upgrading will make the second most significant reduction to heating demand, generating a reduction of over half of the previous retrofit scenario when considering a value of 1 ACH for the retrofitted building. In all three case studies, it would only be possible to achieve the required EnerPHit target

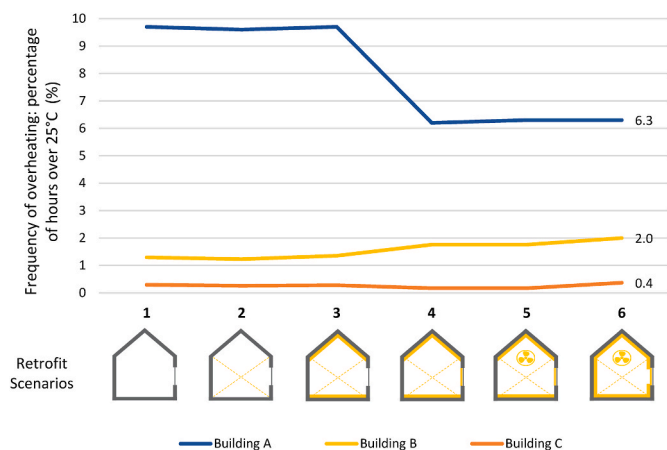
Fig. 13. Cumulative retrofit scenarios 1–6: frequency of overheating (%) results for case studies A, B, and C.

Fig. 13 illustrates the frequency of overheating. The frequency of overheating was calculated in PHPP and represents the number of hours in a year where the indoor temperature exceeds 25 °C, considering that these buildings would not utilise active cooling. The resulting overheating percentage is the number of hours above 25 °C divided by the total number of hours of occupancy. All results were obtained from PHPP models, which included input from thermal bridging calculations developed in the software THERM.
