# Breached sandbar and changing coastal systems: interpreted and perceived impacts of flood-control interventions at Calido Beach, Sri Lanka

Calido Beach, located on the southwestern coast of Sri Lanka, has experienced substantial environmental and socio-economic change in recent years. These changes have coincided with flood-control interventions implemented in 2017, including partial removal of a sand spit barrier and widening of the Kalu River mouth. However, the extent to which observed changes can be attributed to these interventions remains uncertain due to the inherently dynamic nature of coastal systems.

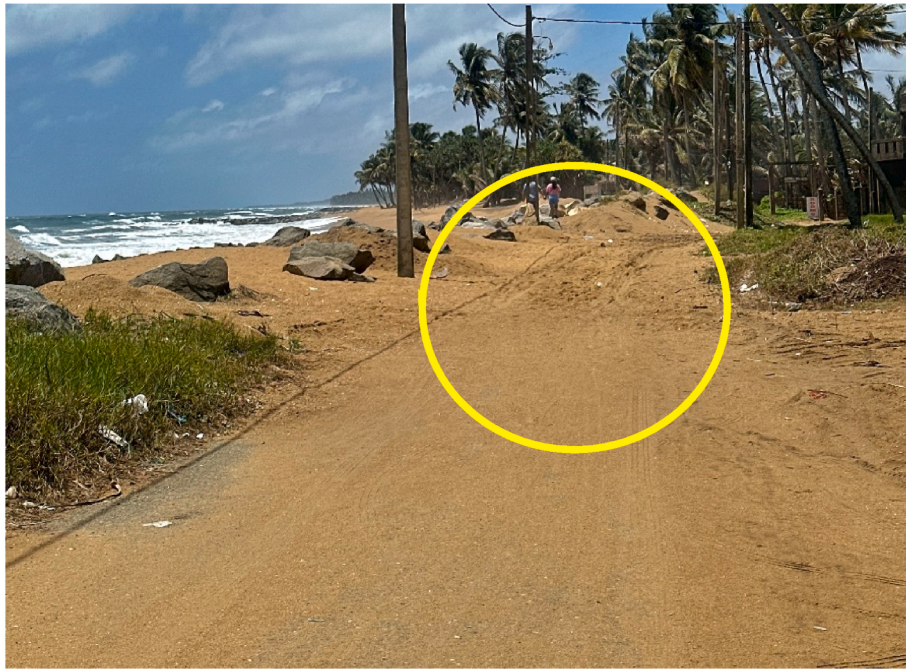
**Fig. 4.** Example of infrastructure impacts associated with sand accumulation at Calido Beach. Photograph showing sand deposition on access roads and within drainage channels following coastal change and mitigation efforts. Sand accumulation has reduced accessibility and disrupted drainage function in the study area. Note: Image captured during field visit in 2025.

Most respondents (93%) reported damage to infrastructure associated with coastal change with 38% of the participants perceiving government and private properties as being the most affected. Roads and bridges were only seen by 3% of respondents as being impacted, despite sand accumulation on roads (Fig. 4), and blockage of drainage systems, and reduced accessibility to coastal areas (Fig. 5) being evident during research site inspections. Participants reported that the government's allocation of around USD 5–7 million for a sand-pumping project and installation of sea walls to reduce coastal erosion after the removal of the sandbar, these mitigation measures were deemed ineffective as the sand rapidly returned to the sea. Similar challenges associated with hard-engineering interventions have been noted in other coastal contexts (Angnuureng et al., 2025).

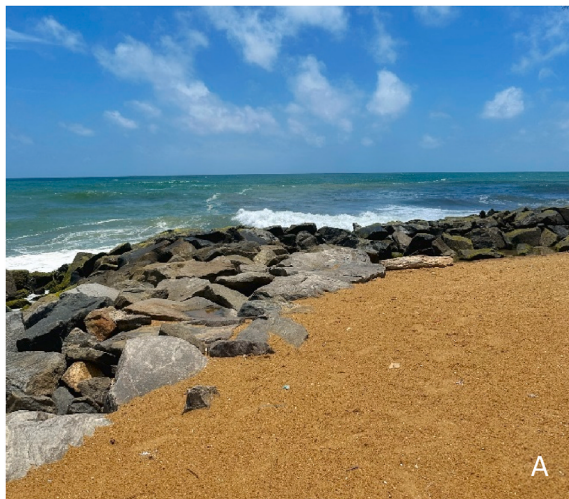
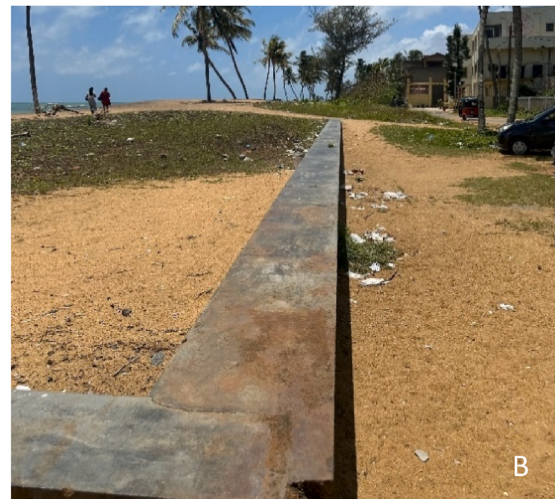
**Fig. 5.** Current coastal conditions at Calido Beach following erosion and mitigation efforts. (A) Stone wall structures installed along the shoreline, limiting beach access. (B) Accumulation of sand and sediment across beachfront areas, affecting usability of the beach and infrastructure. The images illustrate the combined effects of erosion, sediment redistribution, and coastal stabilisation interventions. Note: Photographs taken during field observations in 2025.
