**Investigation of Tribological Performance of Ti-6Al-4V Alloy
Processed by Selective Laser Melting and Electron Beam
Melting Processes**

A thesis submitted to Auckland University of Technology in fulfilment of the requirements for
the degree of Doctor of Philosophy (PhD)

2021

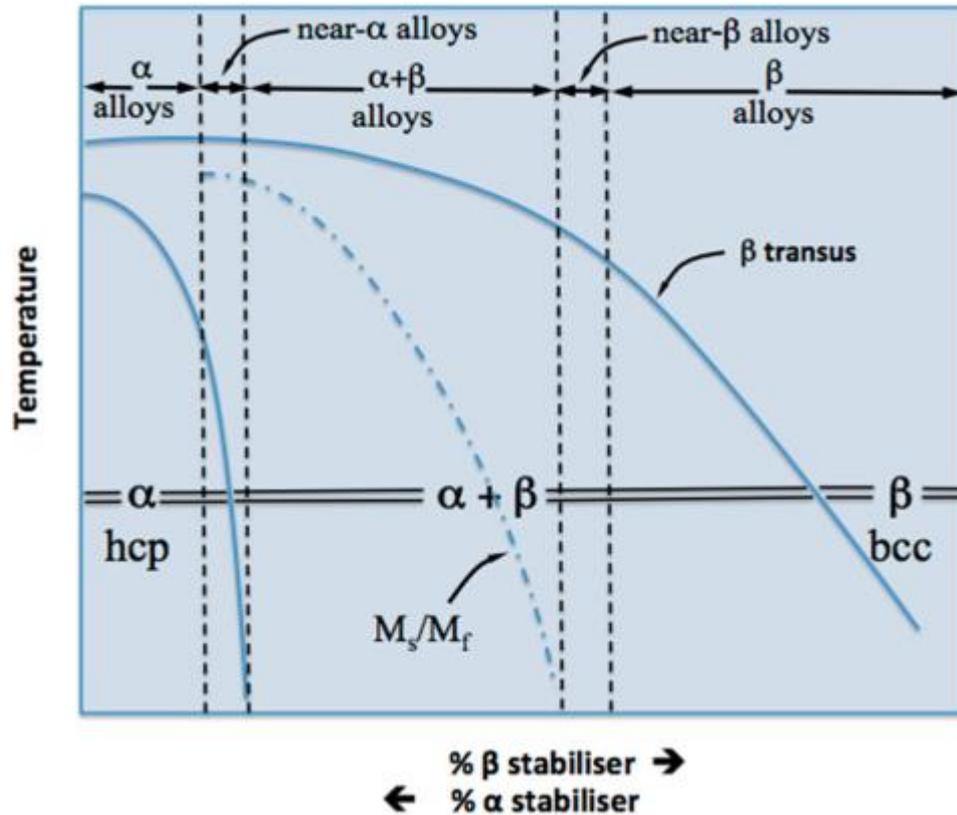
Fig. 1.1 Titanium alloys categories by phases [7].

Pure titanium at room temperature has a hexagonal close packed (hcp) structure, which is called α -phase. α -phase can transform to a body centered cubic (bcc) structure at elevated temperature (around 900°C), called β -phase. Titanium alloys consist of alloying elements which can be the stabilizers of either the α or β phases, resulting in changes in the phase for final parts. Commercially available titanium alloys categories are divided by the contribution of the α - and β -phases, this includes (i) α alloys, (ii) near- α , (iii) α - β (including Ti-6Al-4V), (iv) near- β , and (v) β alloys. Sometimes when the alloy was cooled from above the β -phase transus temperature (around 900°C) very fast, then β -phases undergo a diffusionless transformation to the martensitic phase, α' (hcp). α' martensitic is with great interest to scientists, because a part containing α' martensitic structure has higher hardness, but with the expense of ductility [7]. Fig. 1.1 shows the categories of titanium alloys by phases and M_s/M_f shows the quite close martensitic start and finish lines.

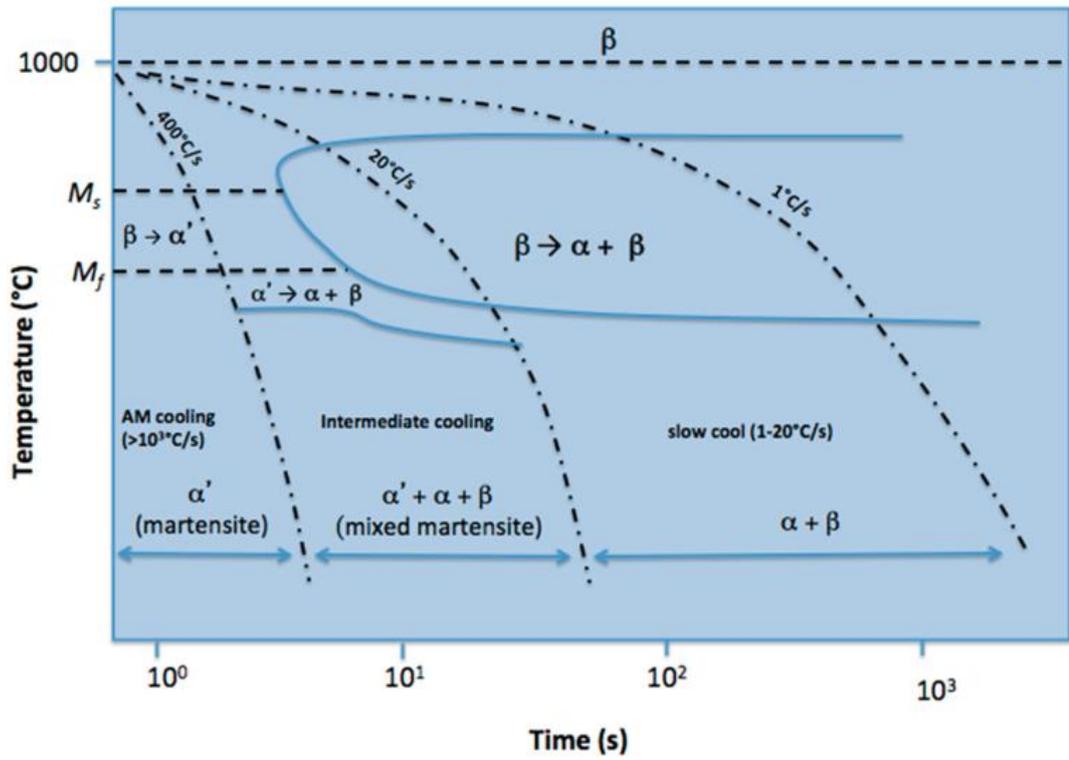
Fig. 1.4 Ti-6Al-4V continuous cooling transformation curve [7].

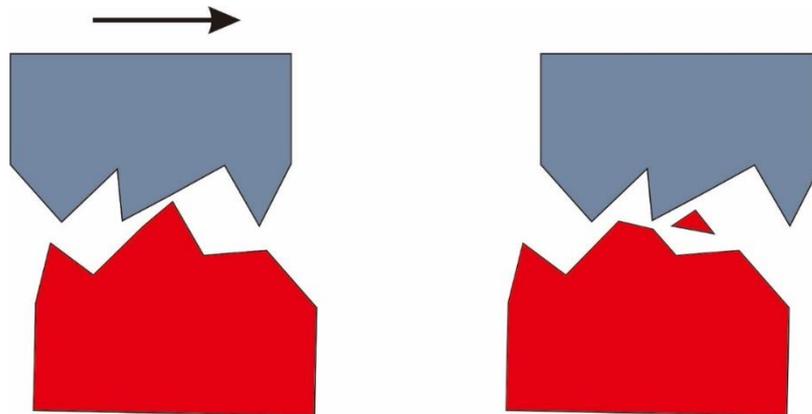
Fig. 2.3 Abrasive wear.

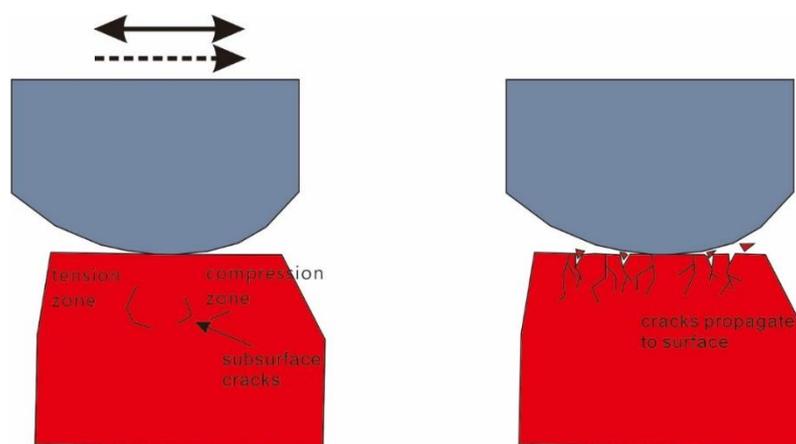
Fig. 2.4 Fatigue wear.

Fatigue wear happens when materials are under cyclic loading during friction contact. The material loss is usually not occurred immediately, but after a considerable number of loads cycles. Fatigue wear usually causes crack initiation in sub-surface and then propagate to the surface. The connection of these cracks would cause delamination and peeling of the surface material resulting in wear loss (Fig. 2.4). The cracks initiated and propagated due to fatigue wear are usually normal to the wear track.

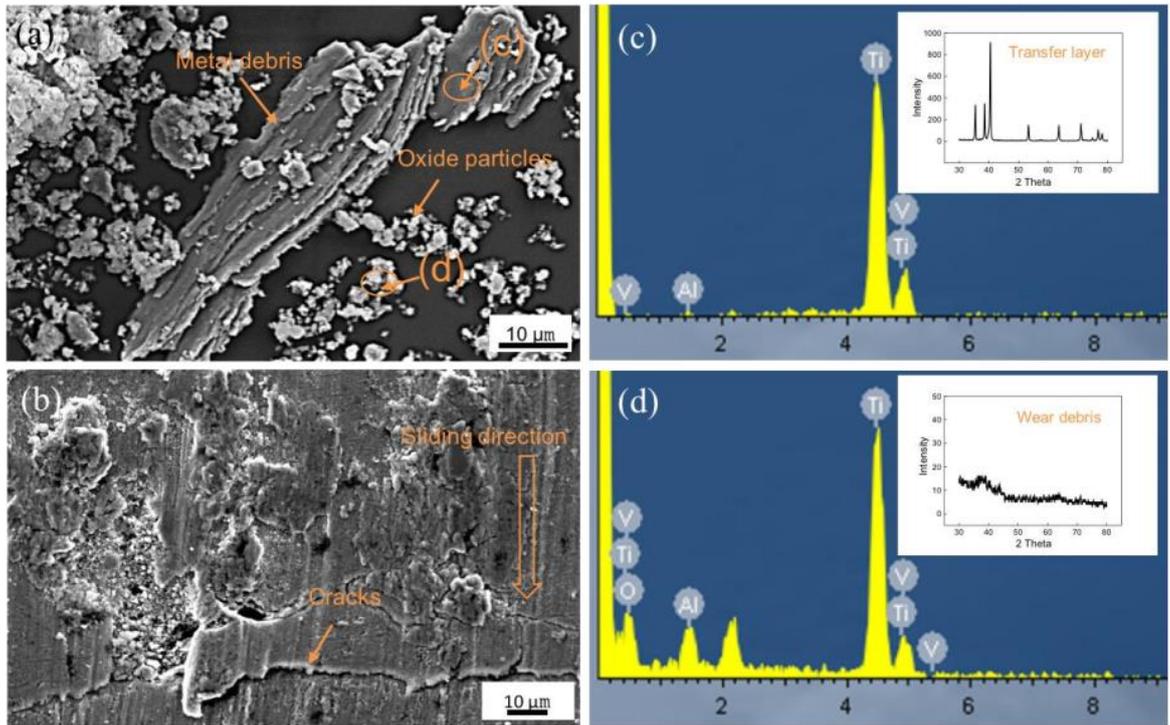
Fig. 2.5 SEM images of a wear test for Ti-6Al-4V alloy (a) wear debris and (b) wear track; EDX spectrum and inserted XRD patterns of two locations indicated in (a) are shown in (c) and (d), respectively [24].

Fig. 2.5(b) shows a typical wear surface. Traces of ploughs and deep grooves along the sliding direction are the typical indications of abrasive wear, while the cracks perpendicular to the rubbing direction were caused by fatigue wear. The adhesion wear is usually combined with other wear mechanisms and not easy to be identified, but the composition of wear debris can help to define adhesive wear clearly from other types of wear. As shown from Fig. 2.5(a), large flake shape debris with chemical composition similar to the base material (Fig. 2.5(c)) is produced by peeling from the surface, which was caused by adhesive wear. Wear debris with high oxygen level shown in Fig. 2.5(d) indicates the oxygen in air caused oxidation of the surface of wear track.

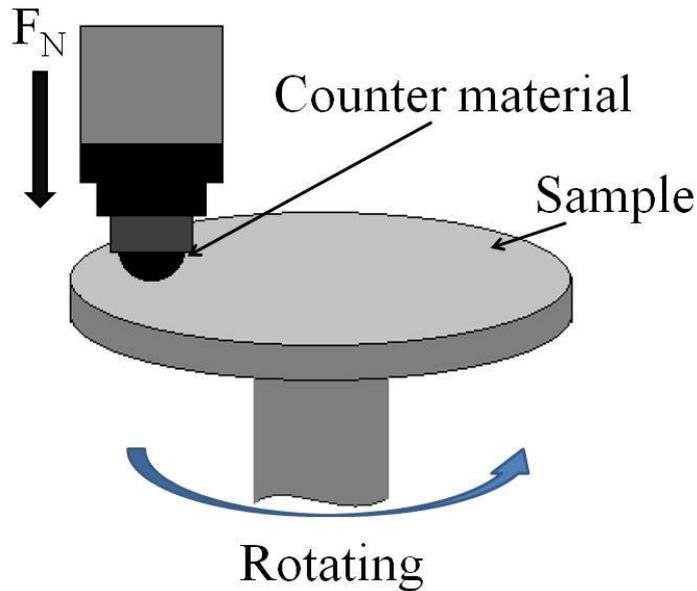
Fig. 2.7 Schematic diagram of rotary pin-on-disk wear tester.

Fig. 2.7 is the schematic of rotatory tribometer, compared with the linear reciprocating tribometer, the wear couple are usually a disk and a pin, the sample or the counter material rotate, resulting in a relative sliding movement on the other material surface. The relative movement is through a single direction [43-47].

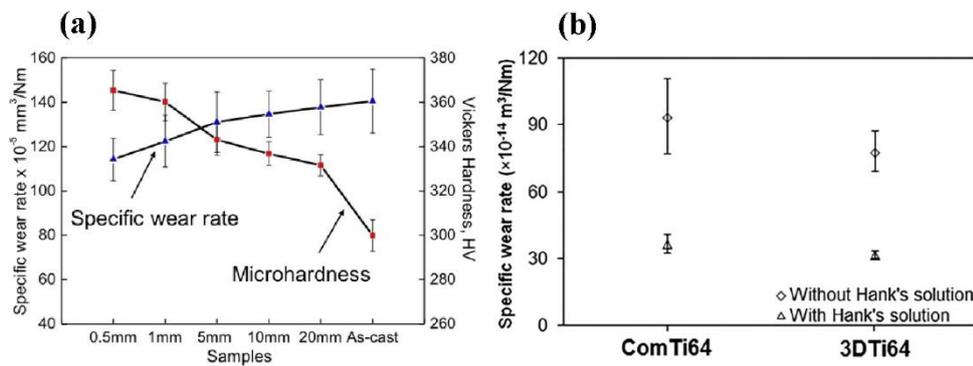
Fig. 2.12 Specific wear rates and Vickers hardness of EBMed and conventional processed Ti-6Al-4V samples (a) [24] ; specific wear rates of conventional processed and EBMed Ti-6Al-4V samples tested under the same conditions

Comparing performance of EBM to cast Ti-6Al-4V in dry sliding wear tests, the relationship between hardness and wear rate is also not clear. Toh et al.[24] showed the normally observed inversely proportional relationship of hardness and wear volume shown from Fig. 2.12 (a). This relationship is however not followed when test was conducted with Hank's solution, as demonstrated by Khun et al. [53] in Fig. 2.12 (b). Furthermore, Ryu et al. [54] also showed that hardness (450HV) of mill-annealed (conventional) Ti-6Al-4V is higher than the hardness (400-410HV) of EBM samples, but WR is lower for the EBM samples in dry sliding test. More recently, data of Ti-6Al-4V rotation wear test from Zhang et al. [55] showed forged/annealed samples (~370HV) worn more than SLM (~400 HV) and EBM (~380HV) samples, while EBM samples worn less than SLM samples (Fig. 2.13). The better performance of EBM samples were simply linked to horizontal cracking and delamination of the tribo-layer in SLM samples (Fig. 2.14). How continuous the layer is and what the mechanism is for cracking to result in less wear loss are however not clear and these studies are not providing detailed mechanistic explanations.

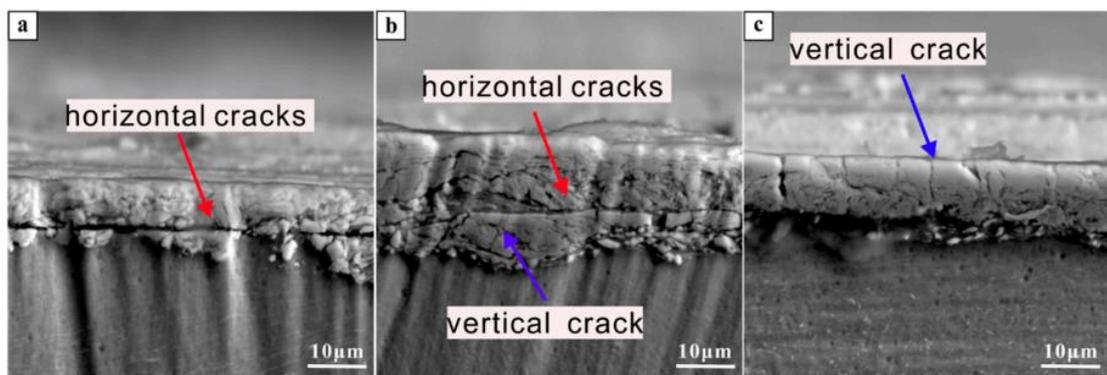
Fig. 2.14 Cross-sections of Ti-6Al-4V alloy produced by (a) forging, (b) SLM and (c) EBM [55].

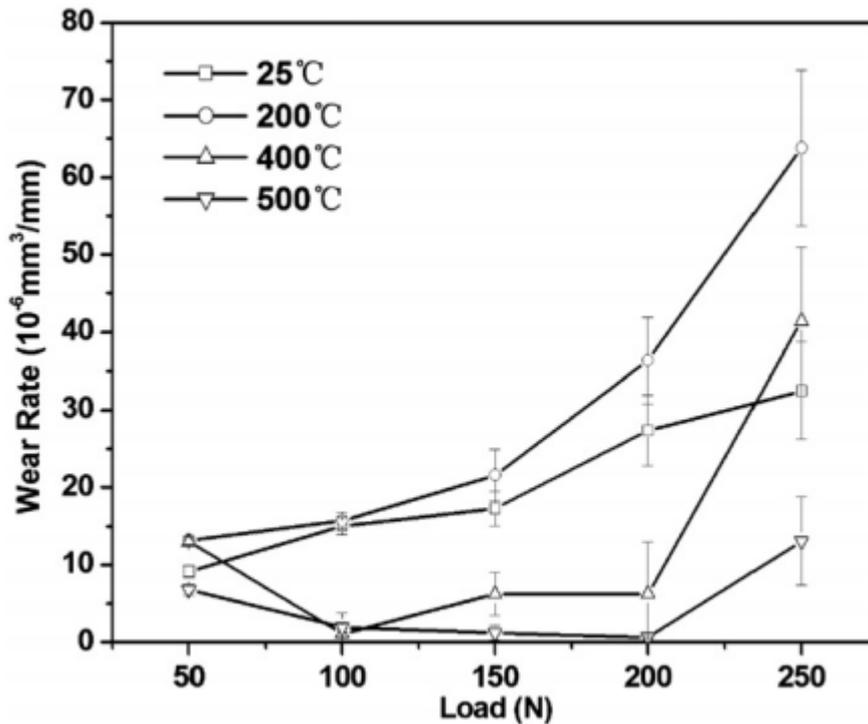
Fig. 2.18 Wear rates of Ti-6Al-4V alloy as a function of temperature and load [44].

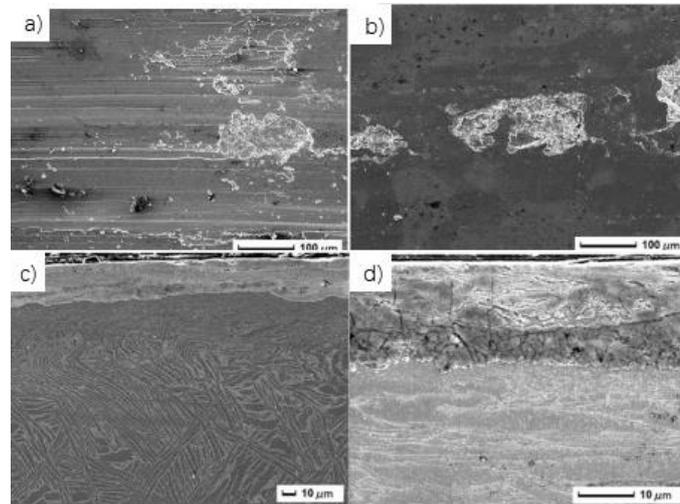
Fig. 2.19 SEM images of worn surfaces of Ti-6Al-4V alloy sliding under various conditions: (a) 200°C, 100N, (b) 400°C, 100N; (c), (d) are their cross-sections respectively [44].

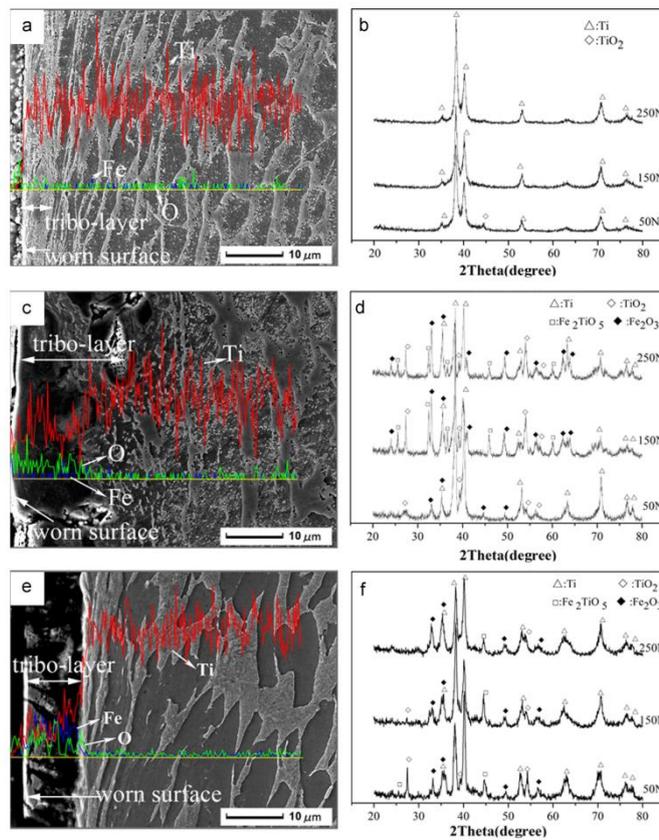
Fig. 2.21 Morphology, EDS line analysis and XRD patterns of tribo-layers under sliding wear tests: at room temperature (a, b); at 600°C (c, d); first sliding at 600°C and then sliding at room temperature (e, f) [43].

Fig. 2.21 shows EDS and XRD results of the study carried by Zhang et al. [43]. In (c) and (e) (which are the tests with 600°C or first with 600°C), the green lines which indicate the amount of oxygen in the tribo-layer region are both higher than the substrate material, which shows the tribo-layers are with higher oxygen content.

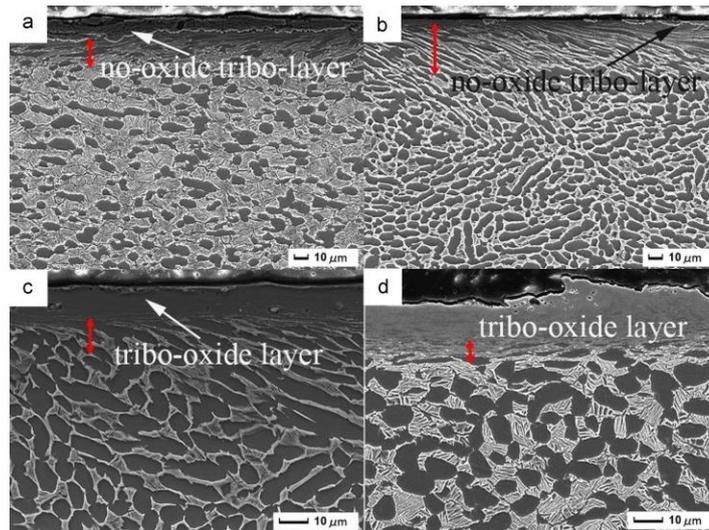
Fig. 2.22 Tribo-layers typical status of: (a, b) sliding at room temperature, 150 and 250 N, respectively; (c, d) sliding at 600 $^{\circ}\text{C}$, 150 and 250 N, respectively [43].

Fig. 2.22 also shows the plastically deformed layers beneath the tribo-layer (red arrow lines show the deformed layers). These deformed layers appear to be associated with the load-bearing capacity of tribo-layers. In Fig. 2.22(a) and (b), which are for 150N and 200N tests under room temperature, in which the tribo-layers have very tiny oxides, the deformed layer thickness is around 30 and 80 μm , respectively. On the other hand, oxide layers which are compact and continuous, can be seen in Fig. 2.22(c) and (d), which are for 150N and 200N tests under 600 $^{\circ}\text{C}$ temperature and the thickness of the deformed layers beneath them are less than 10 μm for both. Thus, Fig. 2.22 can show that hard tribo-layer would possess high load-bearing capacity, and the force was prevented to transfer to the substrate material underneath the tribo-layers. So, a thin plastically deformed layer was presented when there is a hard oxide layer on top of it (Fig. 2.22(c) and (d)).

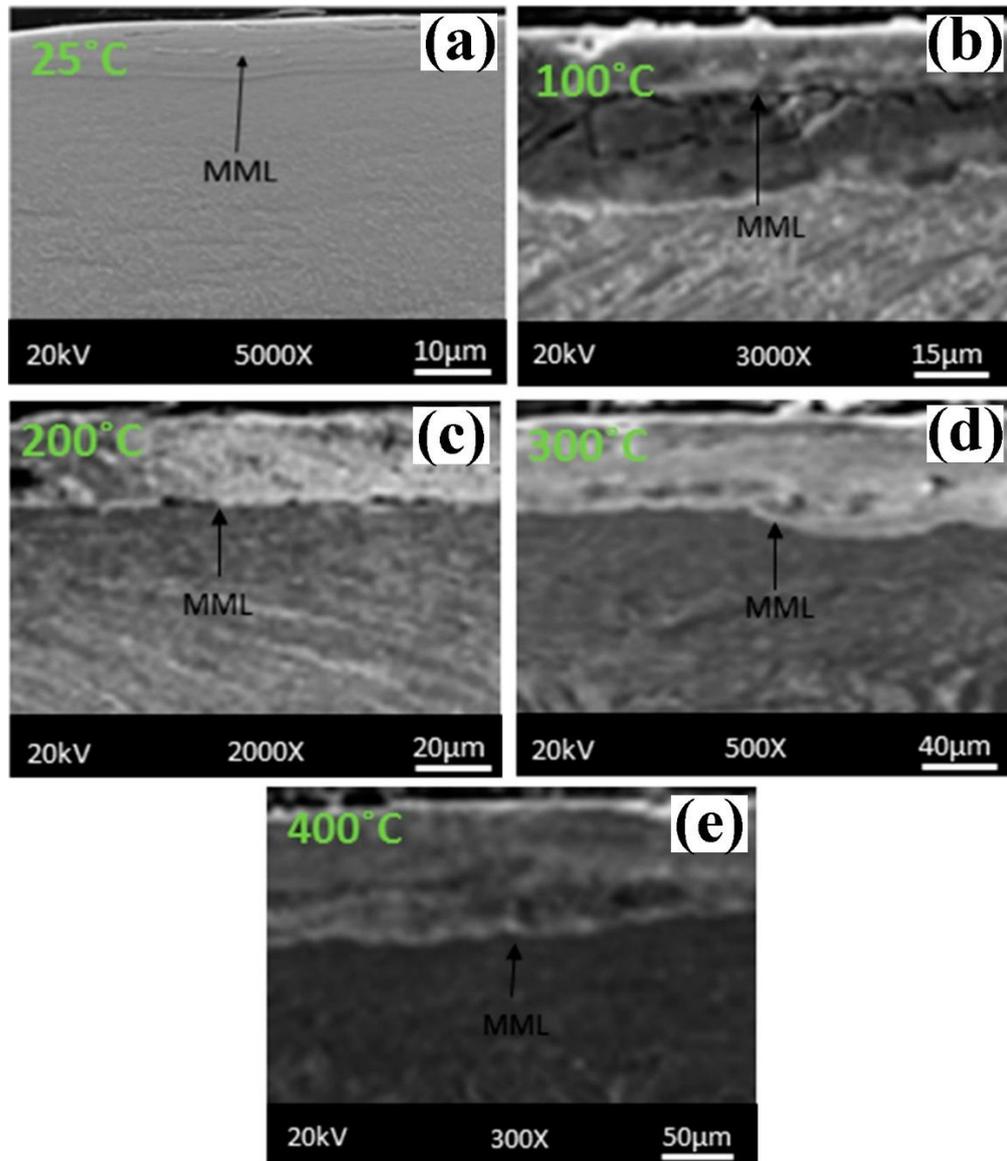
Fig. 2.24 SEM images of mechanically mixed layer (MML) when the tests were conducted at 25°C (a), 100°C (b), 200°C (c), 300°C (d), 400°C (e) [64].

Kumar et al. [64] presented mechanically mixed layer (MML) as can be seen in Fig. 2.24. MML, which is the term they used for tribo-layer, was formed by tribo-chemical reactions during the sliding wear tests. They stated that this layer is surface oxides layer and its thickness increased with increasing temperature. However, they didn't test the oxygen amount of the layers, and due to their tests being conducted at vacuum environment, it is not clear how oxygen is present in the MML layer. They concluded that a thicker tribo-layer with high oxygen is better as it can prevent adiabatic shear band and thus reduce wear loss.

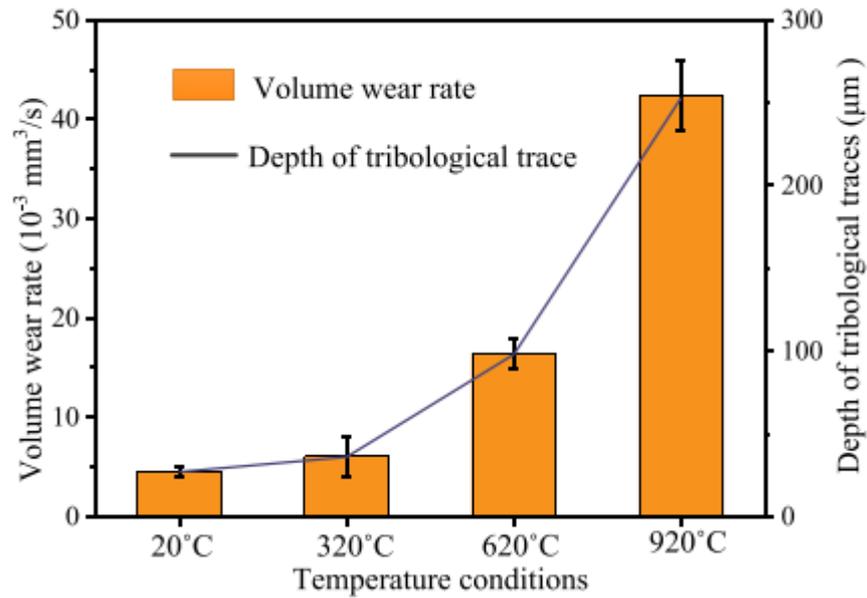
Fig. 2.25 Volume wear rate and depth of wear profiles versus temperature when WC-6Co pin slides against Ti-6Al-4V disk [65].

More recently, Liang et al. [65] conducted pin-on-disk rotatory testing with WC-6Co as pin and Ti-6Al-4V as the disk at temperatures up to 900°C and traced the 3D wear tracks to convert to wear volume rate. Fig. 2.25 shows that increase in temperature from room temperature to 320°C slightly increases the wear volume from $\sim 5 \times 10^{-3} \text{mm}^3/\text{s}$ to $\sim 7 \times 10^{-3} \text{mm}^3/\text{s}$. By further increasing the temperature to 600°C, wear volume increased significantly to $\sim 17 \times 10^{-3} \text{mm}^3/\text{s}$. Increasing the temperature to 900°C resulted in a considerable increase in wear volume to $\sim 42 \times 10^{-3} \text{mm}^3/\text{s}$ (Fig. 2.25). Thus, the effect of increasing T on increasing WR by Liang et al. is strong when $T > 320^\circ\text{C}$ and is completely opposite to the observations by Cui et al. [63], Mao et al. [44] (Fig. 2.18), Zhang et al. [43] (Fig. 2.20) and Kumar [64] (Fig. 2.23).

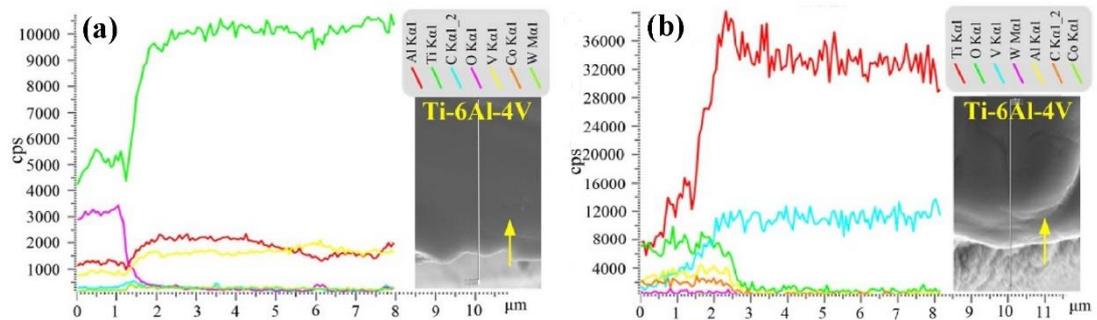
Fig. 2.26 Elemental composition profiles of cross-sectional view of Ti-6Al-4V, (a) 320 °C, (b) 920 °C [65].

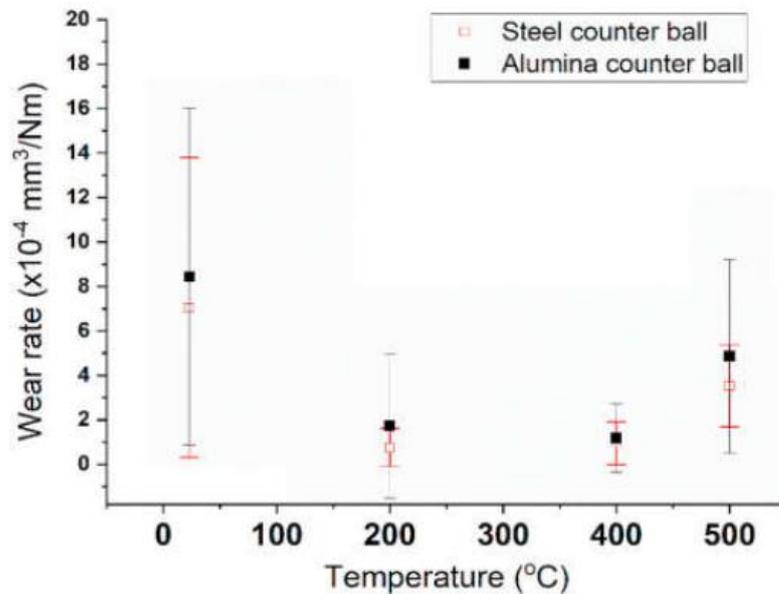
Fig. 2.27 Wear rate versus temperature when steel or alumina counter ball sliding against EBM Ti-6Al-4V disk (error bars represents standard deviations) [66].

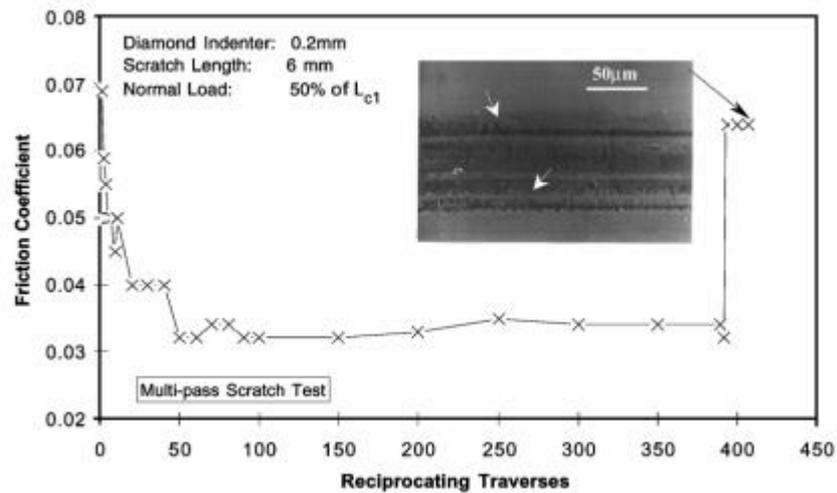
Fig. 2.28 Friction coefficient versus traversals during multi-scratch test on TiN coated Ti-6Al-4V; a SEM image inside showing worn surface morphology with micro cracking and delamination of TiN films after 400 passes [69].

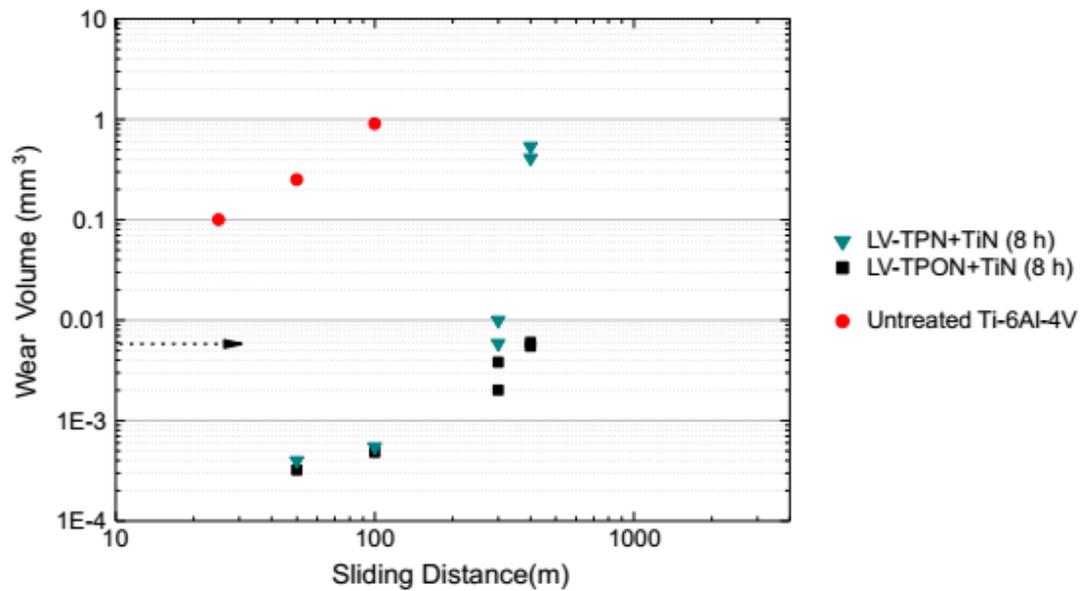
Fig. 2.29 Wear volumes measured for untreated Ti-6Al-4V and TiN-coated TPN and TPON samples, tested against WC-Co at a normal load of 13.5N [70].

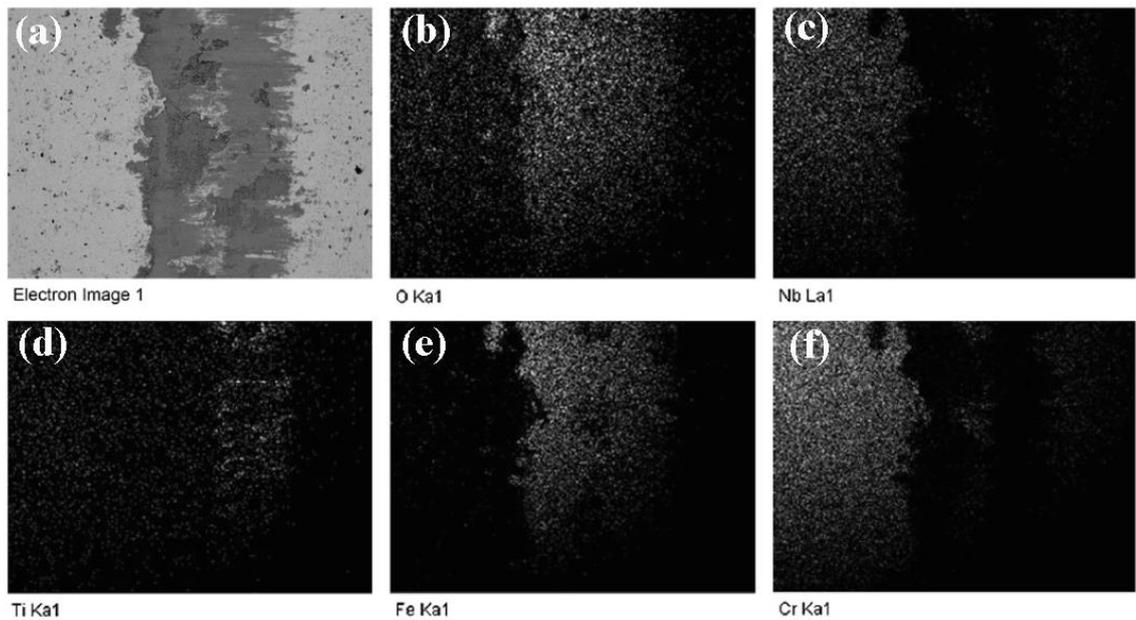
Fig. 2.30 SEM image of the wear track (a) and corresponding X-ray maps of elemental distribution (b) to (f) for the wear test of CrN/NbN-coated Ti-6Al-4V sliding against SAE52100-EN100Cr6 steel under 40N applied load [71].

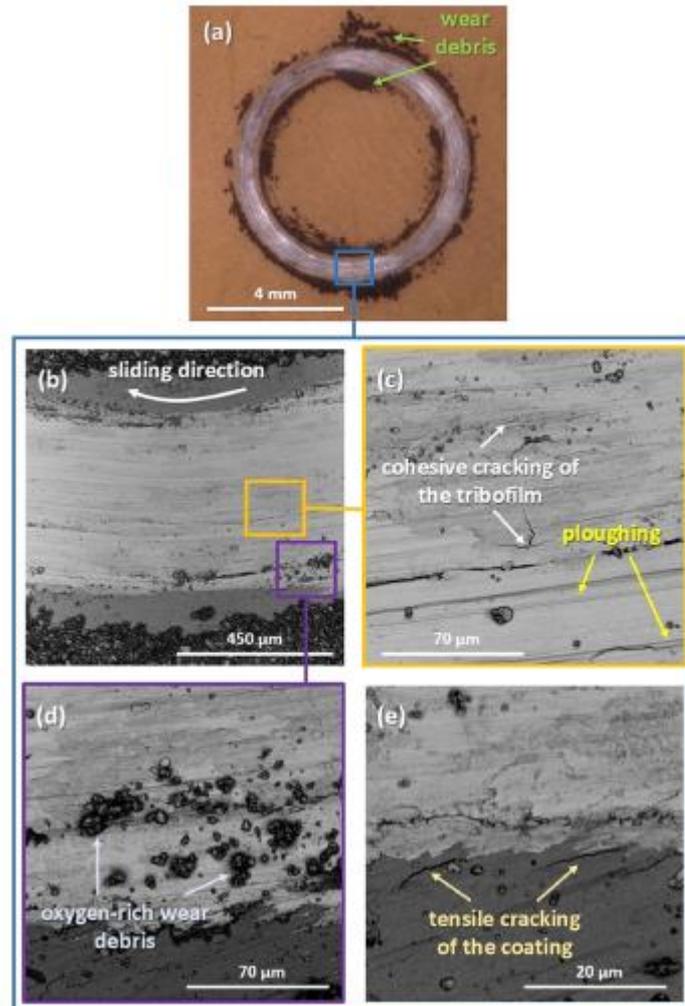
Fig. 2.32 Optical microscope (a) and SEM (b)–(e) images of wear track obtained for TiN coated Ti-6Al-4V alloy after 263.7m sliding distance in dry condition [72].

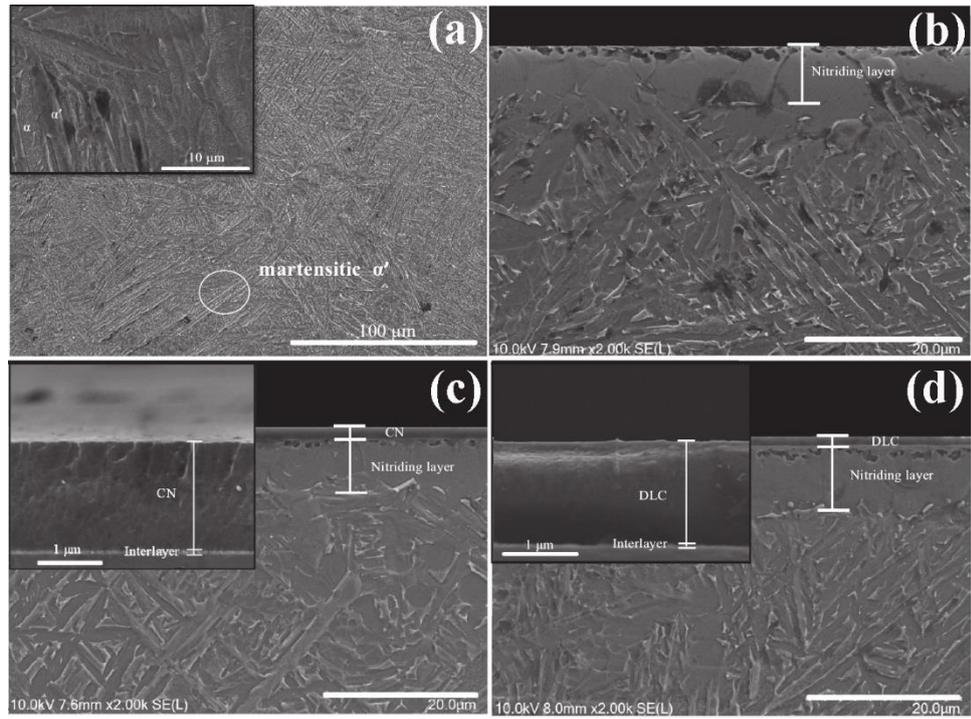
Fig. 2.33 SEM cross-sectional micrographs of: (a) 3DT, (b) N3DTs, (c) CN-N3DTs and (d) DLC-N3DTs [74].

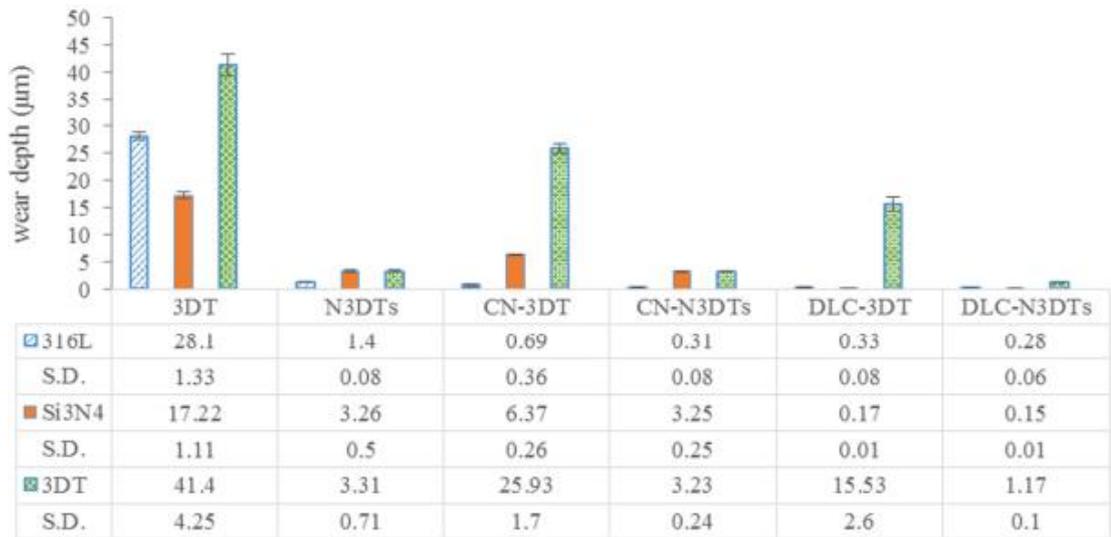
Fig. 2.34 Wear depths of all specimens when sliding against 316L, Si₃N₄ and 3DT balls. (S.D. denotes standard deviation) [74].

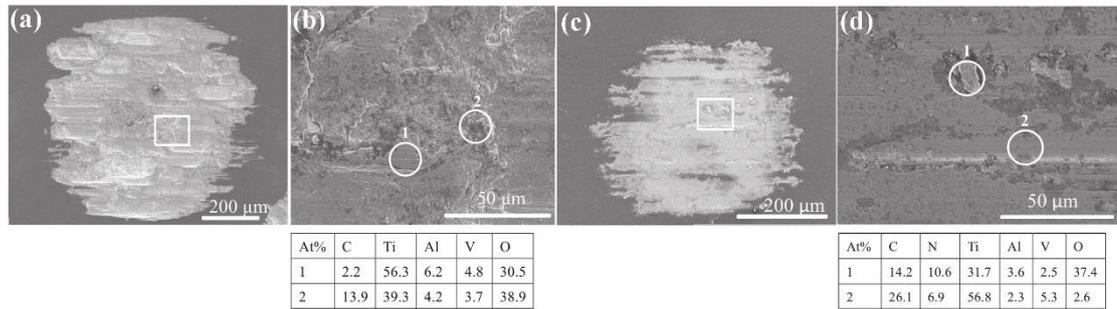
Fig. 2.35 SEM images for wear surfaces on: (a) DLC-3DT, (b) DLC-3DT (1000×), (c) DLC-N3DTs and (d) DLC-N3DTs (1000×) when sliding against 3DT ball, and the EDS analysis results for the regions marked in the corresponding figures (labelled 1 or 2), respectively [74].

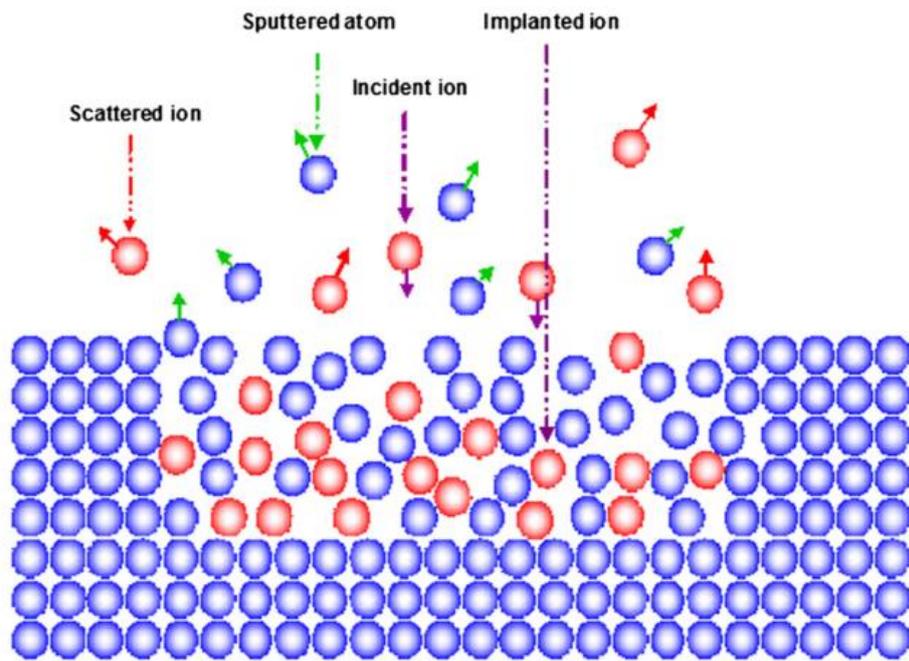
Fig. 2.37 Schematic of ion-solid interactions [77].

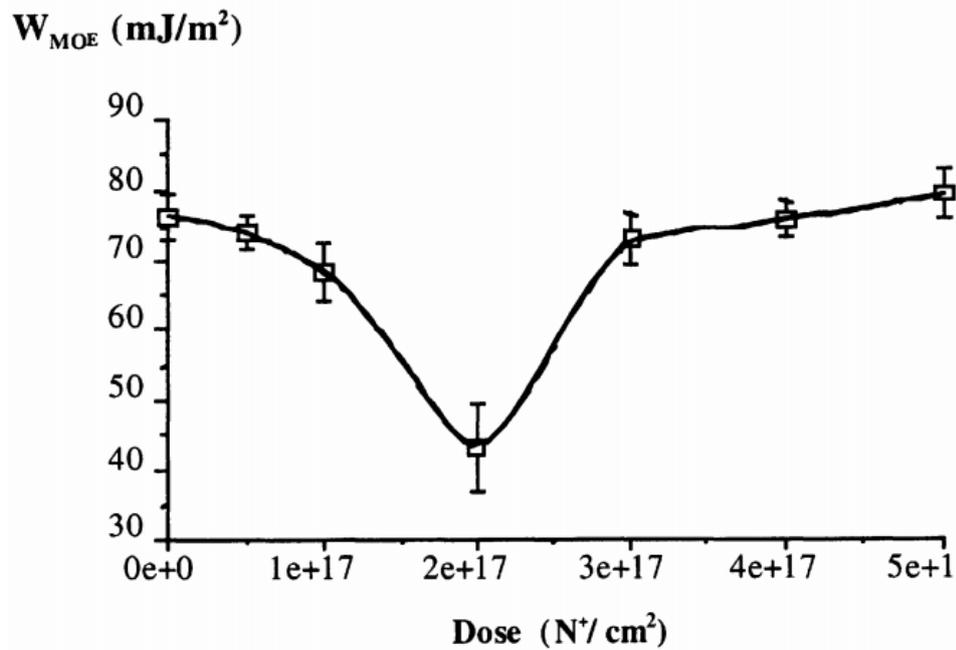
Fig. 2.40 Adhesion work variation of implanted Ti-6Al-4V [84].

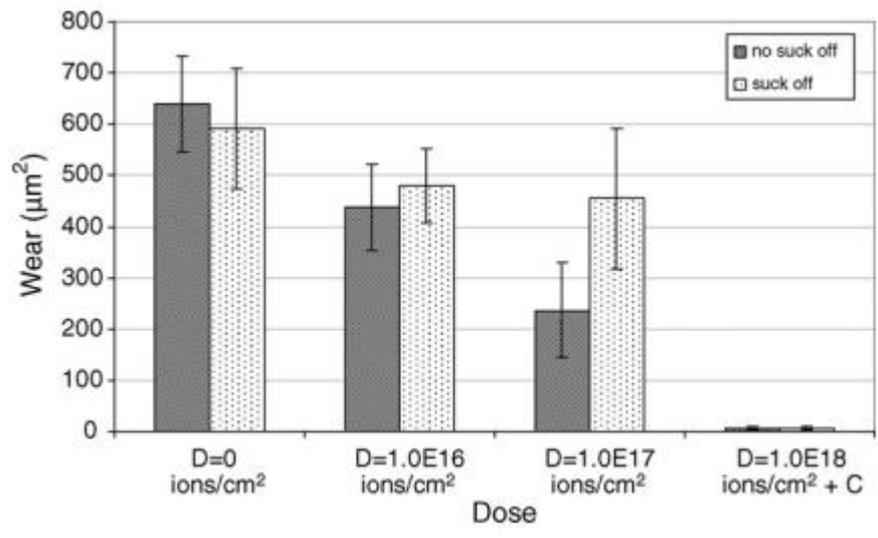
Fig. 2.42 Wear values of implanted and unimplanted samples after 2000 cycles [86].

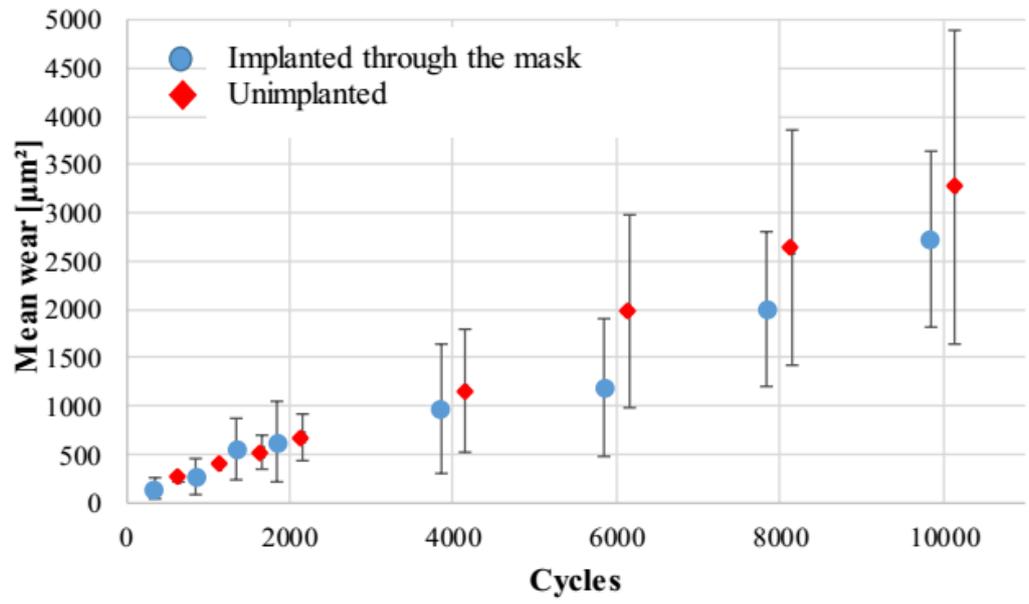
Fig. 2.43 Mean wear of Ti Grade 5 samples with standard deviations [87].

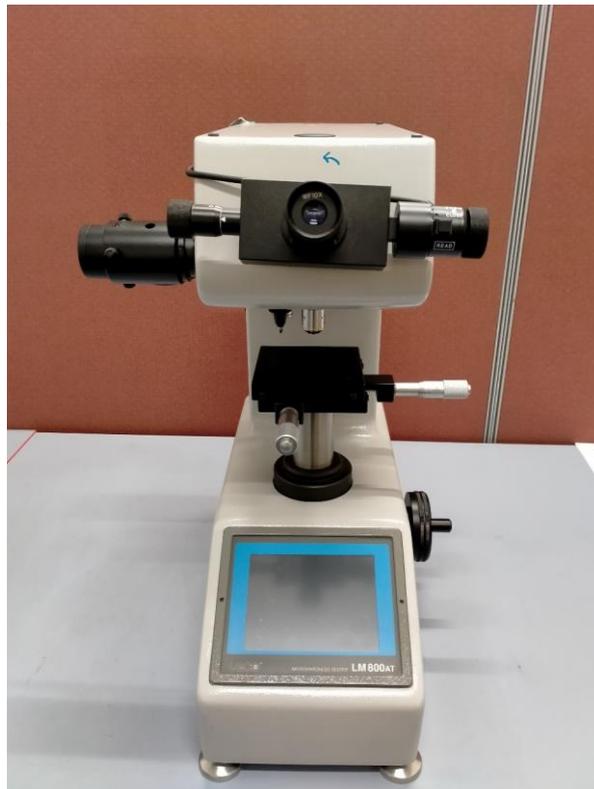
Fig. 3.1 Micro-hardness tester.

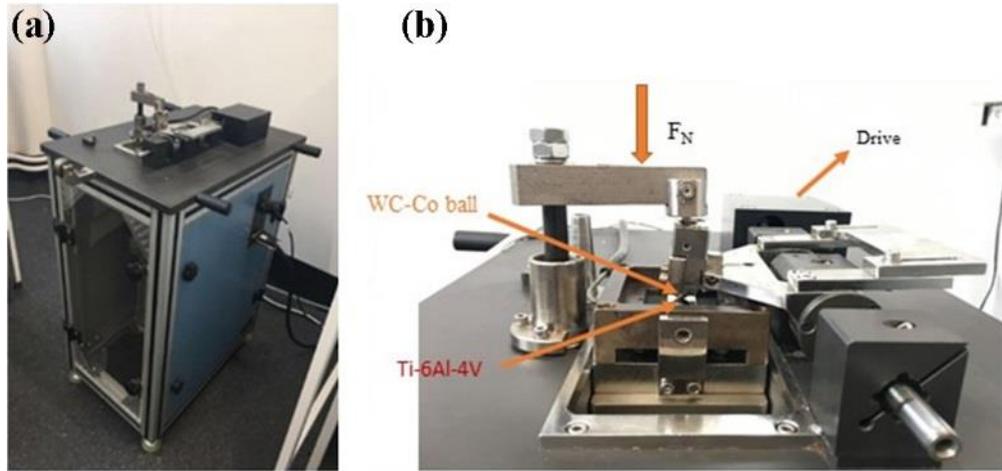
Fig. 3.2 Liner reciprocating tribometer.

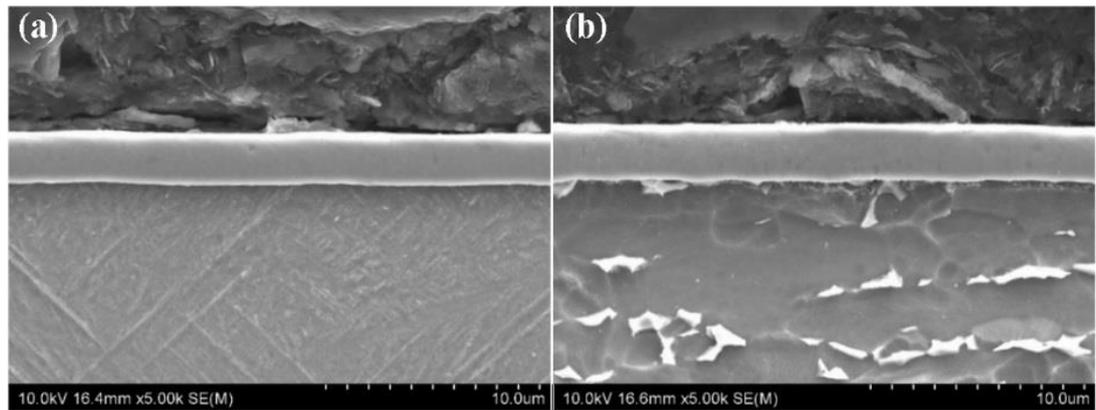
Fig. 3.3 Cross sections of PVD TiN coated on: (a) SLM martensitic and (b) CP $\alpha+\beta$ Ti-6Al-4V samples.

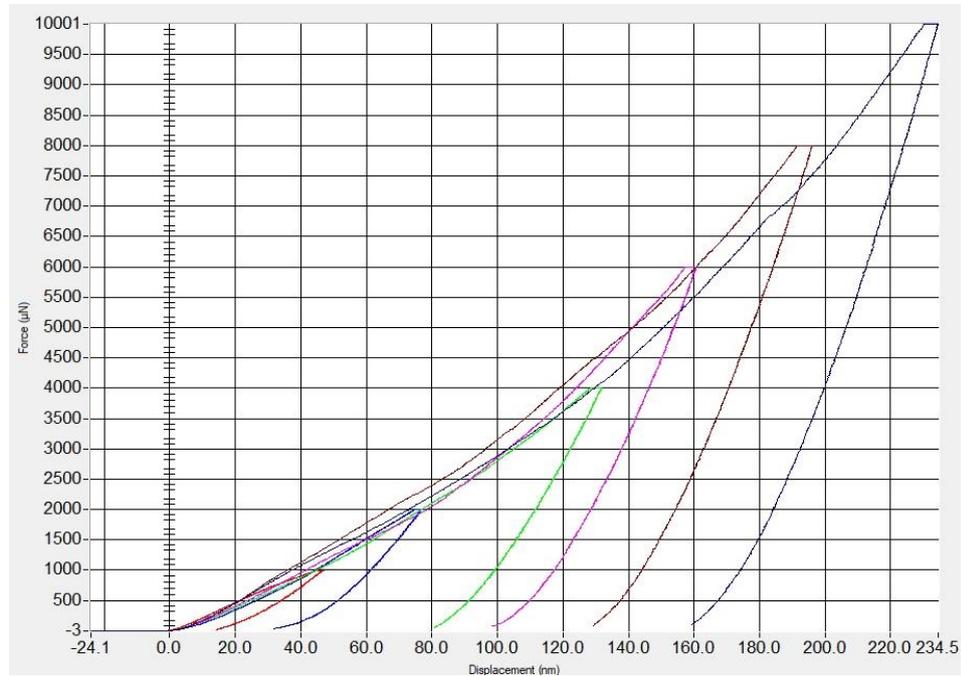
Fig. 3.5 Curves for nanoindentation test of a SLM N2 ion-implanted sample.

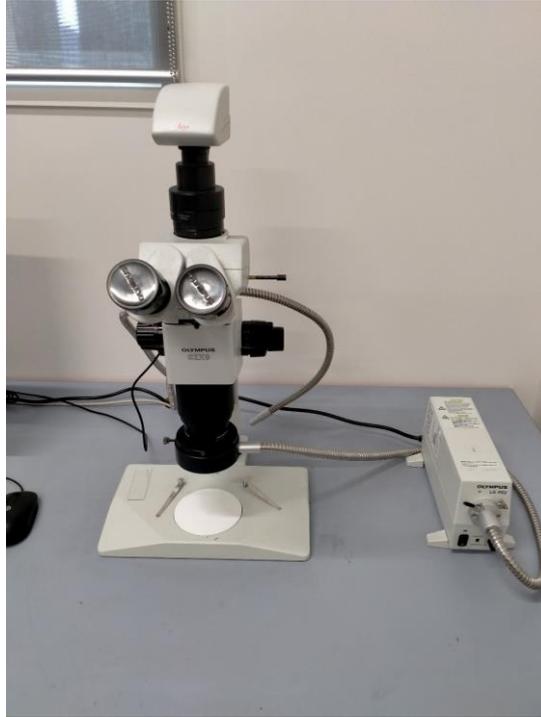
Fig. 3.6 Olympus SZX9 stereomicroscope.

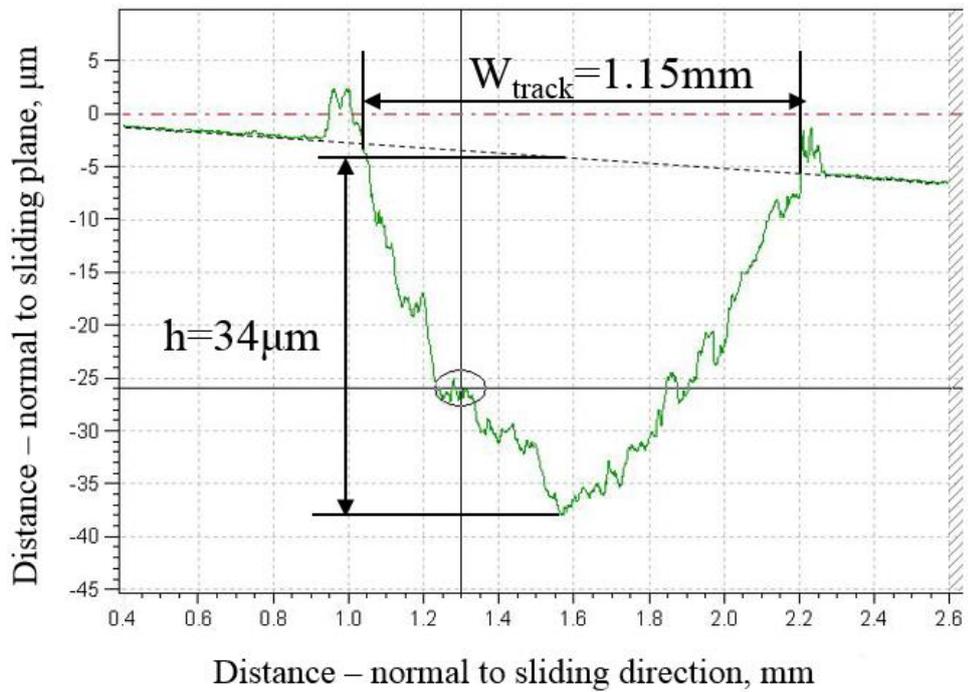
Fig. 3.7 A sectional profile for a CP sample wear track tested under 200°C and 2N load.

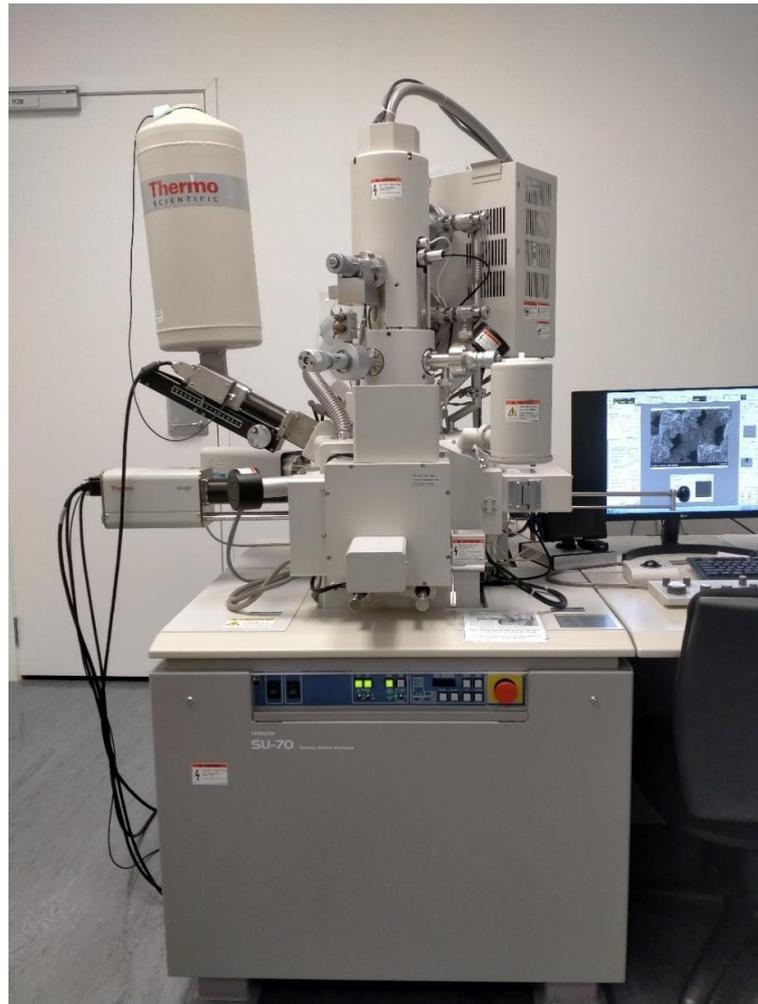
Fig. 3.8 Hitachi SU-70 field emission scanning electron microscope (FE-SEM).

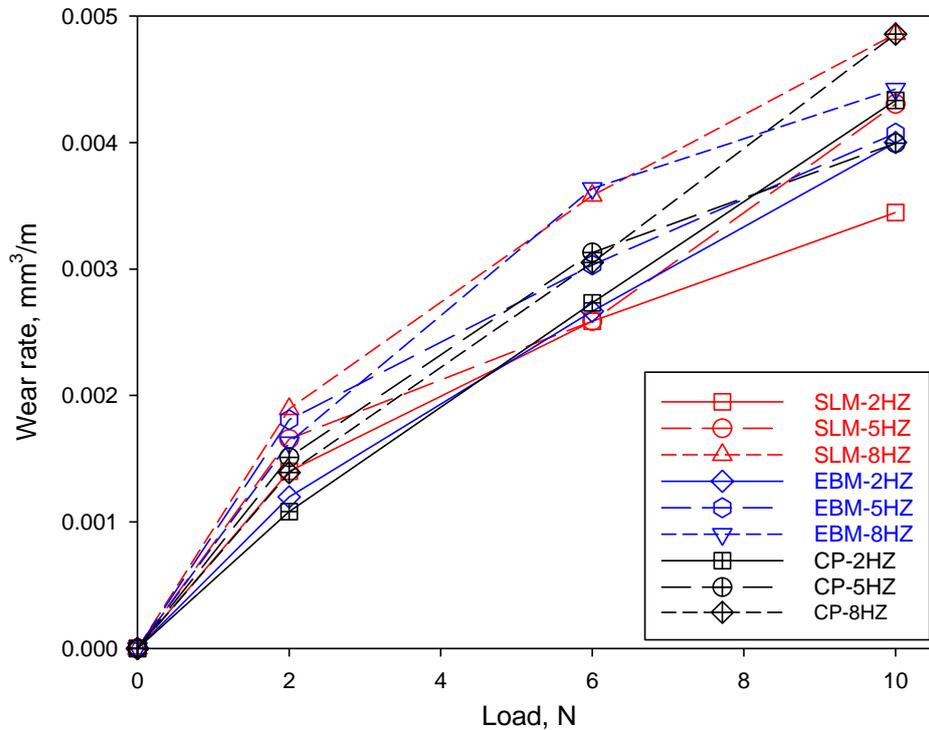
Fig. 4.1 Values of WR plotted as a function of test load.
