**Investigation of Tribological Performance of Ti-6Al-4V Alloy
Processed by Selective Laser Melting and Electron Beam
Melting Processes**

A thesis submitted to Auckland University of Technology in fulfilment of the requirements for
the degree of Doctor of Philosophy (PhD)

2021

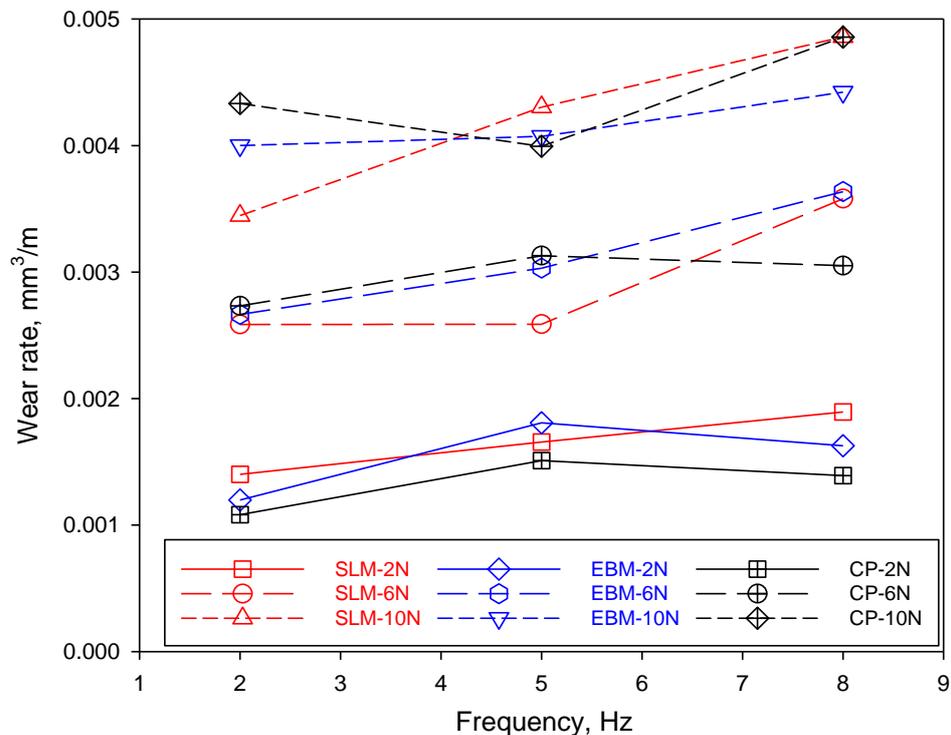
Fig. 4.2 Values of WR plotted as a function of test frequency.

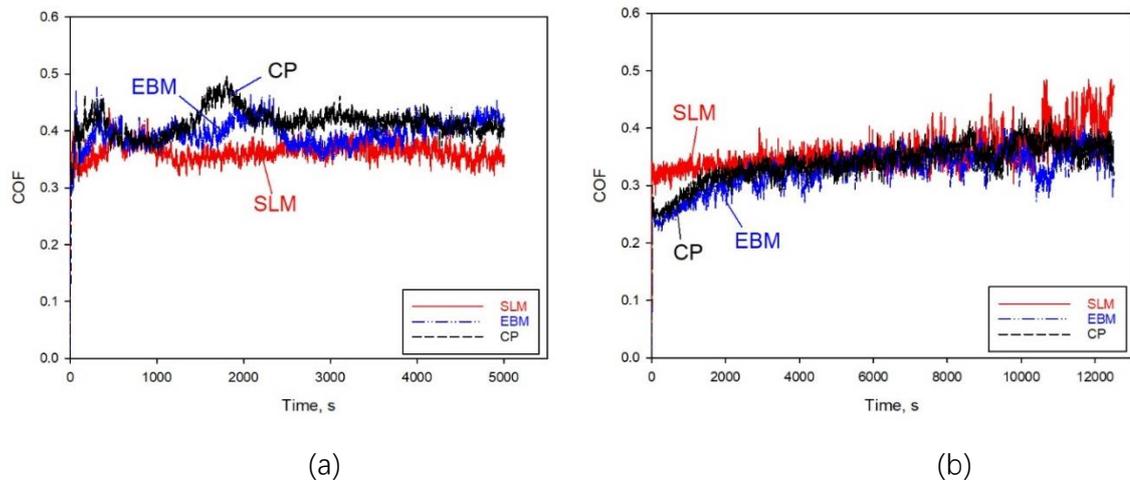
Fig. 4.3 COF values plotted as a function of time for test conditions: (a) 6N at 5Hz and (b) 10N at 2Hz.

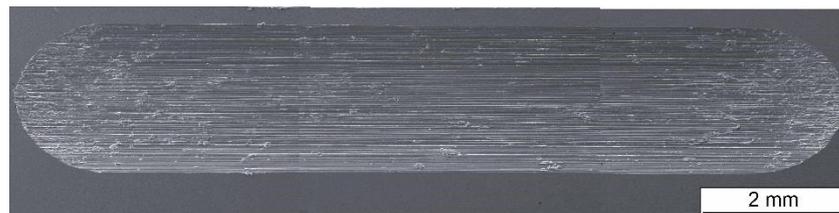
Fig. 4.4 shows four selected track surface images of samples tested at various conditions. Tracks can be quite uniform in width for some cases, as can be seen in Fig. 4.4(a) and Fig. 4.4(b). The image in Fig. 4.4(a) for a SLM sample is however seen smoother with less wear debris smeared on the track comparing to the CP sample in Fig. 4.4(b). The edges of the CP sample wear track (Fig. 4.4(b)) are seen to be decorated intermittently with small flown out pieces and these pieces are largely absent in the SLM sample (Fig. 4.4(a)). In some cases, irregular shape of the track could be observed where the width varies along the length of the track. Fig. 4.4(c) and Fig. 4.4(d) display two wear tracks of highly irregular shapes. This irregularity in track shape has been reported by Niu et al. [4, 5] who present wear tracks in their entirety. As this irregularity is not confined in a particular kind of sample (SLM, EBM or CP), the reason for it is not studied further.

Fig. 4.4 Appearances of selected wear tracks showing various track features, (a) SLM sample tested at 2Hz and 6N - straight track, (b) CP sample tested at 2Hz and 6N - straight track with edge pieces, (c) SLM sample tested at 5Hz and 2N - width variation, and (d) EBM sample tested at 8Hz and 6N - width and height variations.

Take Fig. 4.4(d) as an example to discuss further the track width (W_{Track}) and its variation. Observing from top, the lower W_{Track} in the mid location of the track in the longitudinal direction should mean a less wear track depth (h), as is also observable in the cross sectional view, which indicates $h \approx 60 \mu m$ in mid-track location in the cross section. The values of h increase on both sides of the mid-track location and the maximum $h \approx 150 \mu m$. This means $\Delta h \approx 150 - 60 = 90 \mu m$, which is much higher than the value of h in mid-track location ($60 \mu m$), and means that this wear track is very “bumpy” along the track length. From the measured sectional profiles, the averaged h and W_{Track} can be obtained and data for all tested samples are plotted in Fig. 4.5. The scatters of the data are quite small and the regression line is quite close to the calculated curve of h - W_{Track} based on the diameter of the ball used. This suggests that debris on track surface has not affected the wear volume and thus WR estimation.

Selected cross sectional images are shown in Fig. 4.7, each corresponding to the respective one in Fig. 4.4 taken in the mid-length location of the track. These images reveal that the thickness of the debris is uneven and discontinuous. As observed in Fig. 4.4, the SLM sample tested at 2Hz has less wear debris smeared on the track comparing to the CP sample. This is consistent with what can be observed in the cross sections in Fig. 4.7(a) and Fig. 4.7(b) that wear debris can readily be observed to have been smeared on the surface of the CP sample while little can be observed in the SLM sample. The images in Fig. 4.7(c) and Fig. 4.7(d), where debris layers are not continuous and are not seen to be thick, are taken in hump locations shown in Fig. 4.4(c) and Fig. 4.4(d). This suggests that a hump is locally less worn, but does not strongly relate to the amount or form of debris.

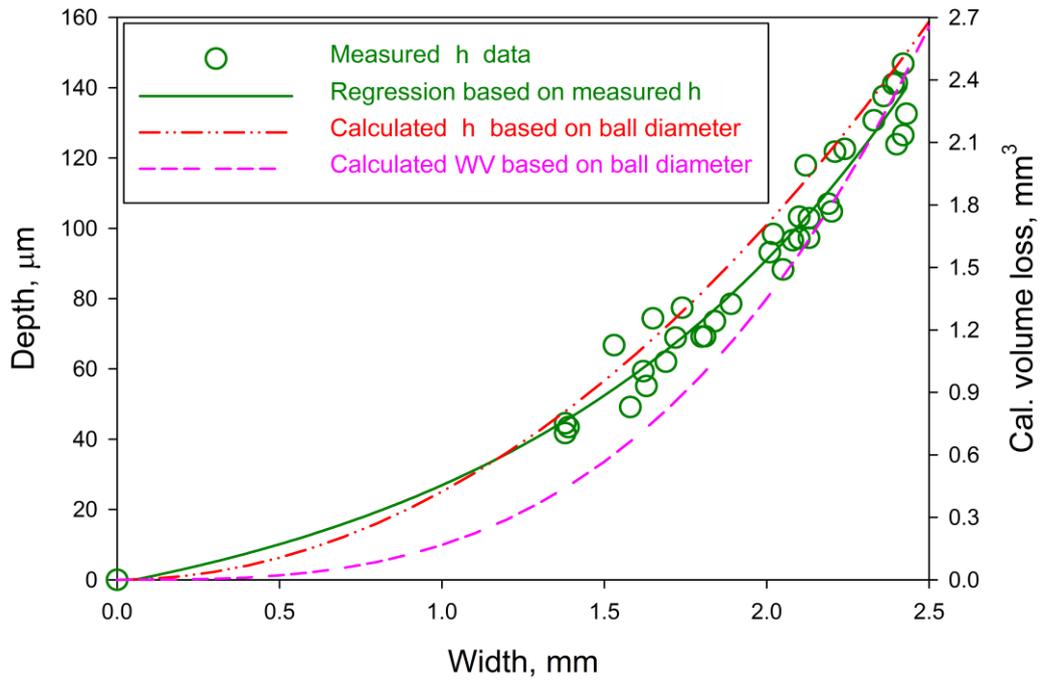
Fig. 4.5 Measured depth, calculated depth and calculated wear volume plotted vs. track width.

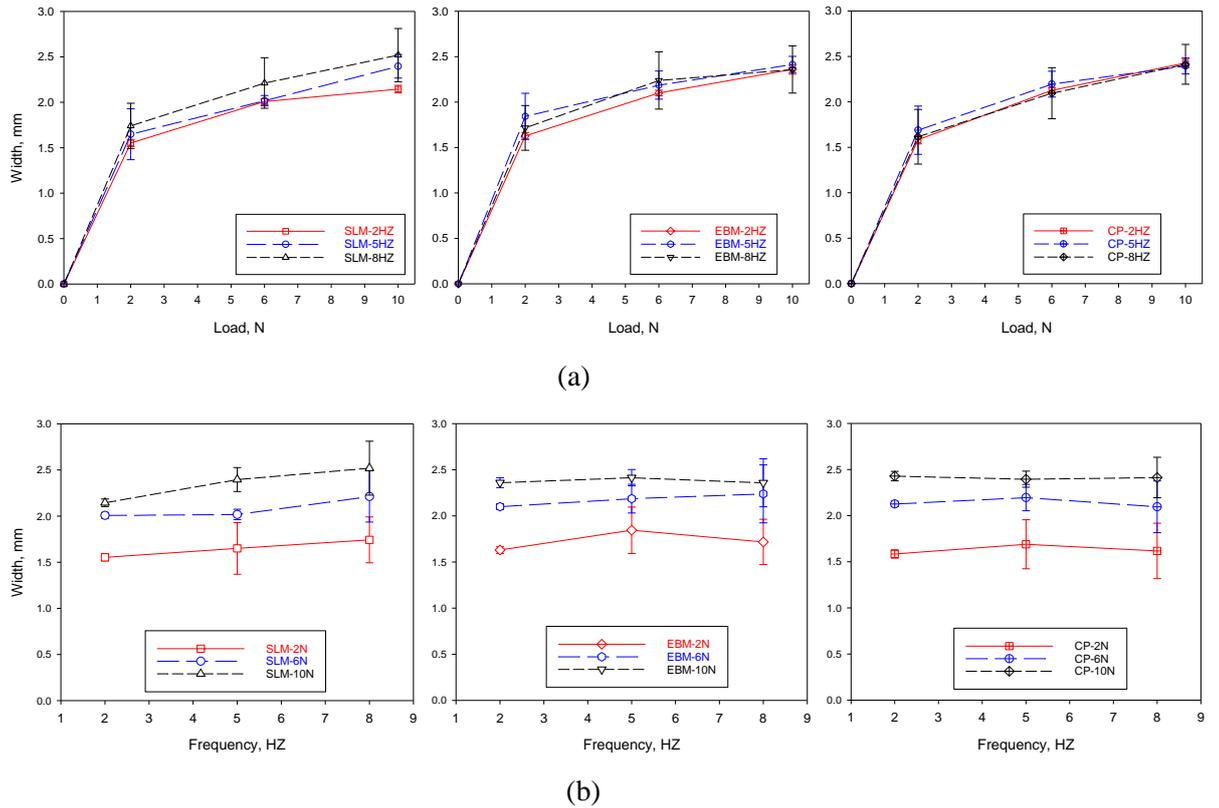
Fig. 4.6 Average measured width and standard deviation values plotted as a function of (a) test load and (b) test frequency.

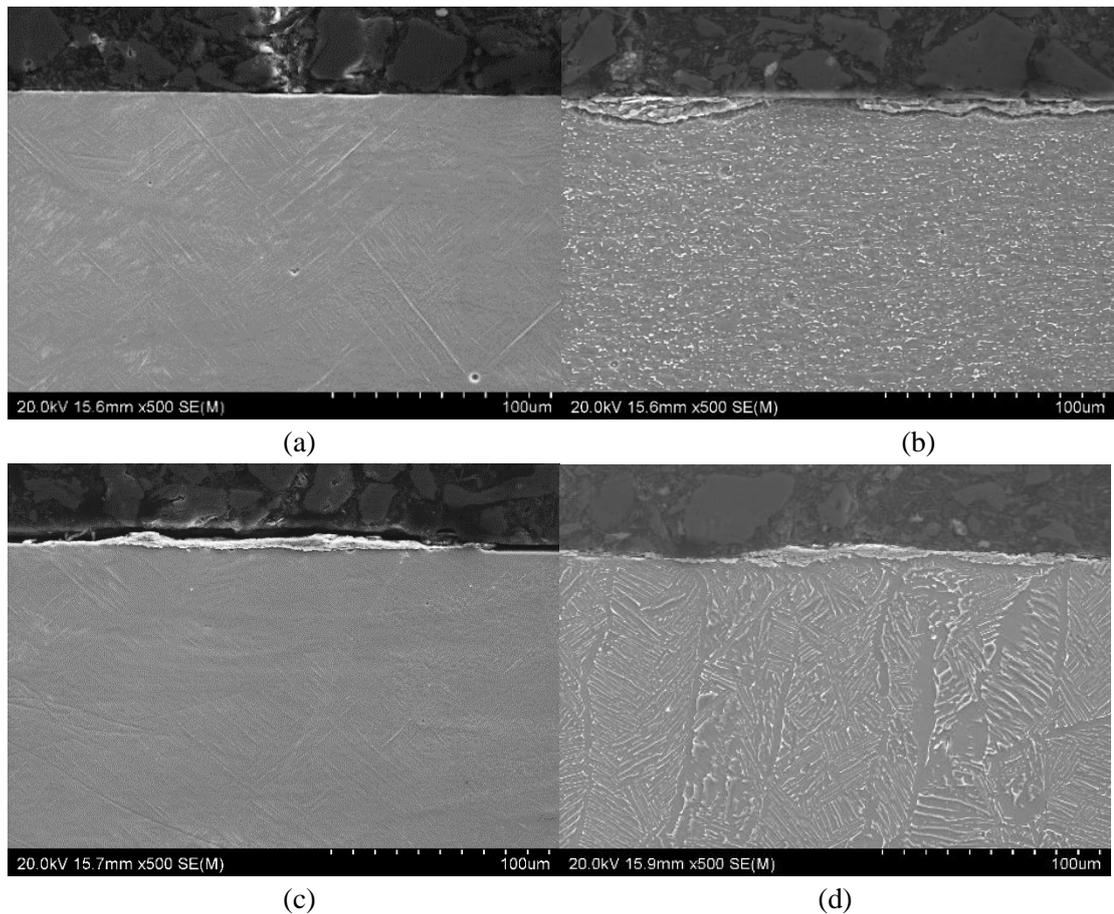
Fig. 4.7 Cross sectional SEM micrographs showing: (a) SLM sample tested at 2Hz and 6N – little debris, (b) CP sample tested at 2Hz and 6N – discontinuous debris layer, (c) SLM sample tested at 5Hz and 2N – uneven and discontinuous debris layer, and (d) EBM sample tested at 8Hz and 6N - uneven and discontinuous debris layer.

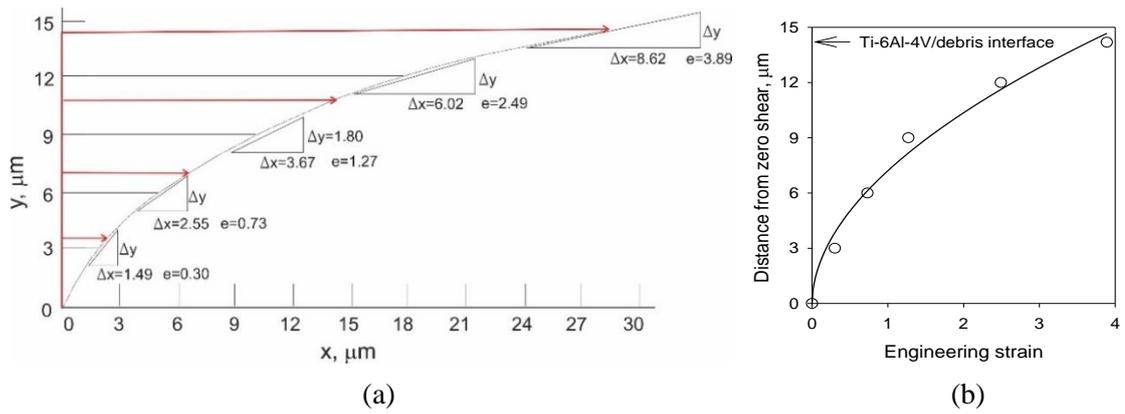
Fig. 4.10 An illustration of shear strain in shear layer, (a) shear distance in the shear field measured in the micrograph in Fig. 4.8(b) and (b) increase in shear strain towards the Ti-6Al-4V/debris interface.

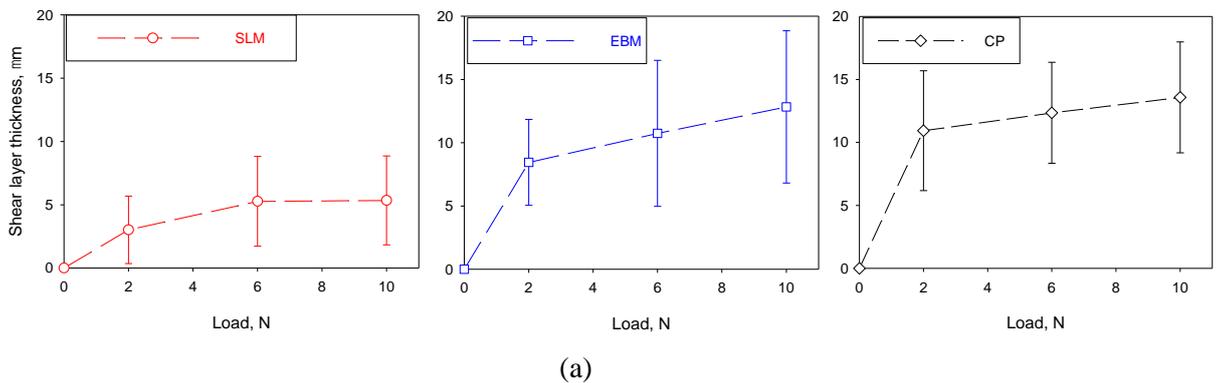
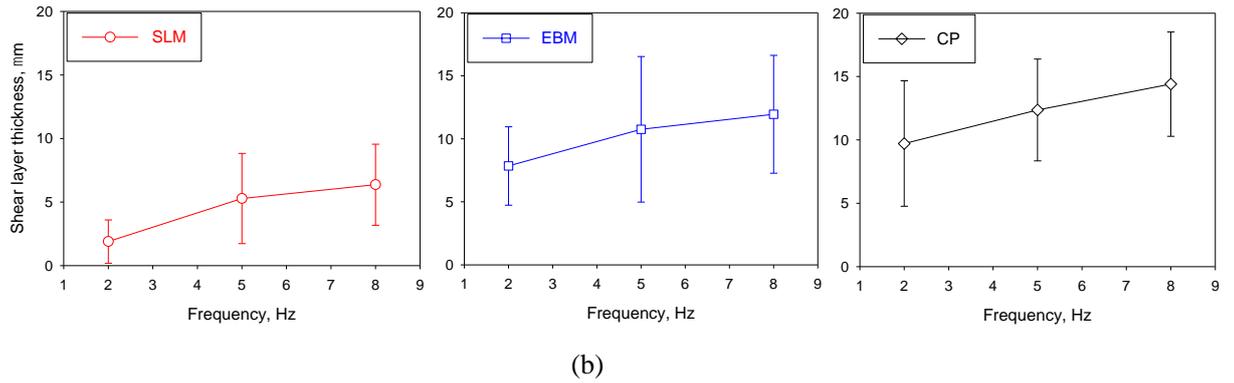
Fig. 4.11 Values of shear layer thickness (h_{sh}) plotted as a function of (a) F_N with $f=5$ Hz and (b) f with $F_N = 6$ N, for SLM, EBM and CP samples as indicated.

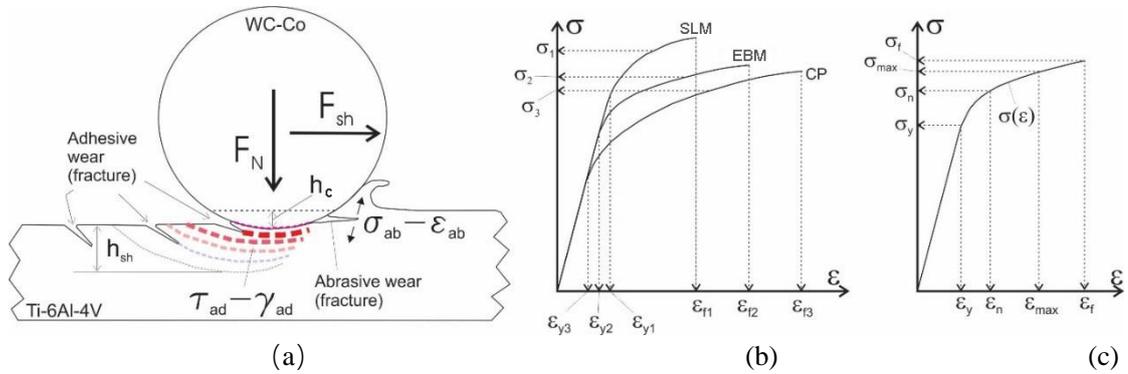
Fig. 4.12 Schematic illustration of (a) sliding wear test with forces, shear stress-strain ($\tau_{ad}-\gamma_{ad}$) field causing adhesive wear, shear layer thickness (h_{sh}), and stress-strain ($\sigma_{ab}-\epsilon_{ab}$) causing abrasive wear indicated, (b) stress-strain curves of Ti-6Al-4V alloy, and (c) stress (σ_n) corresponding to hardness value of the alloy.

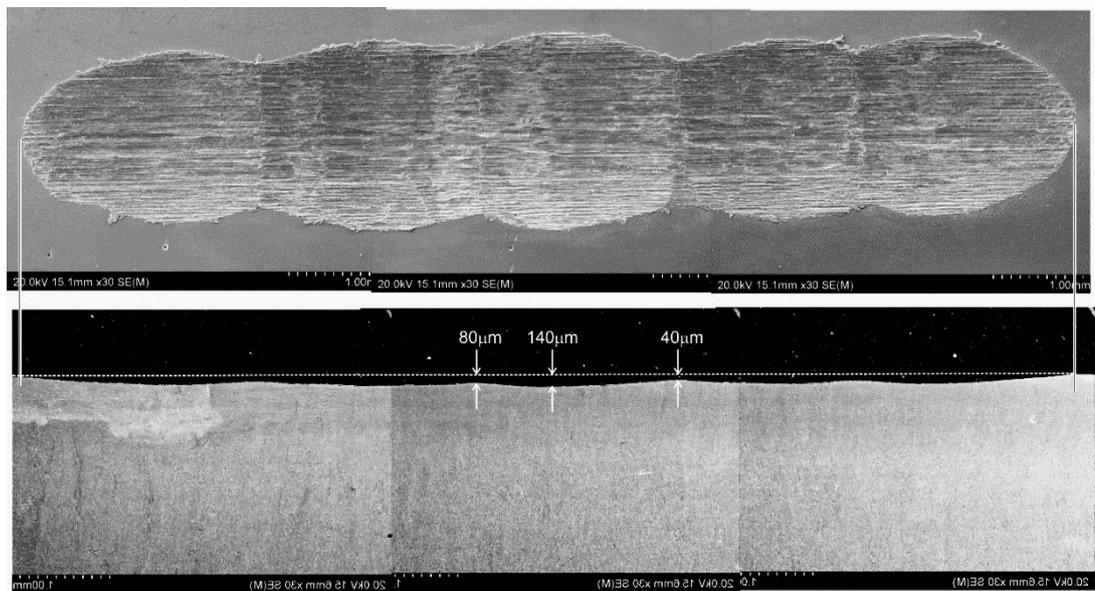
Fig. 5.4 Whole wear track SEM images of EBM sample tested at 400°C and 6N observed from top (top image) and mid cross section (bottom image).

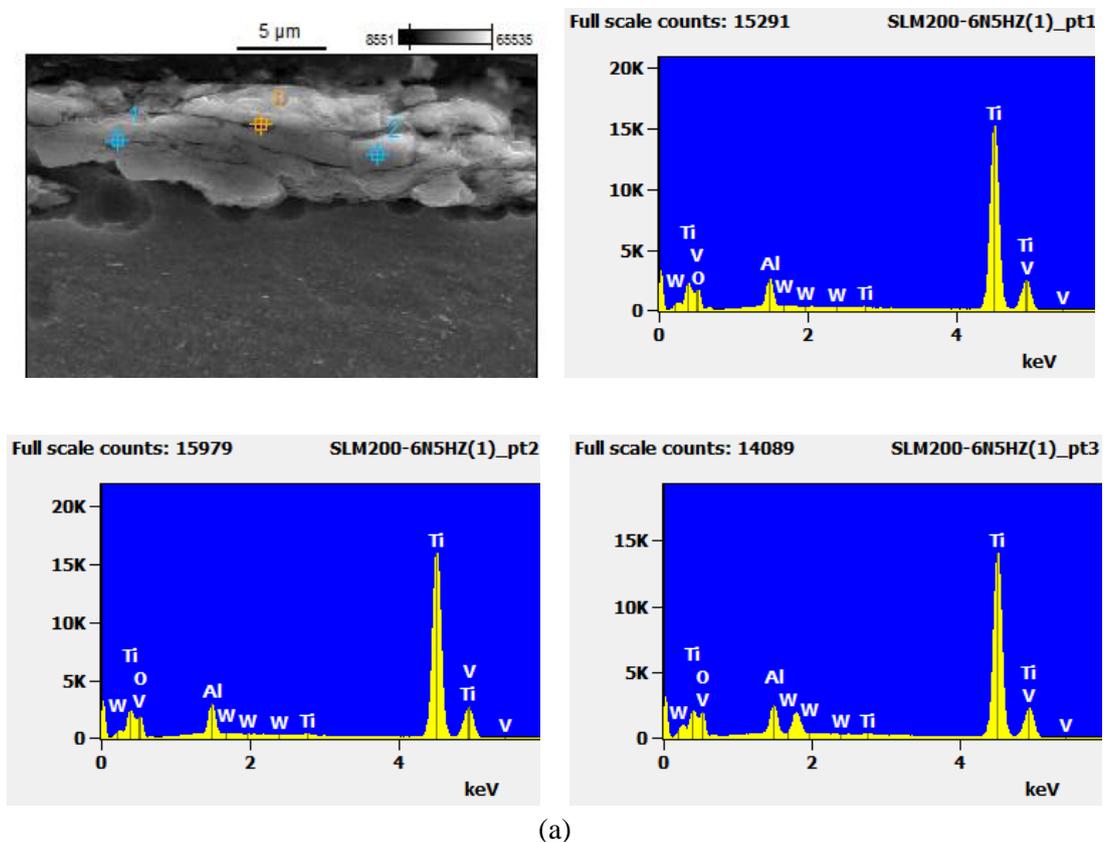
Fig. 5.8 SEM cross sectional images and EDS spectra from analysis of points (1, 2 and 3) marked in the SEM image of SLM samples tested at (a) 200°C, (b) 400°C and (c) 600°C, and under the test load of 6N.

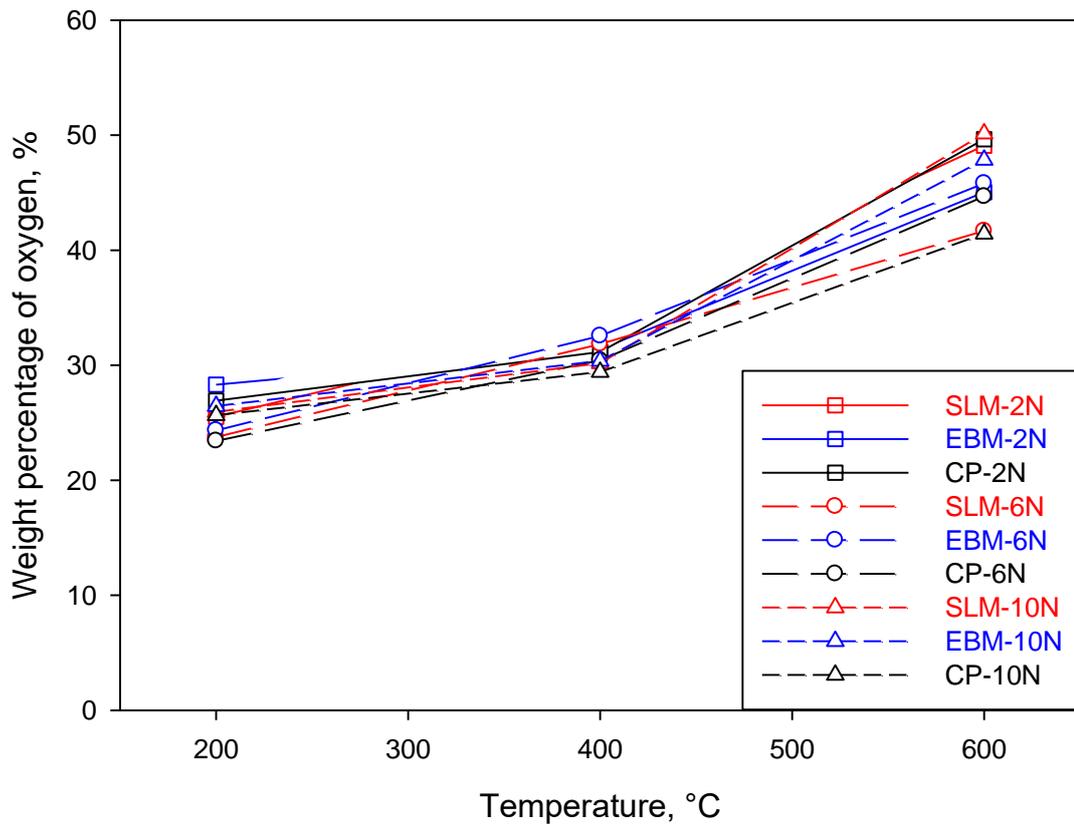
Fig. 5.11 Oxide content determined by EDS-ZAF analysis on wear debris in cross sectional samples plotted vs. tested temperature.

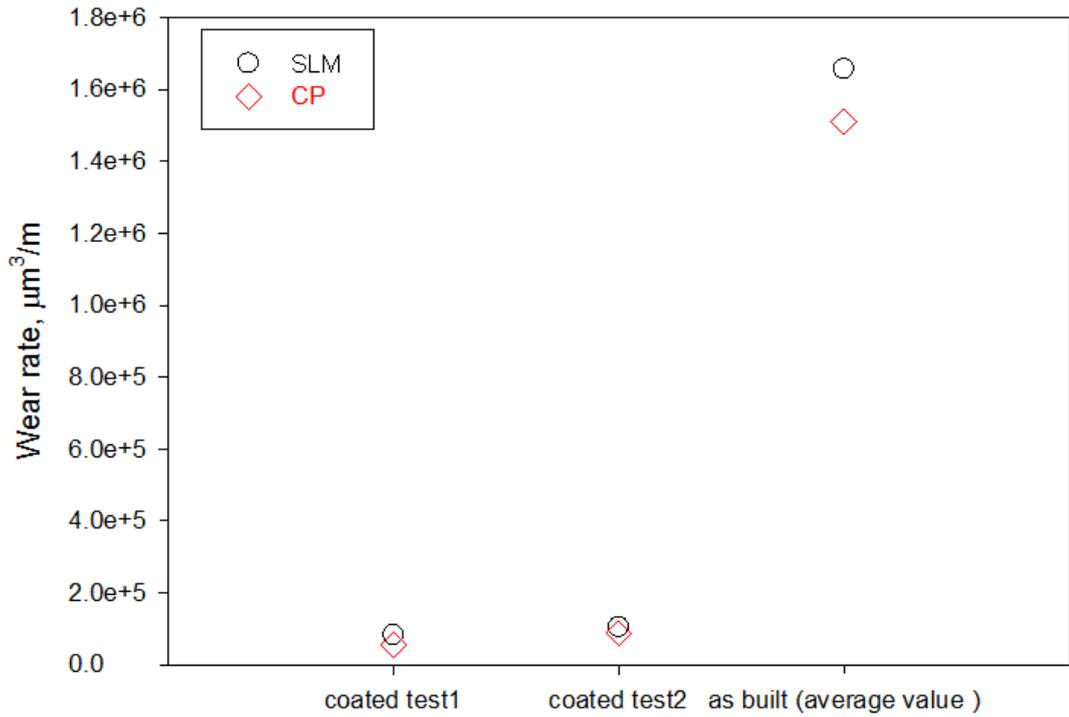
Fig. 6.1 Wear rate for SLM and CP samples with and without PVD coating.

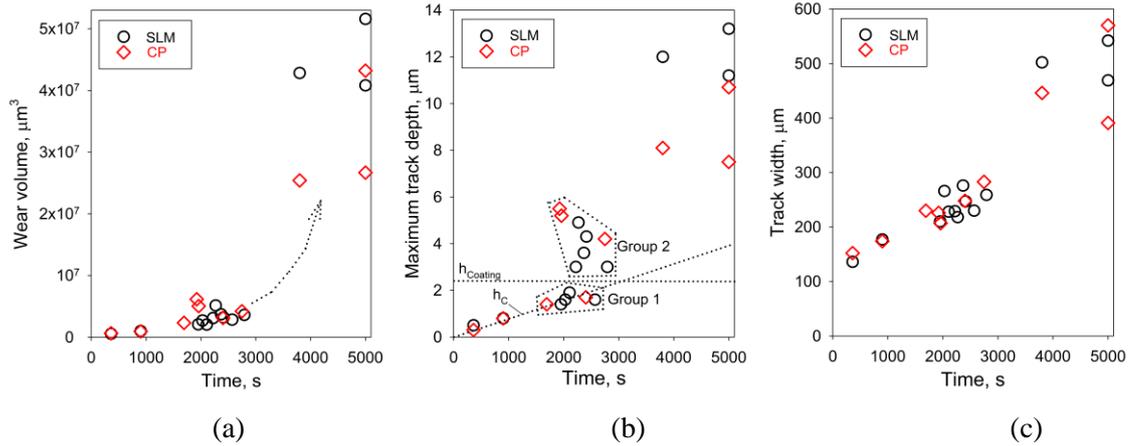
Fig. 6.2 Measured data of (a) WV, (b) h_{Max} and (c) W_{Track} plotted as a function of time for the two types of coated samples. In (b), a horizontal line representing $h_{Coating}$, outline of group 1 data with $h_{Max} < h_{Coating}$, outline of group 2 data with $h_{Max} > h_{Coating}$, a regression line labelled as h_c based on data below $h_{Coating}$ line are drawn.

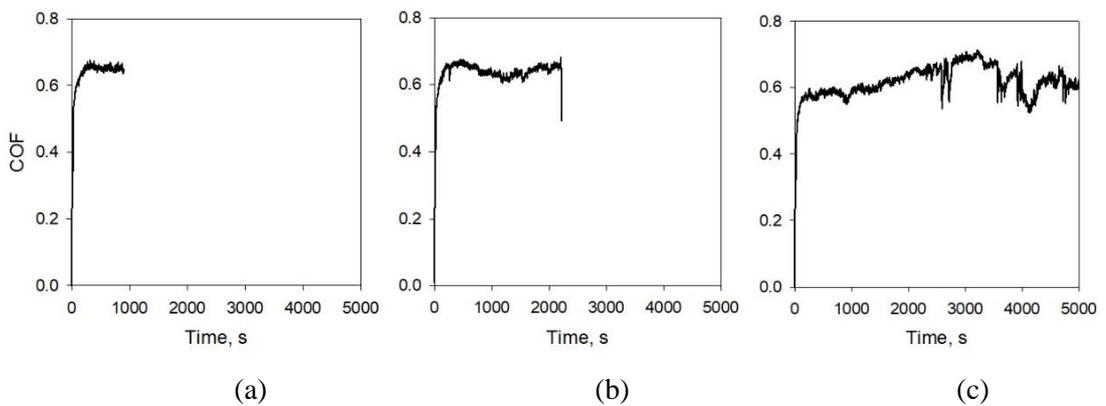
Fig. 6.3 Coefficients of friction during testing of SLM samples for (a) 900s, (b) 2219s and (c) 5000s.

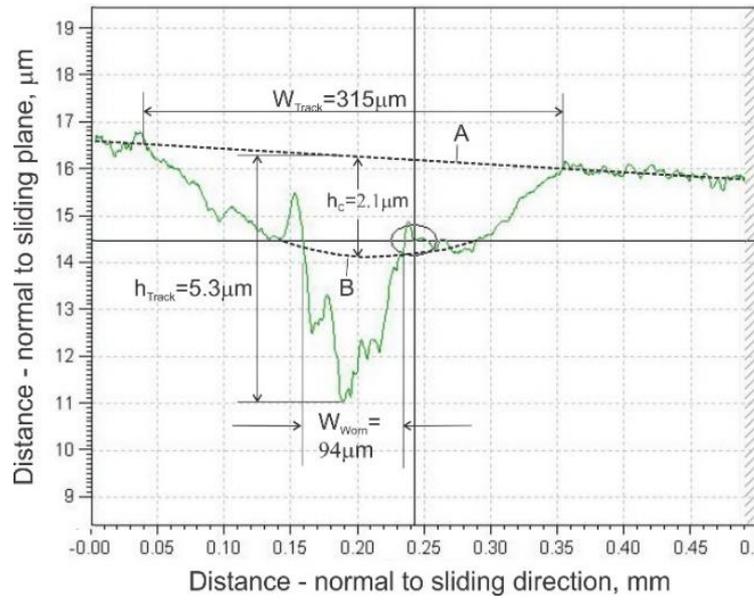
Fig. 6.4 A trace from the profilometry measurement for a CP sample wear track with sliding wear stopped at 2747s.

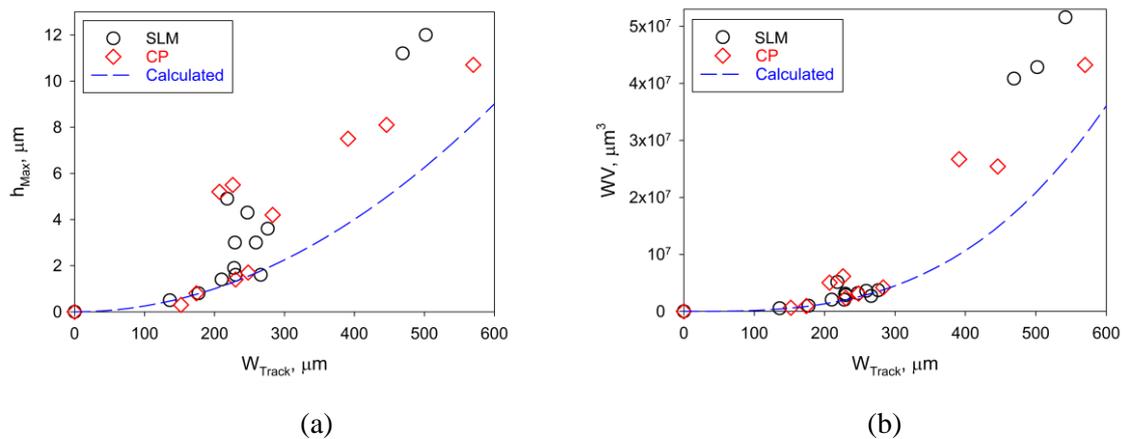
Fig. 6.6 Measured and calculated (a) depth and (b) wear volume plotted against track width for both SLM and CP

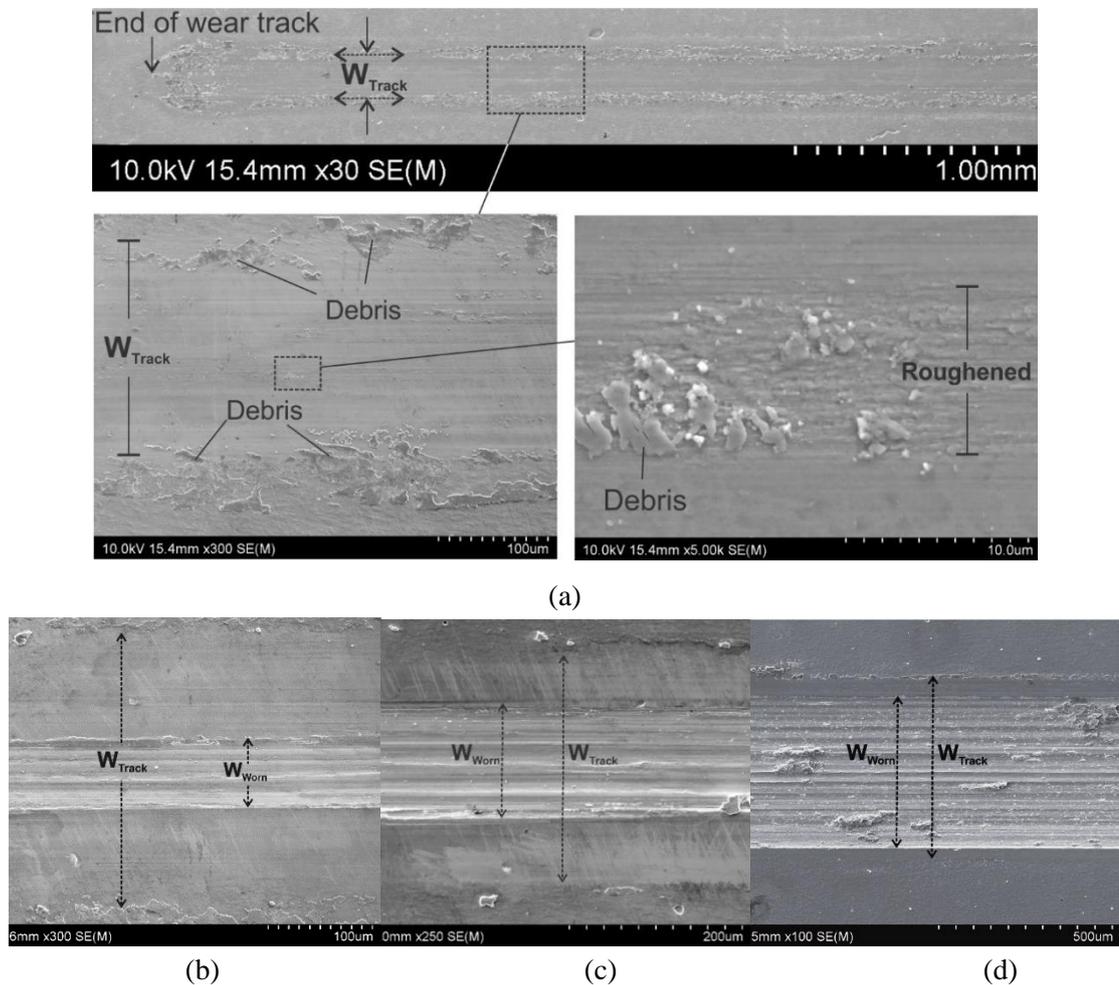
Fig. 6.7 SEM images of track surfaces of SLM samples tested for (a) 900s and (b) 2219s, (c) 2268s and (d) 5000s.

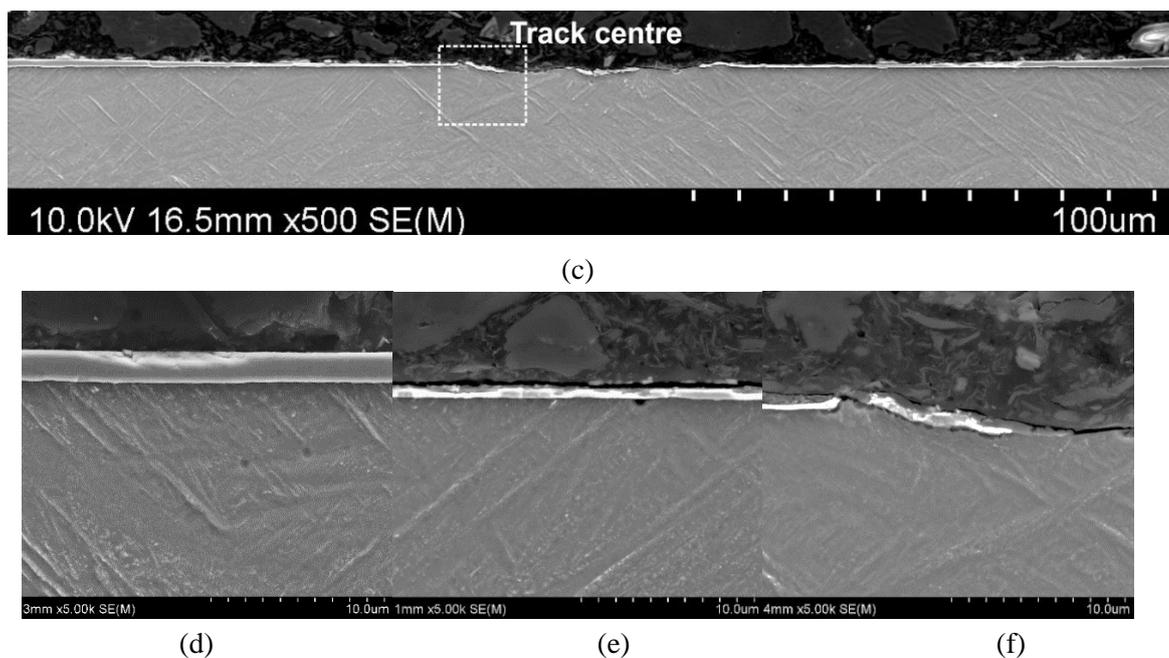
Fig. 6.8 SEM micrographs of track cross sections of SLM samples tested for (a) 900s, (b) 2105s, and (c) 2219s, (d), (e) and (f) are high magnification micrographs in local area marked with a small square in (a), (b) and (c), respectively.

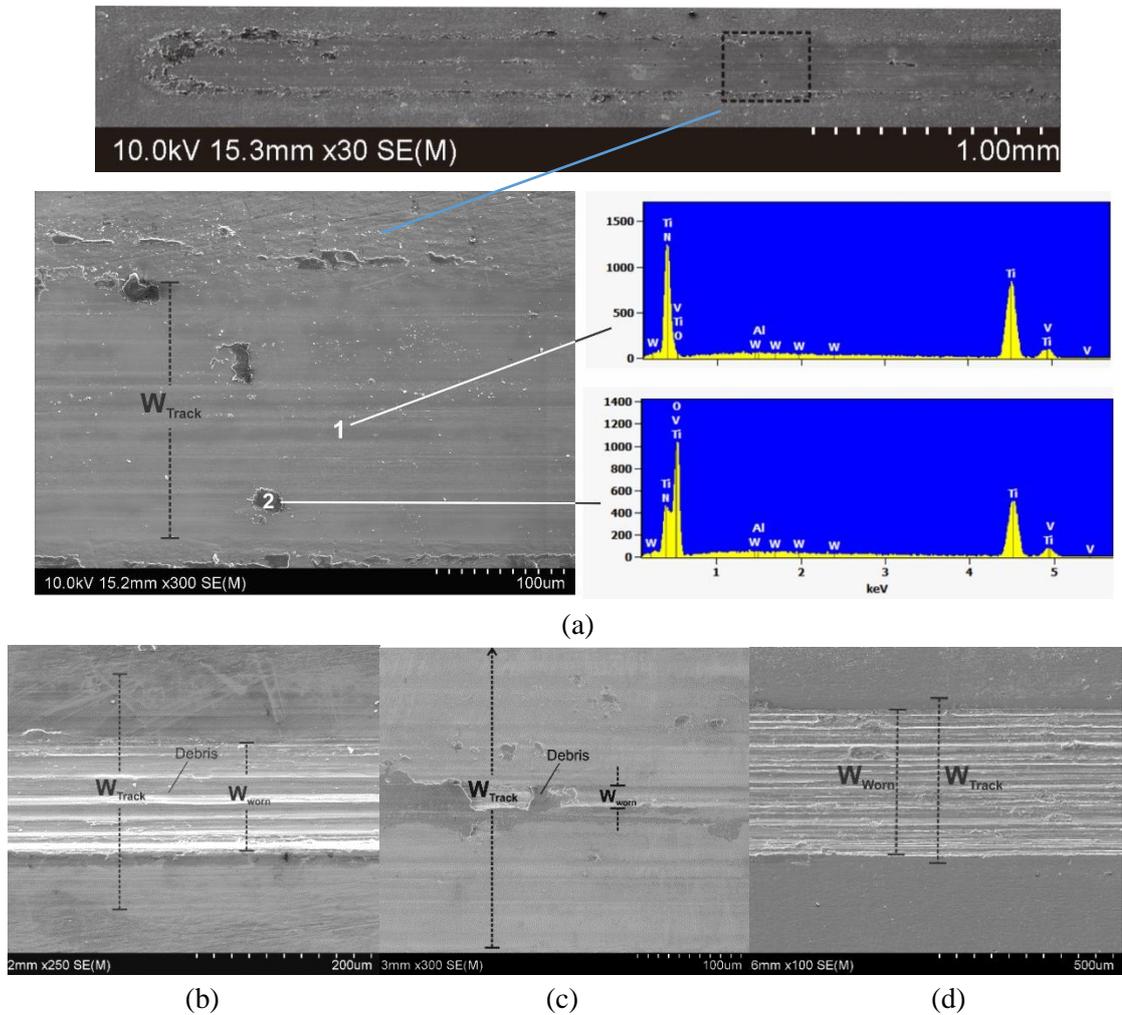
Fig. 6.9 SEM images of track surfaces of CP samples tested for (a) 900s and (b) 1958s, (c) 2401s and (d) 5000s. In

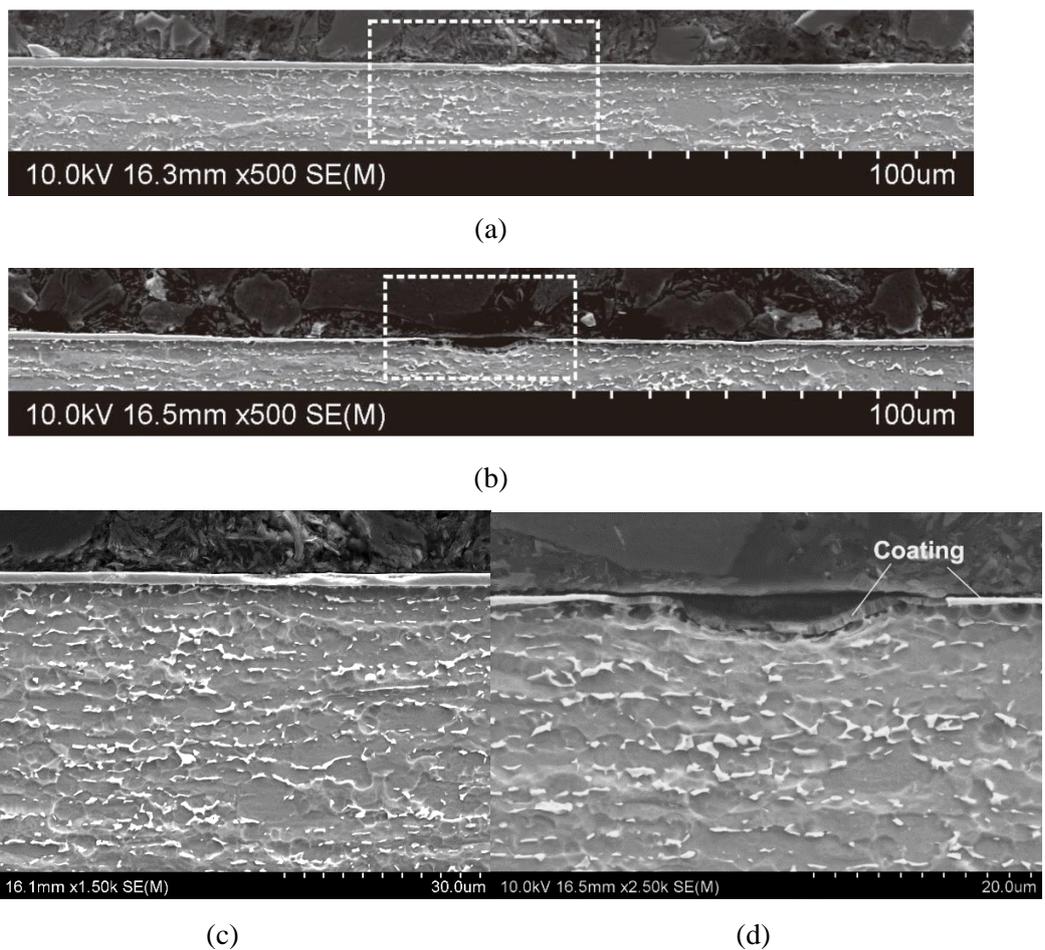
Fig. 6.10 SEM micrographs of track cross sections of CP samples tested for (a)900s and (b) 2401s, (c) and (d) are high magnification micrographs in local area marked with a small square in (a) and (b), respectively.

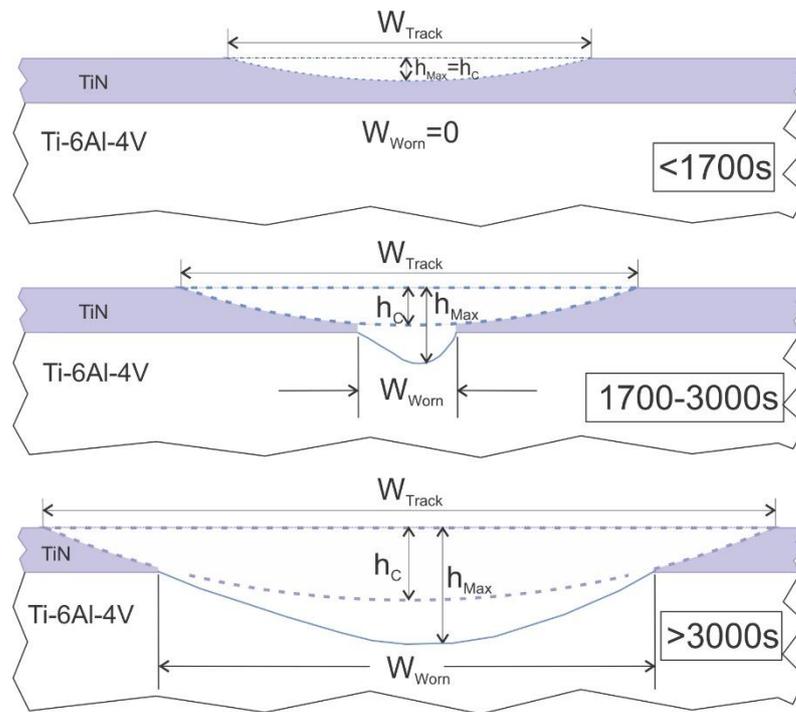
Fig. 6.11 Schematic illustration of wear track before (top schematic) and after the coating having locally broken in mid track (mid schematic), respectively, and continuation of wear with the portion of coating resisting wear becoming less and less (bottom schematic).

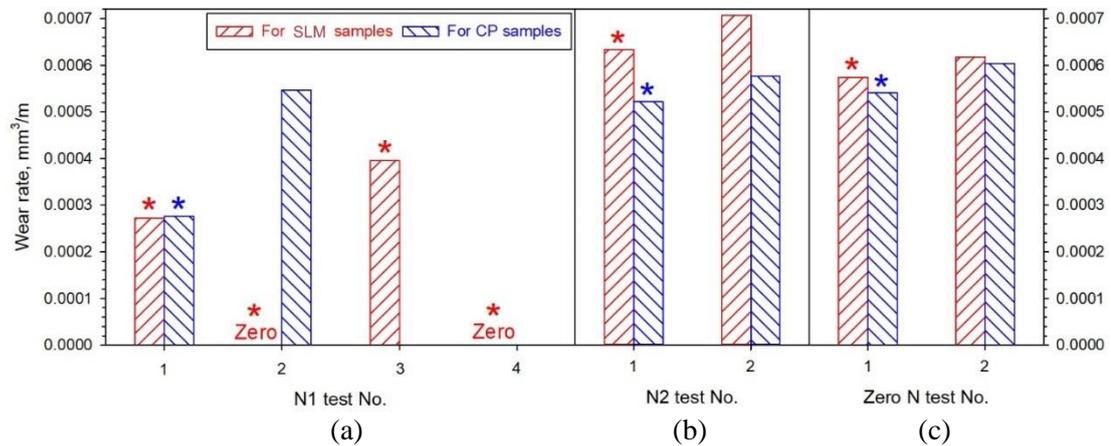
Fig. 7.1 Wear rate of eight tests conducted with $F=1N$ and $f=5Hz$ for 40m and on samples with (a) N1 and (b) N2 nitrogen concentration profile after ion implantation and (c) with samples without ion implantation. Note: data with * mean their track appearances will be shown.

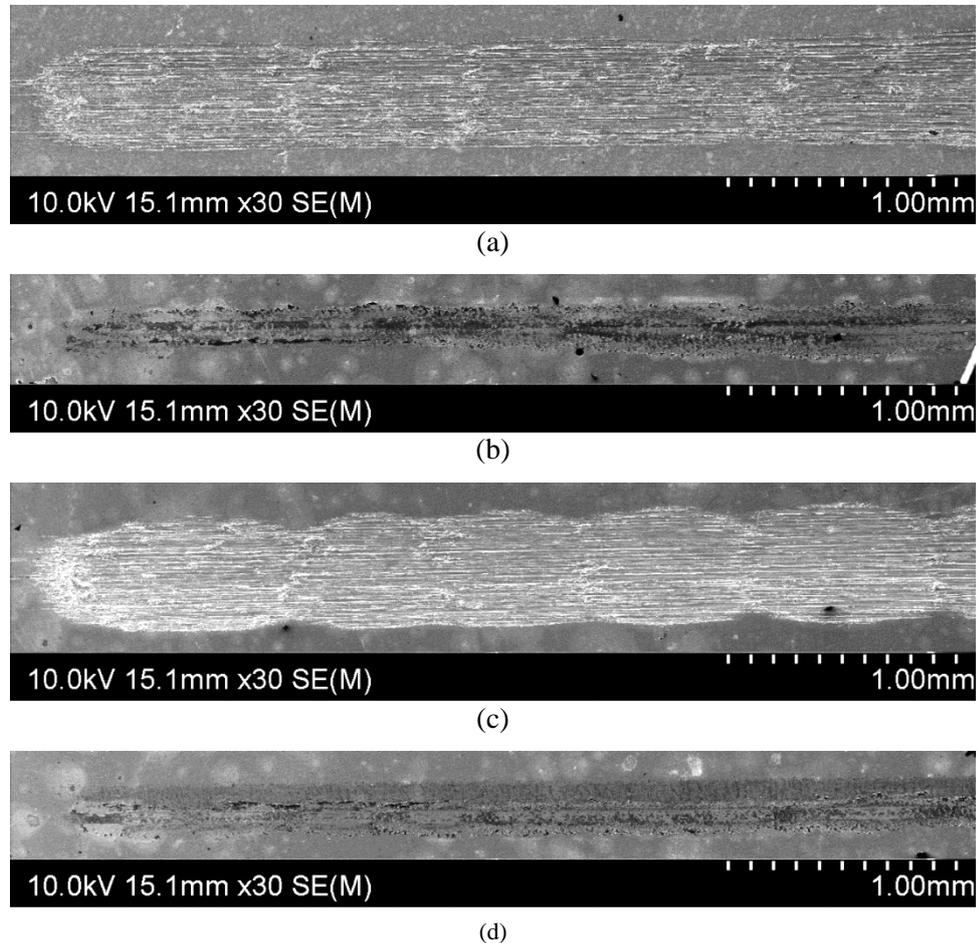
Fig. 7.2 SEM images of SLM-N1 sample wear tracks after (a) first, (b) second, (c) third and (d) fourth experiments.

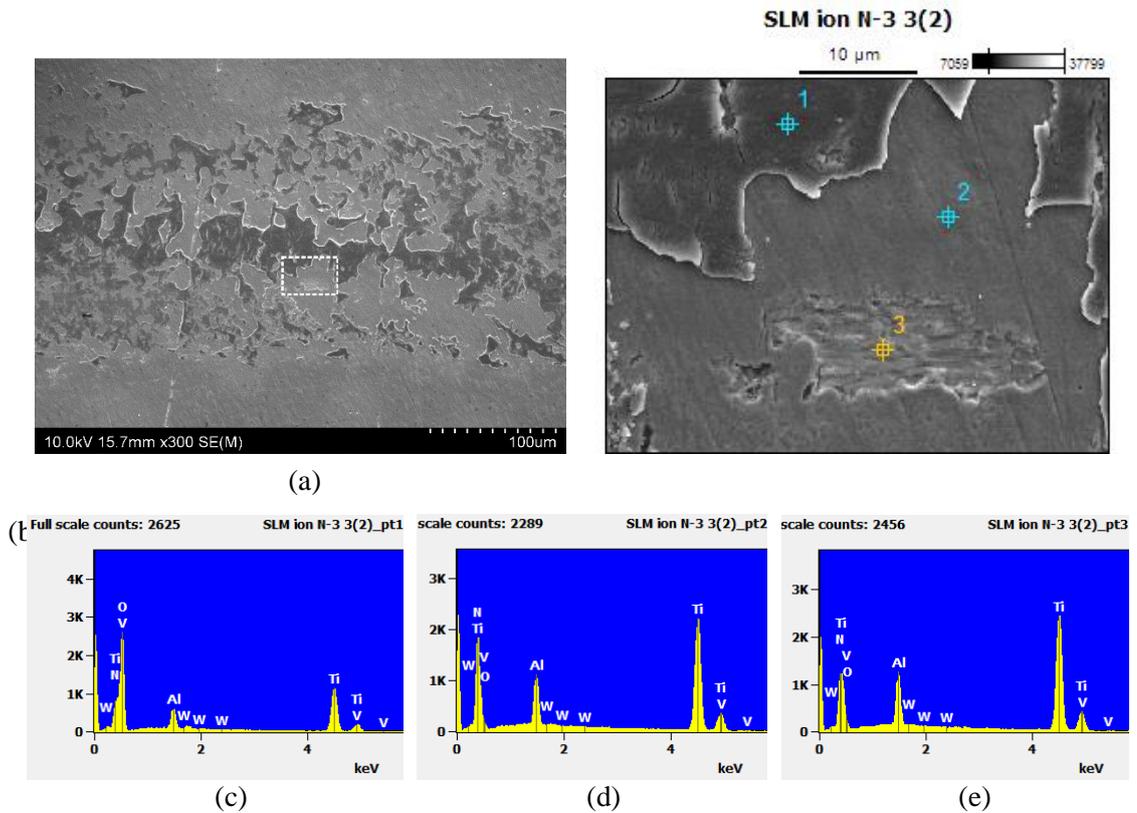
Fig. 7.3 SEM images (a) and (b) in higher magnifications taken in SLM-N1 track from the second test and EDS spectra in locations of (c) point 1, (d) point 2 and (e) point 3 as indicated in (b).

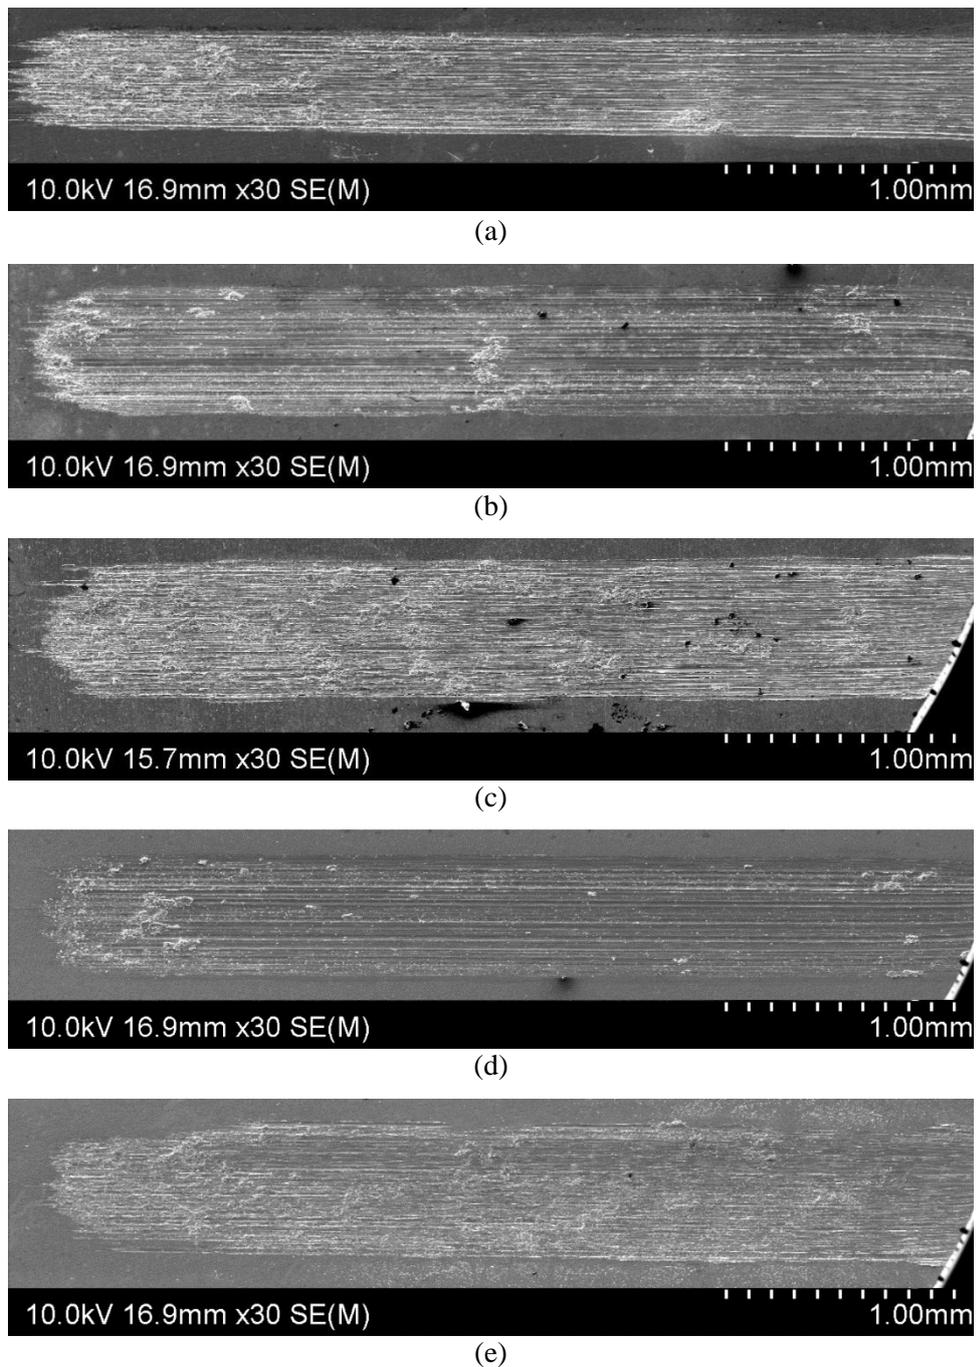
Fig. 7.4 SEM images of wear tracks of (a) CP N1, (b) SLM N2, (c) CP N2, (d) SLM non-treated and (e) CP non-treated samples, after the first respective wear experiment.
