**Investigation of Tribological Performance of Ti-6Al-4V Alloy
Processed by Selective Laser Melting and Electron Beam
Melting Processes**

A thesis submitted to Auckland University of Technology in fulfilment of the requirements for
the degree of Doctor of Philosophy (PhD)

2021

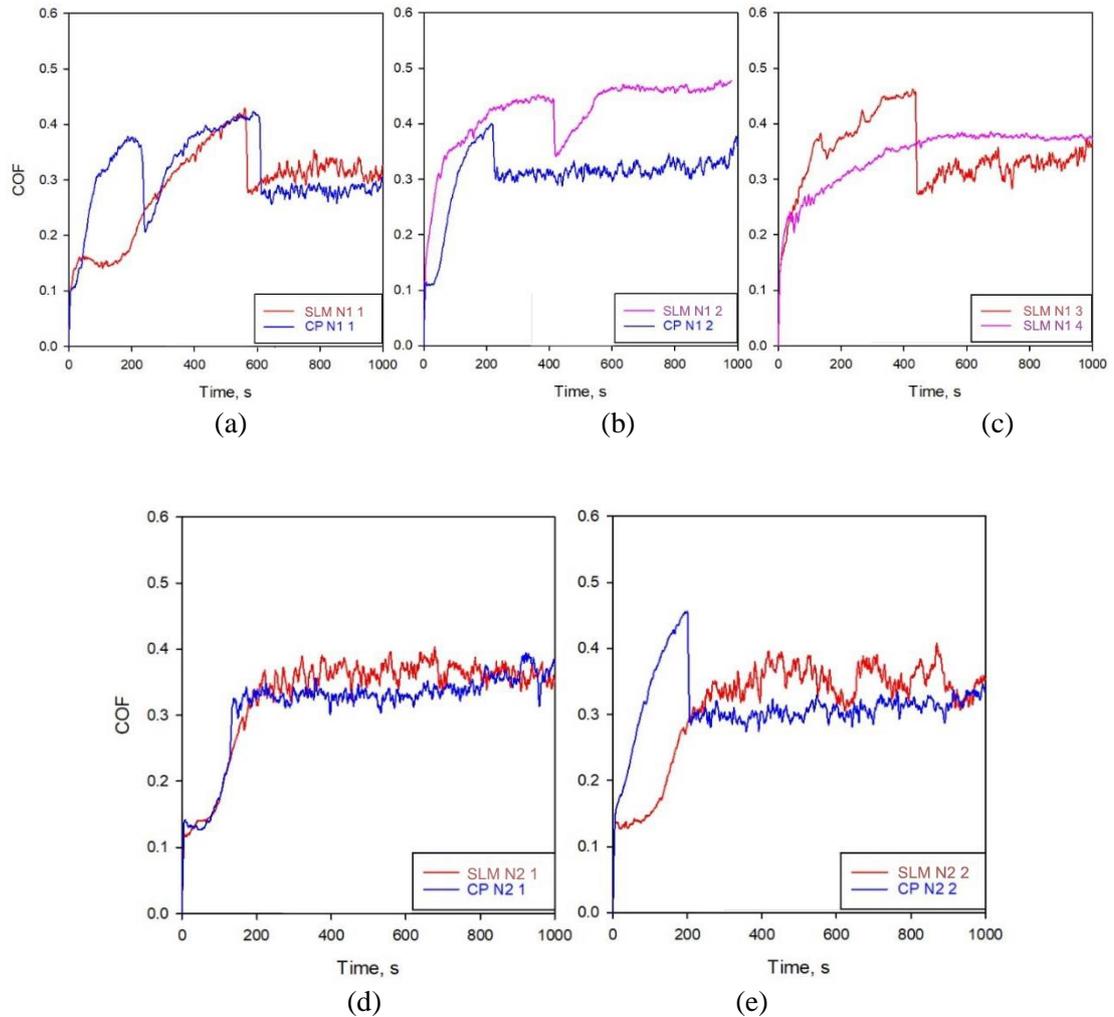
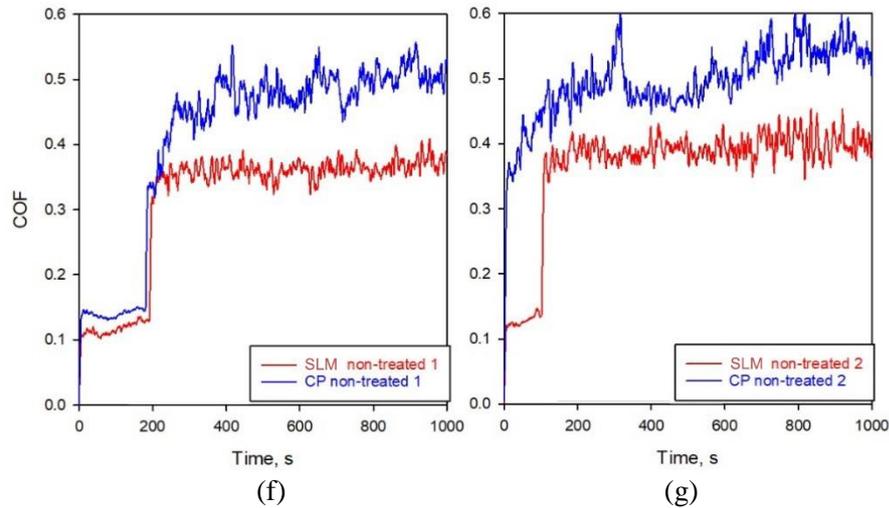
Fig. 7.5 COF plots for (a) SLM and CP N1 first tests, (b) SLM and CP N1 second tests, (c) SLM N1 the third and fourth tests, (d) SLM and CP N2 first tests, (e) SLM and CP N2 second tests, (f) SLM and CP non-treated sample first tests, and (g) SLM and CP non-treated sample second tests.
