(Re) Inhabitation

Pursuing the Continued Use of Auckland CBD's Disused Heritage
Through an Approach of Minimum Intervention

A thesis submitted to Auckland University of Technology in partial fulfilment of the requirements
for the degree of Master of Architecture (Professional)

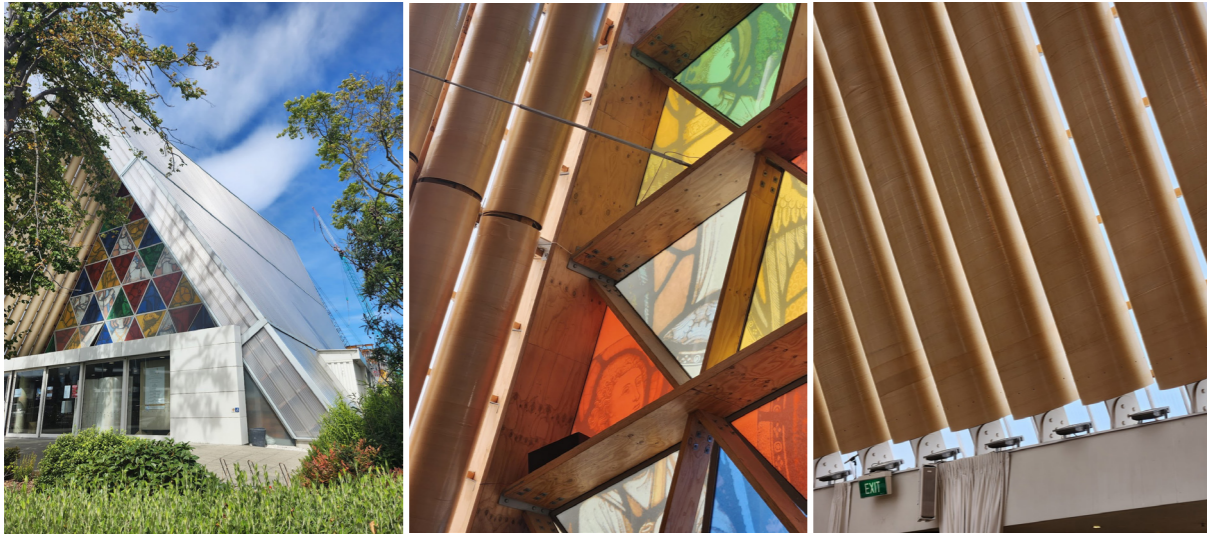
Figure 14. Image of Transitional Cathedral Exterior, by Author. Figure 15. Image of Transitional Cathedral interior window, by Author. Figure 16. Image of Transitional Cathedral structure, by Author.

In 2011, a magnitude 6.3 earthquake left much of Christchurch in disrepair. Two years later, Shigeru Ban architects produced The Transitional Cathedral as a temporary place of worship for those who had lost Christchurch Cathedral as their place of religious practice (Shigeru Ban, 2025). A large component of the original cathedral's cultural heritage value is in the community around it. This existing community is an example of "Intangible Values" as represented in *Respect for surviving evidence and knowledge* in the ICOMOS New Zealand Charter (2010). While the original cathedral and cathedral site could not continue to be used, The Transitional Cathedral enables continued use for the existing community, thus conserving the intangible cultural heritage value of the original cathedral. In a city known for its traditional architecture reminiscent of towns in the United Kingdom, The Transitional Cathedral has impact in the juxtaposition between the traditional & permanent, and the modern & temporary (Crook, 2025). While traditional cathedrals are built of solid, enduring materials, Ban opted for Lightweight and readily available alternatives. This not only ensures ease of assembly and disassembly but also gives the space personality. The building itself is a modern take on a traditional basilica. Ban's signature paper tubing creates an A-frame nave which is flanked by shipping container side aisles. Simple polycarbonate roofing floods the space with daylight, eliminating the need for extensive lighting. The Transitional Cathedral proves that architecture does not need to be extravagant and resource intensive to be impactful. This precedent demonstrates successful application of Minimum Intervention and Continued Use principles.

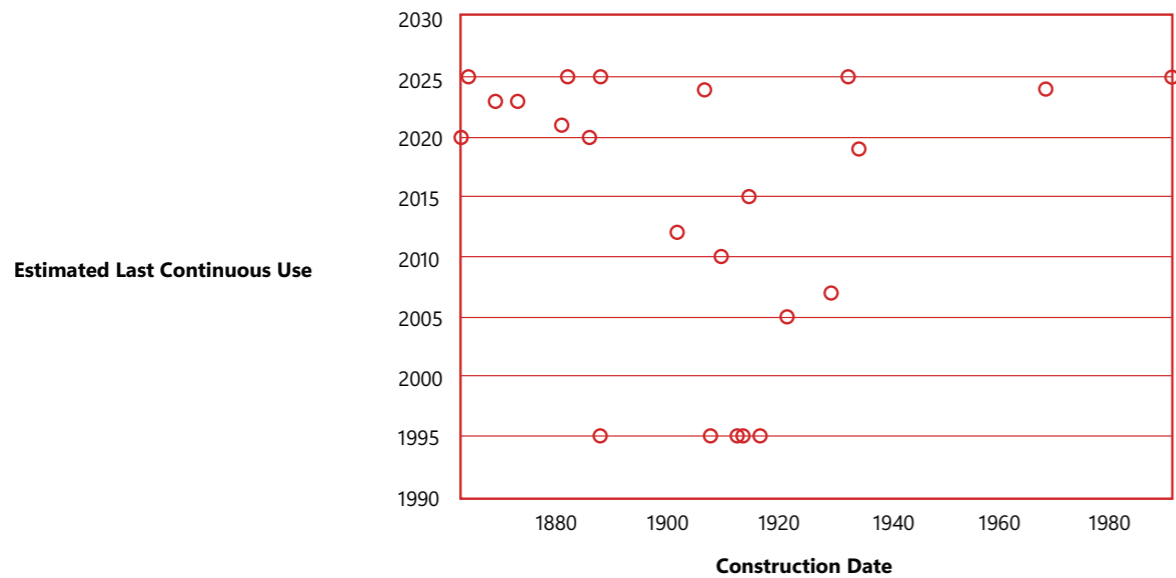
Figure 19. Graph showing relationship between estimated last continuous use and construction date of disused buildings in Auckland CBD, by Author.

23 of the 30 sites featured in the previous mapping contain existing buildings. The above scatter plot displays the relationship between their age and estimated last continuous use. Although not a large enough sample size to draw wider conclusions from, the graph does suggest a weak positive relationship between these two factors. A cluster of the oldest buildings have been left in a disused state in the last five years. While it is easy to dismiss this as simply the turnover period between use and finding a new tenant, the long-term continuous use of 2 sites included in this cluster would suggest otherwise. Blackstone Chambers operated as a law office from 1901 until its closure in 2023 (122 years), and Smith and Caughey's operated from 1880 until their recent closure in 2025 (145 years).

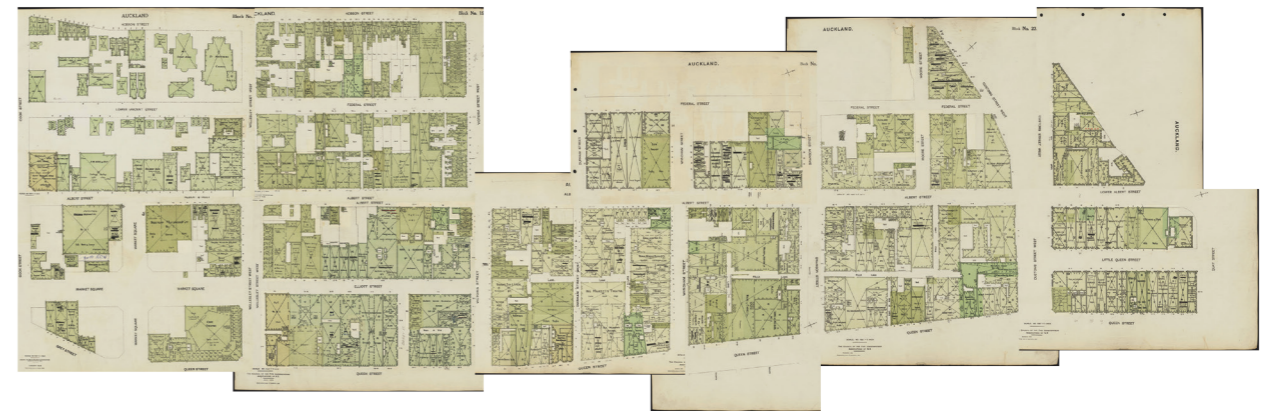
1916 Fire Insurance Plans

Figure 22. Map of original Albert Street area blocks merged by Author, (Auckland Libraries Heritage Collections Maps, 1916-1929)

A closer investigation of selected sites was undertaken by comparing the building footprints of the Albert Street area in 2024 with the historic building footprints that are shown on the 1916 fire insurance plans found online in the Auckland Council Archives. Due to the extent of the heritage maps, calculations between time periods are measured by ground floor area.

Disclaimers: While initially drawn in 1916, it is evident that undated updates were made to the plans in at least the following decade. This is evident in Block 18, with Smith and Caughey's Lippincott Building (Constructed 1929). Additionally, Blocks 20A and 20 are missing from the Council archives and thus have not been included in the 1916 totals. Block 20 in particular is notable for containing St Patrick's Cathedral which would have been included in any such maps, having been completed in 1907. The missing blocks are detailed in the below image. It is also worth noting that the Albert Street area Ground Floor Area (GFA) has densified 32.1% between each mapping. It is for this reason that building footprint totals are shown as a percentage of the historic and existing ground floor area.

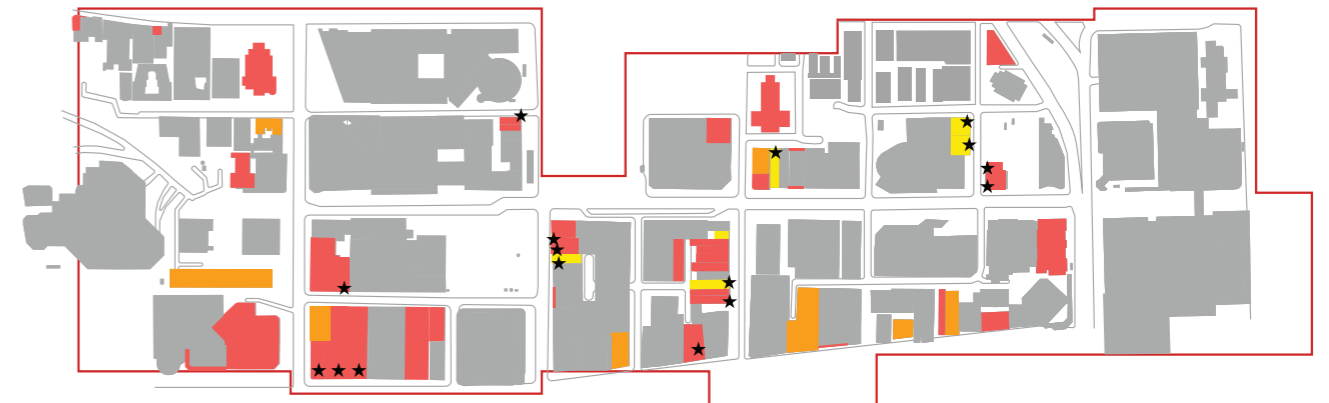
2024 Building Footprints

Figure 23. Map of Albert Street area blocks in 2024, by Author.

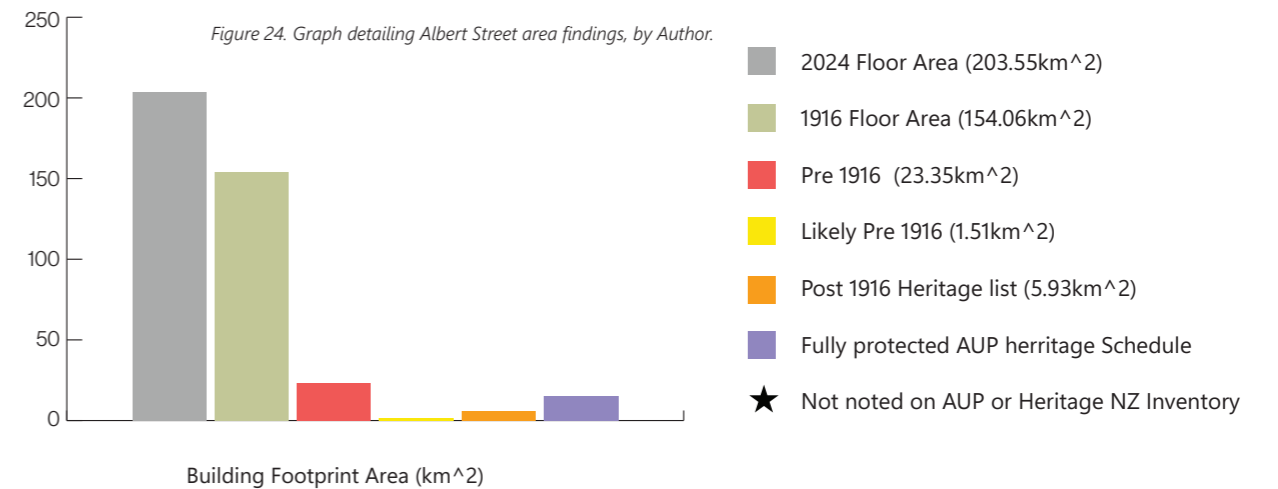
*15.16% of 1916 buildings exist in 2024 by ground floor area

*11.47% of 2025 buildings are pre 1916 by ground floor area

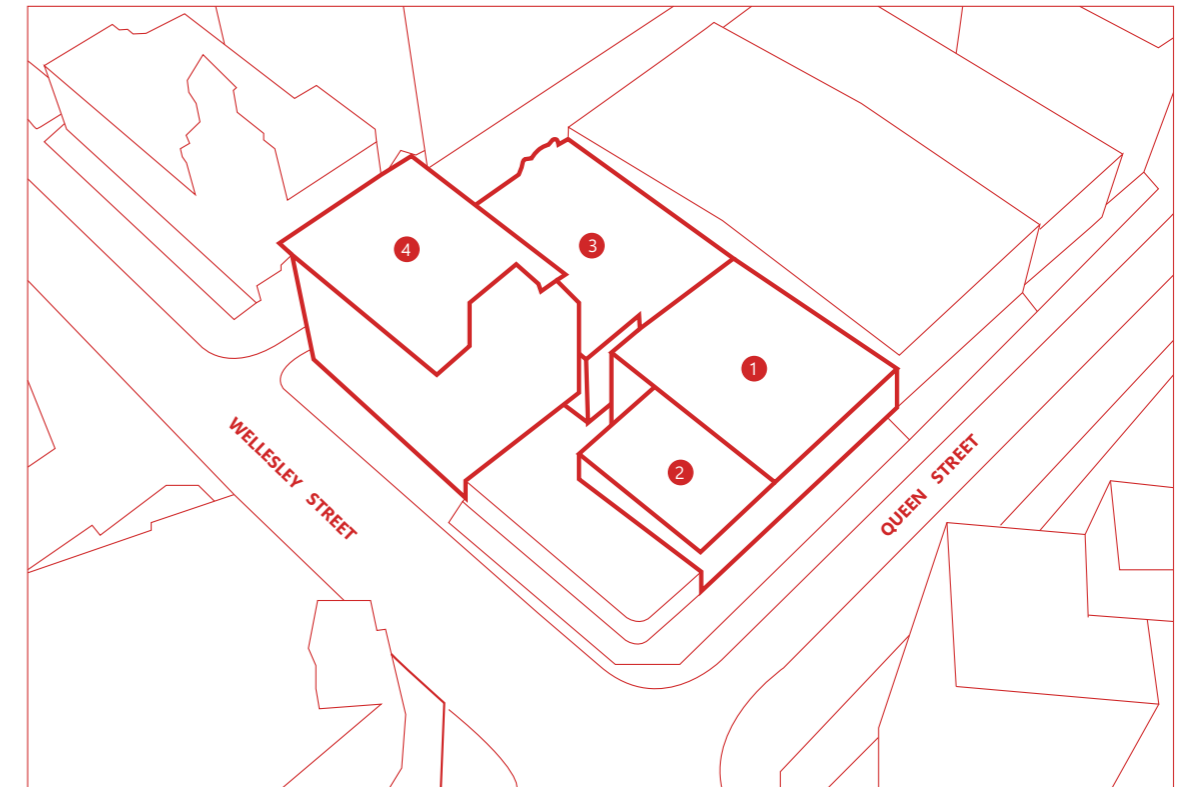
1 McArthur Warehouse ca.1876 2 Original Premises 1880 (Reconstructed 1921) 3 Mahoney Building 1908 4 Lippincott Building 1929

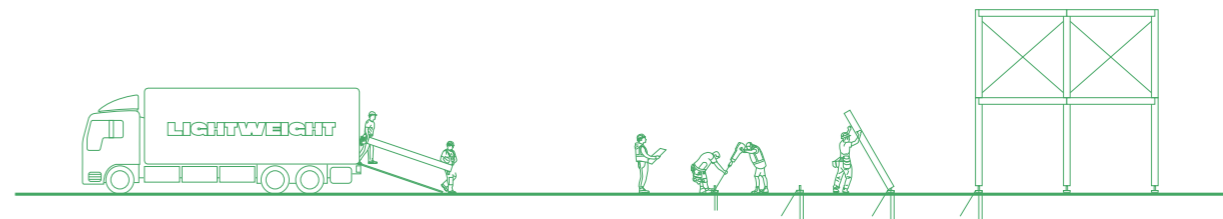
Figure 87. Assembly diagram, by Author.

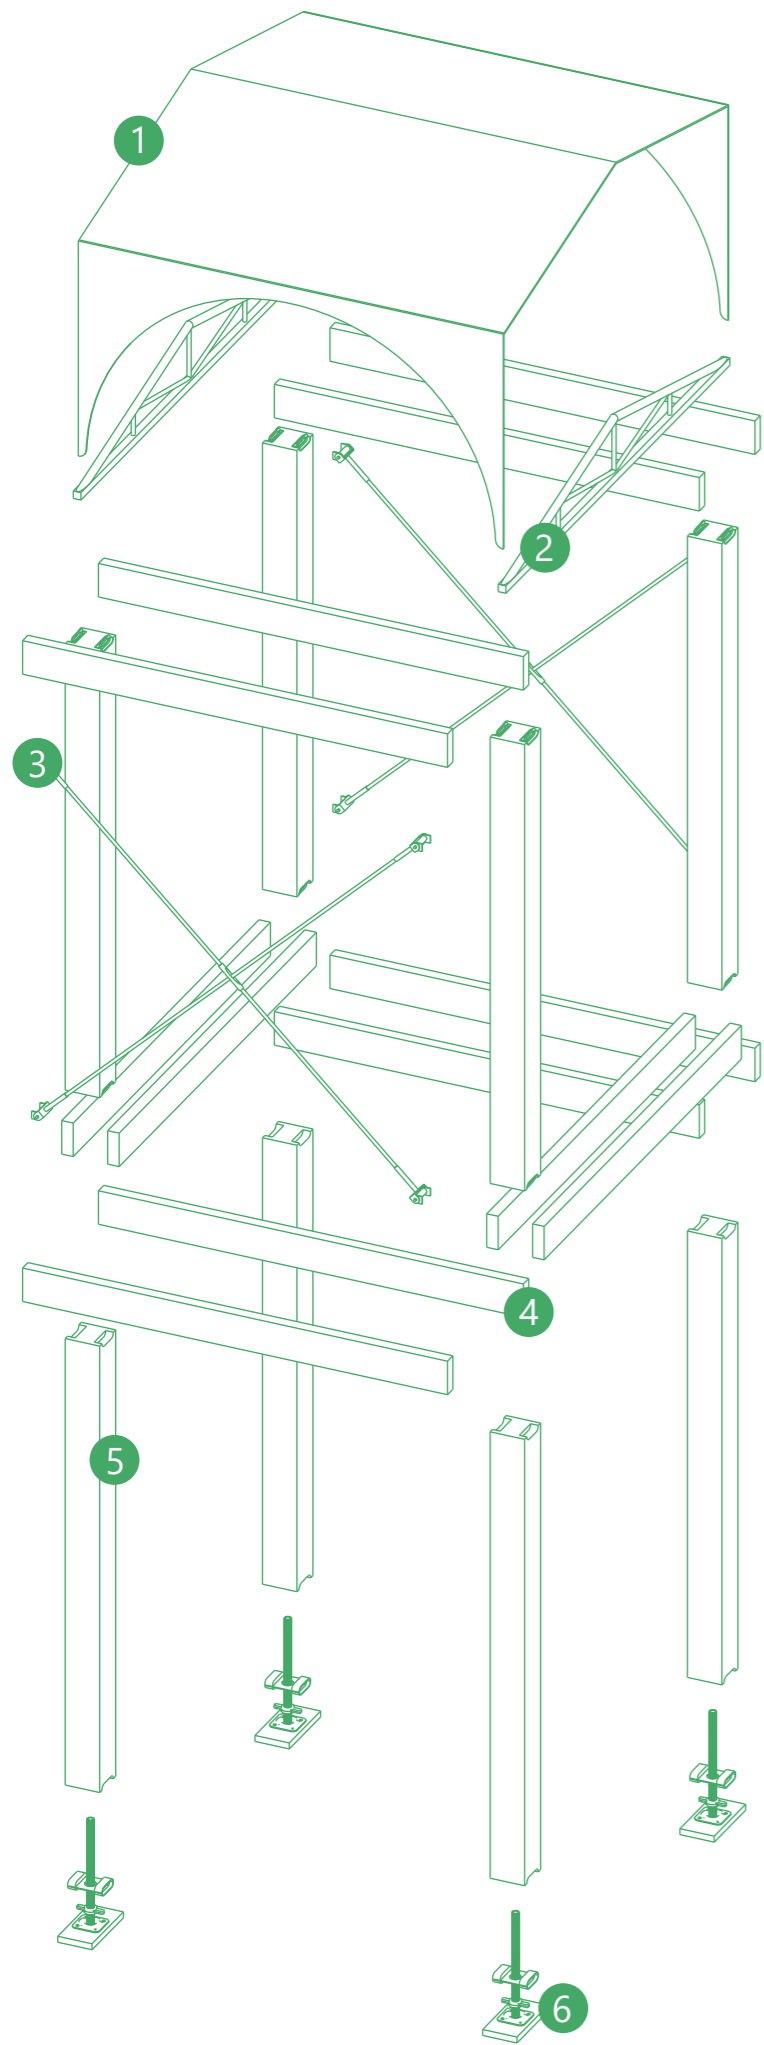
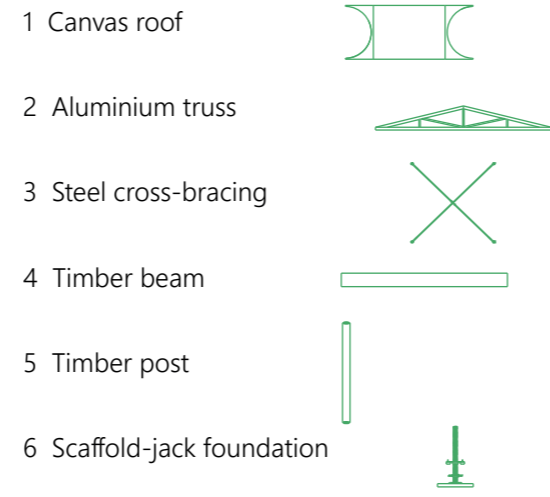
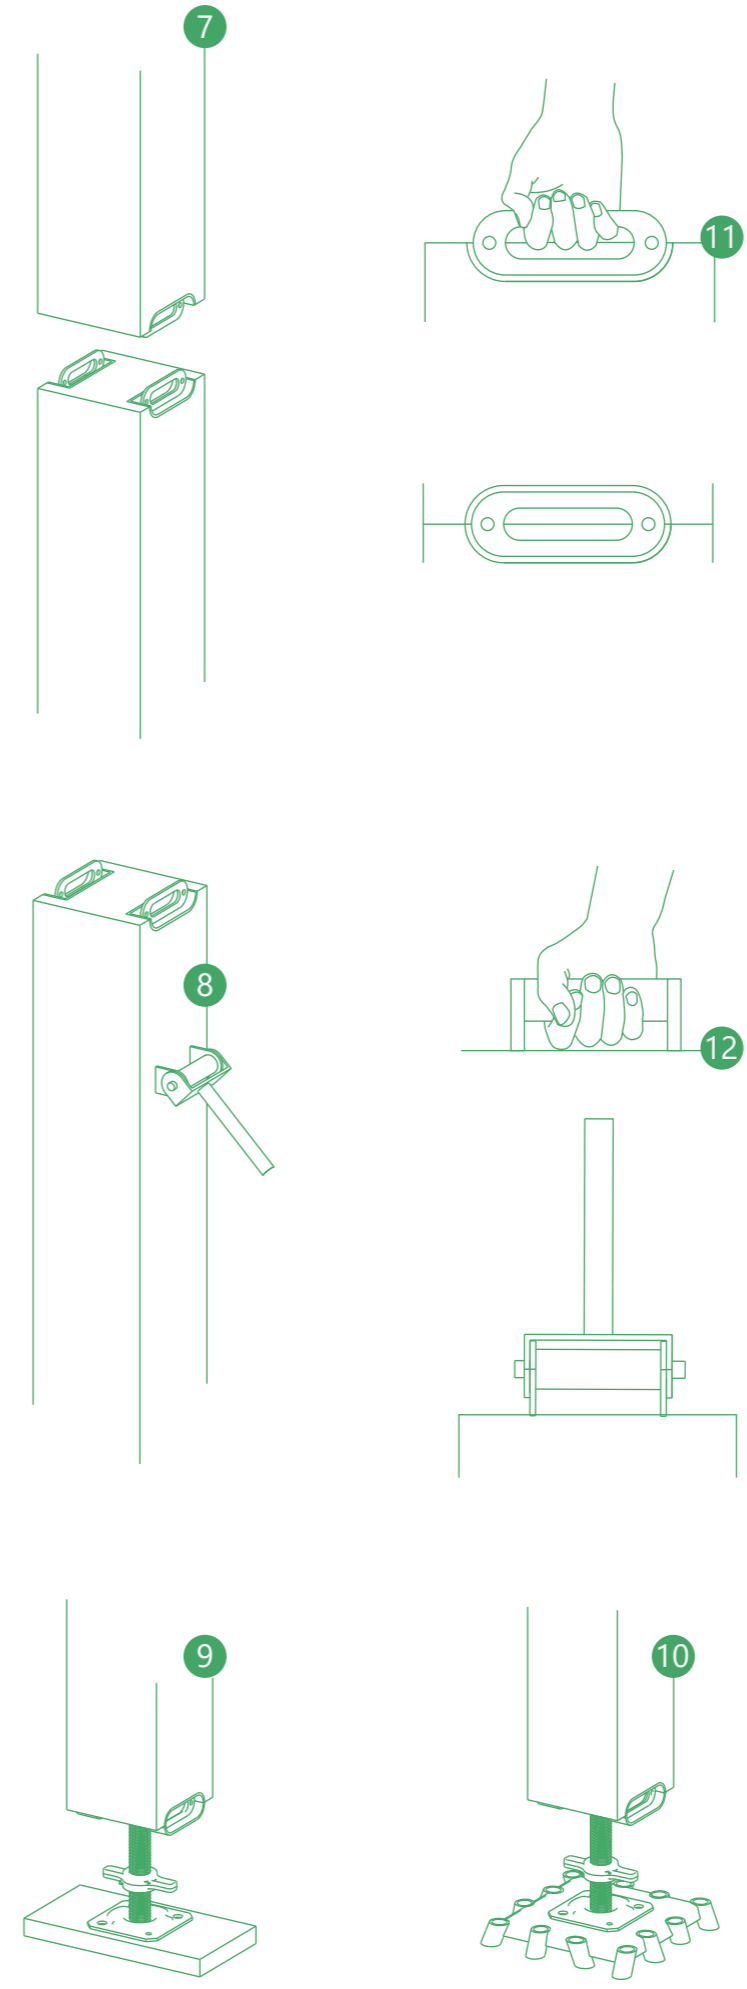
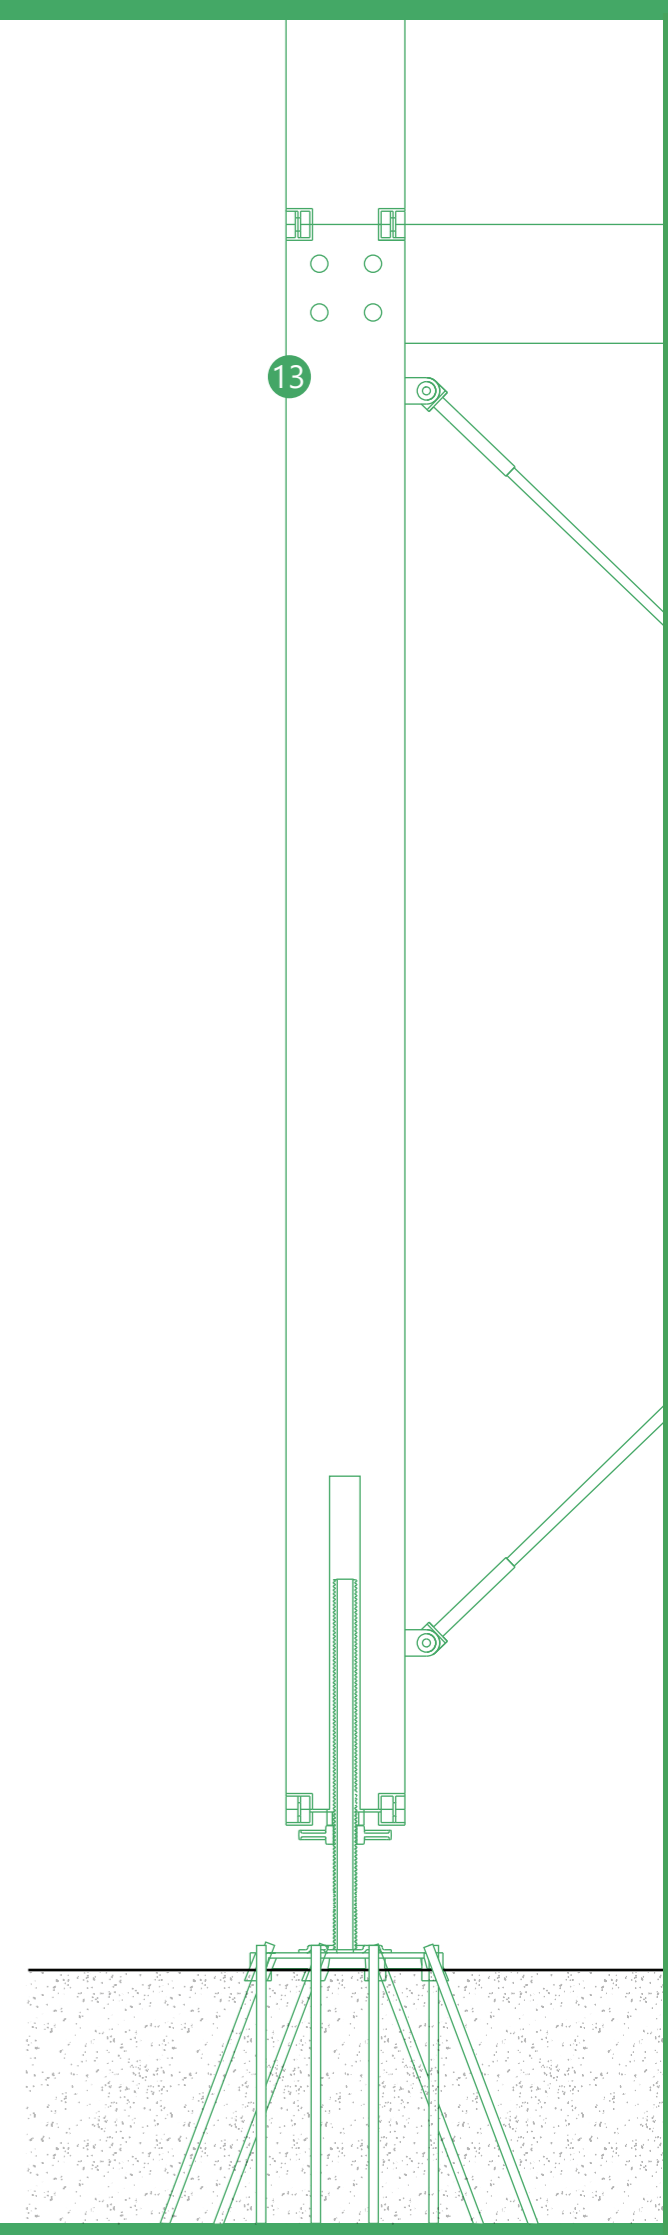
- 1 Canvas roof
- 2 Aluminium truss
- 3 Steel cross-bracing
- 4 Timber beam
- 5 Timber post
- 6 Scaffold-jack foundation
- 7 Post to post detail
- 8 Bracing detail
- 9 Scaffold jack plate foundation
- 10 Scaffold jack Eco-Pile foundation
- 11 Handle shaped post to post brackets
- 12 Handle shaped cross bracing brackets
- 13 Structure section

Figure 88. Tectonic diagrams and details, by Author.

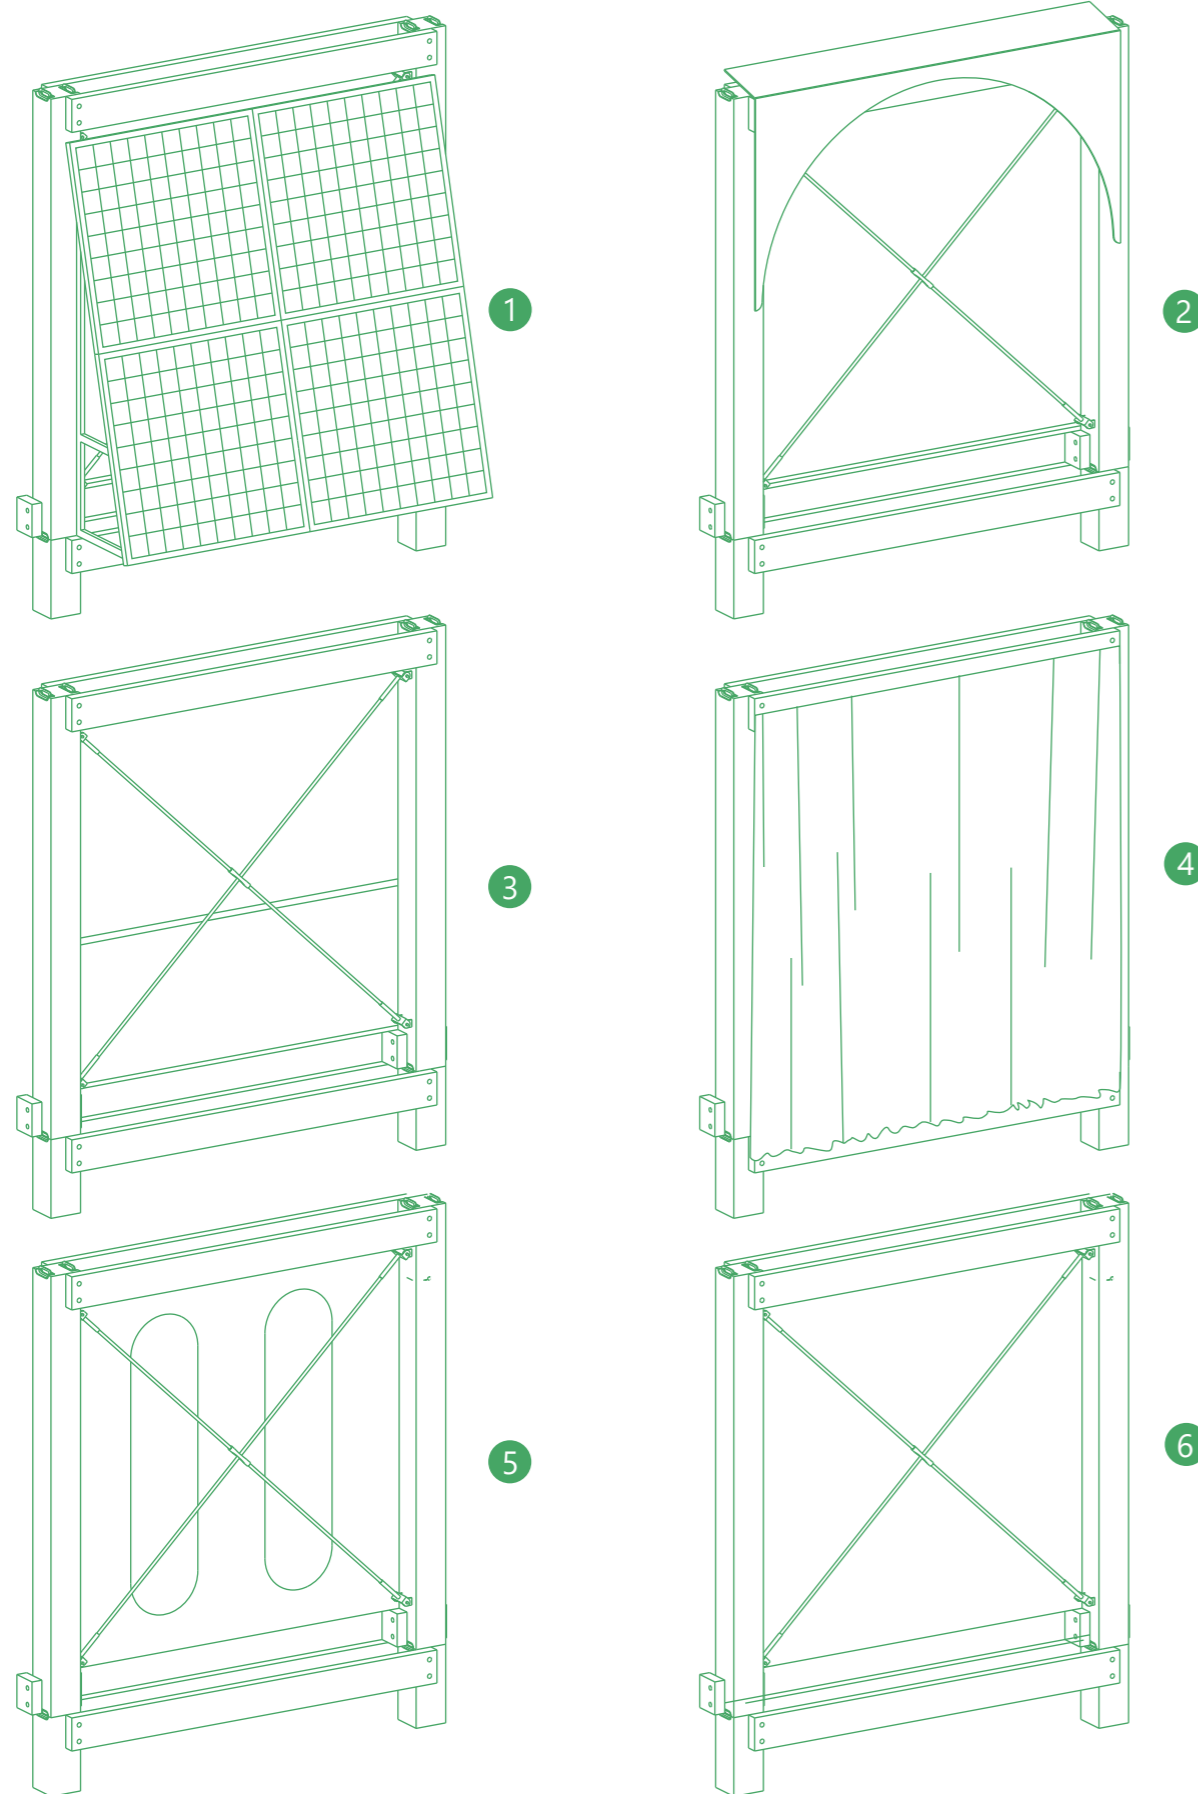
- 1 Solar panel attachment
- 2 Canvas roof
- 3 Aluminium railing with polycarbonate lower
- 4 Curtain
- 5 Mixed polycarbonate wall & Window
- 6 Single polycarbonate wall

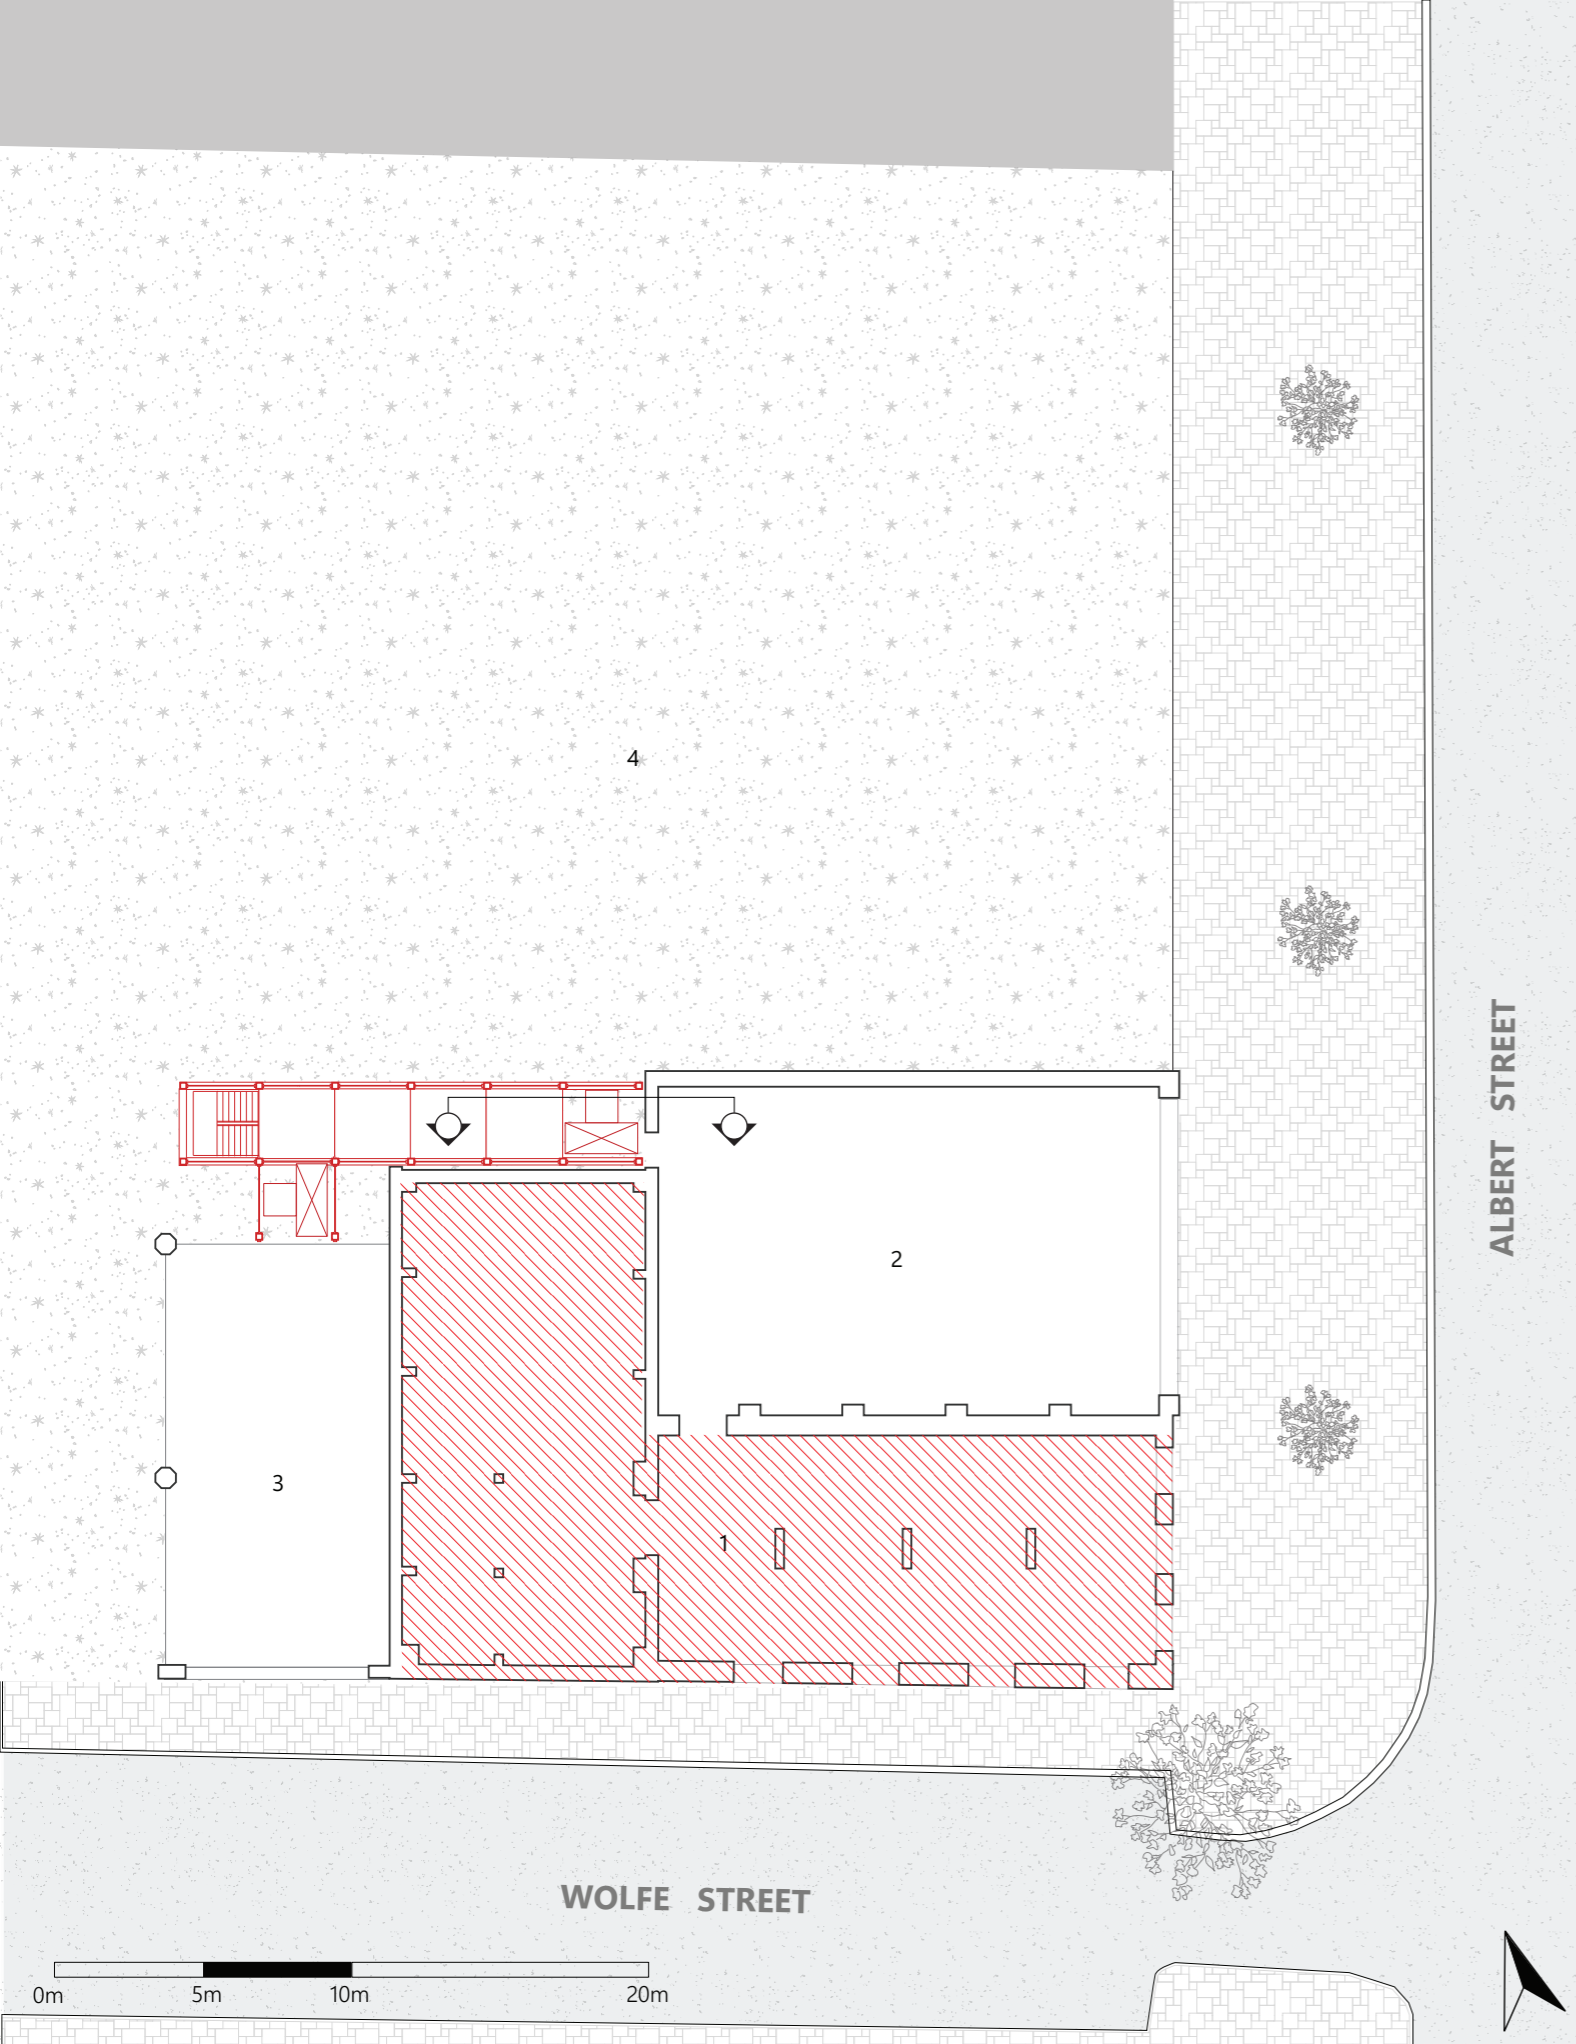
- 1 Link House (Uninhabitable)
- 2 Former Yates Retail & Office Building
- 3 Former Yates Warehouse (Partially Demolished)

Figure 90. Yates site plan, by Author

The intervention itself is arranged to avoid the inherently repetitive nature of modularity by breaking up the spaces with alternative accessways. This is done to encourage exploration within the space and experience the building that it sits alongside.

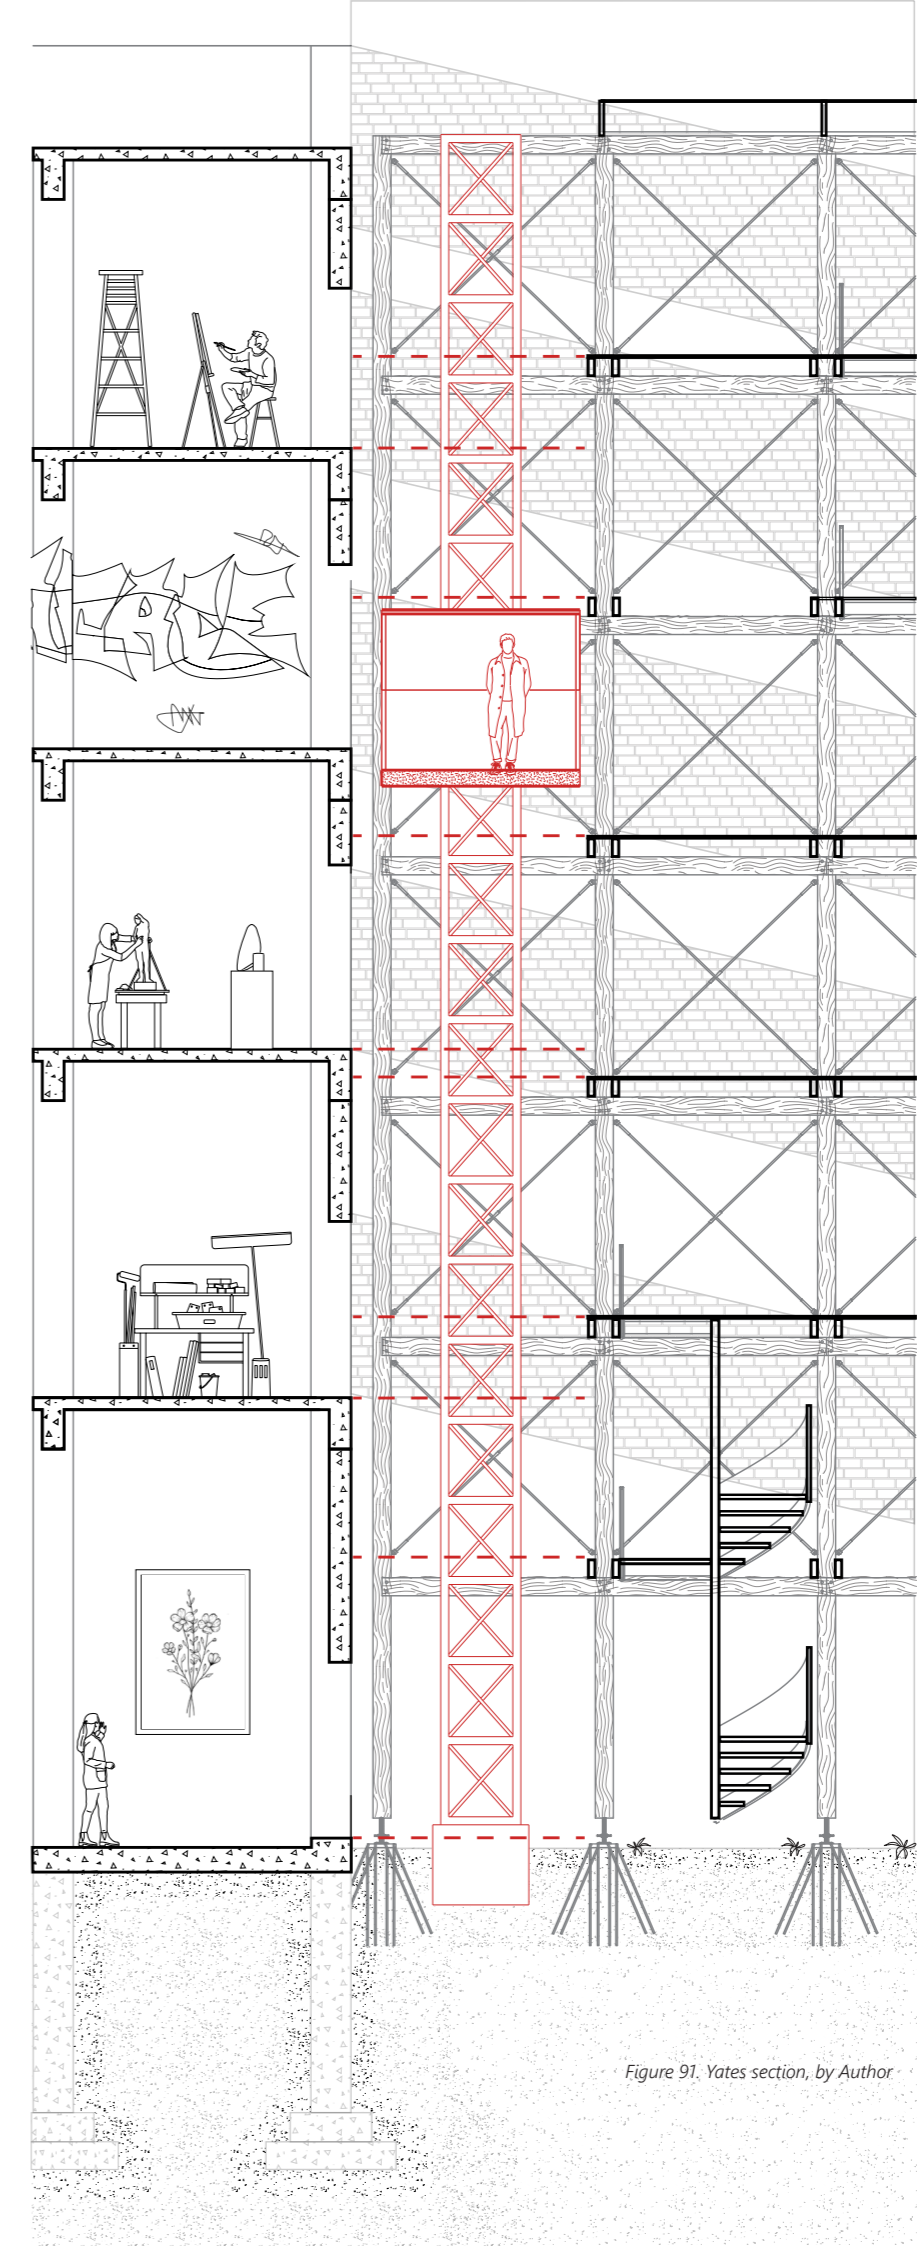
Figure 91. Yates section, by Author

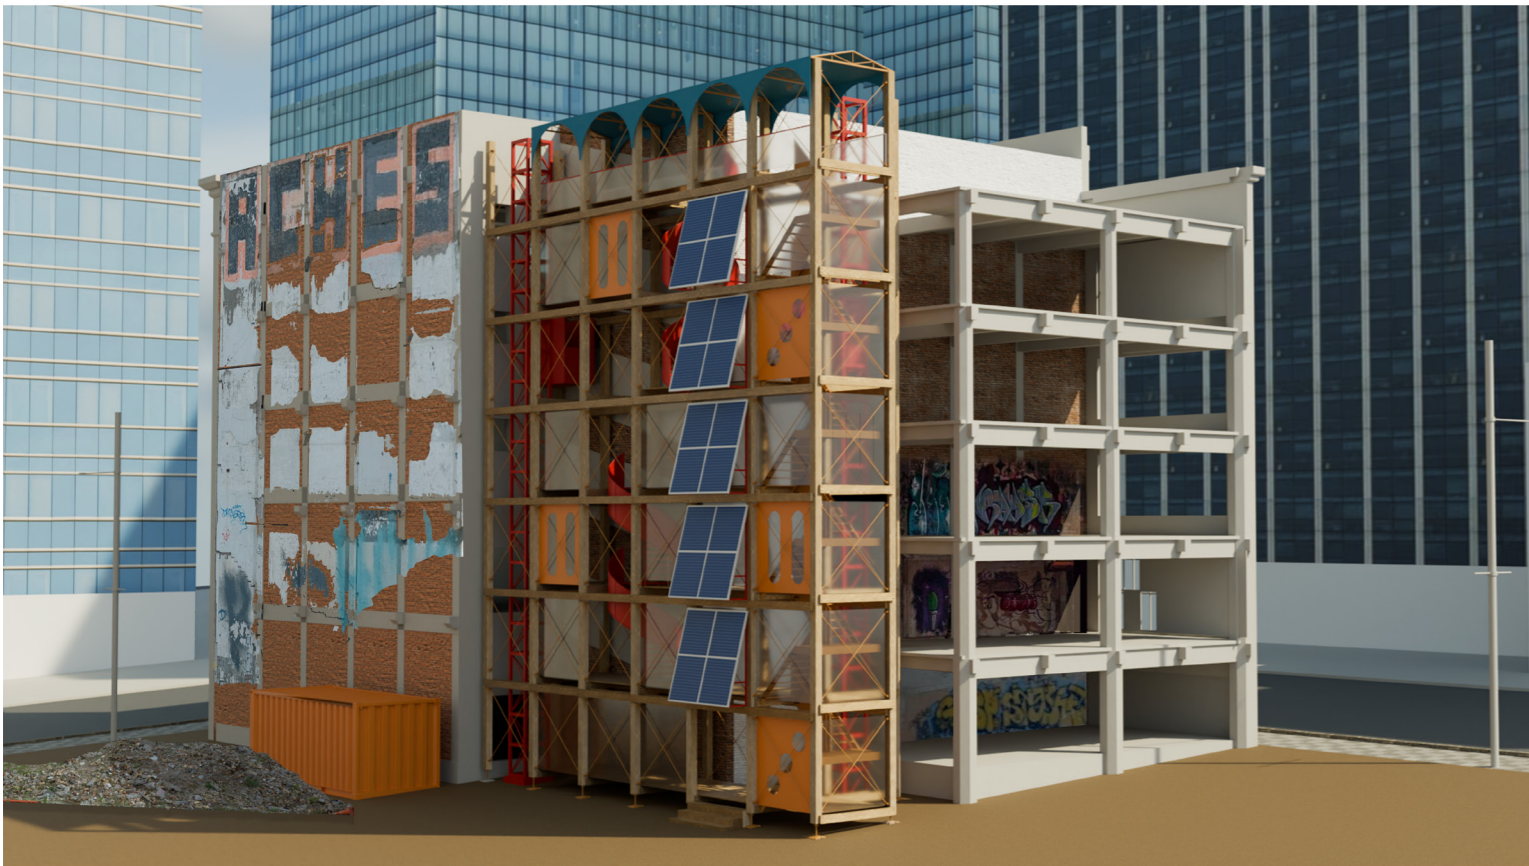
Figure 92. Yates Intervention render from Federal Street, by Author

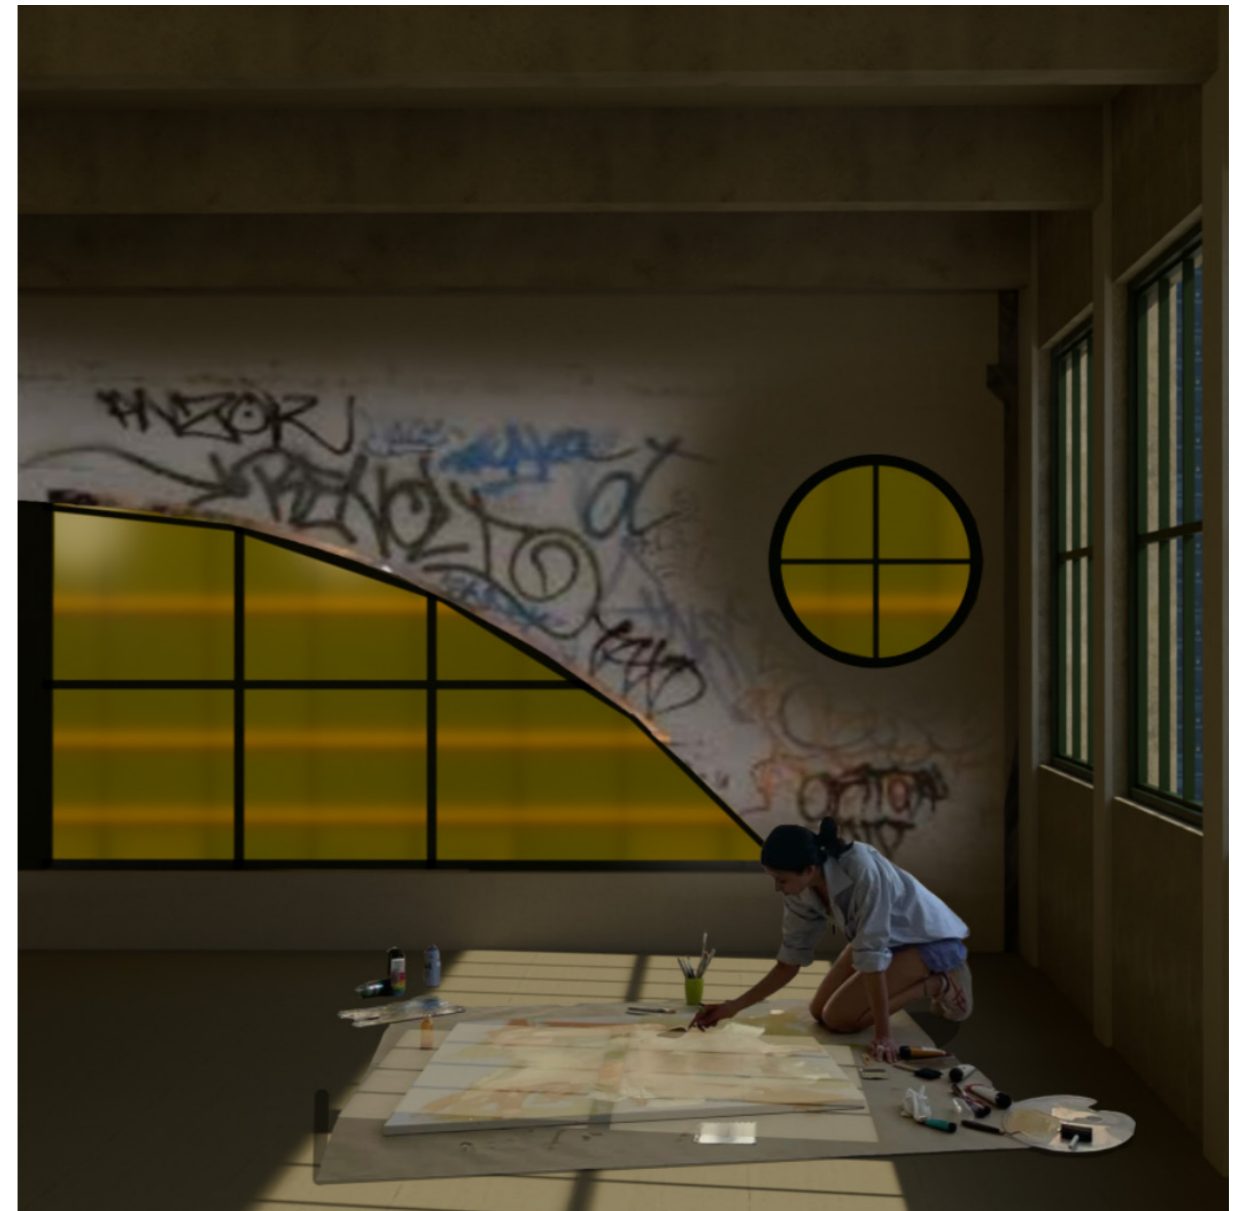
Figure 93. Yates interior render, by Author
