(Re) Inhabitation

Pursuing the Continued Use of Auckland CBD's Disused Heritage
Through an Approach of Minimum Intervention

A thesis submitted to Auckland University of Technology in partial fulfilment of the requirements
for the degree of Master of Architecture (Professional)

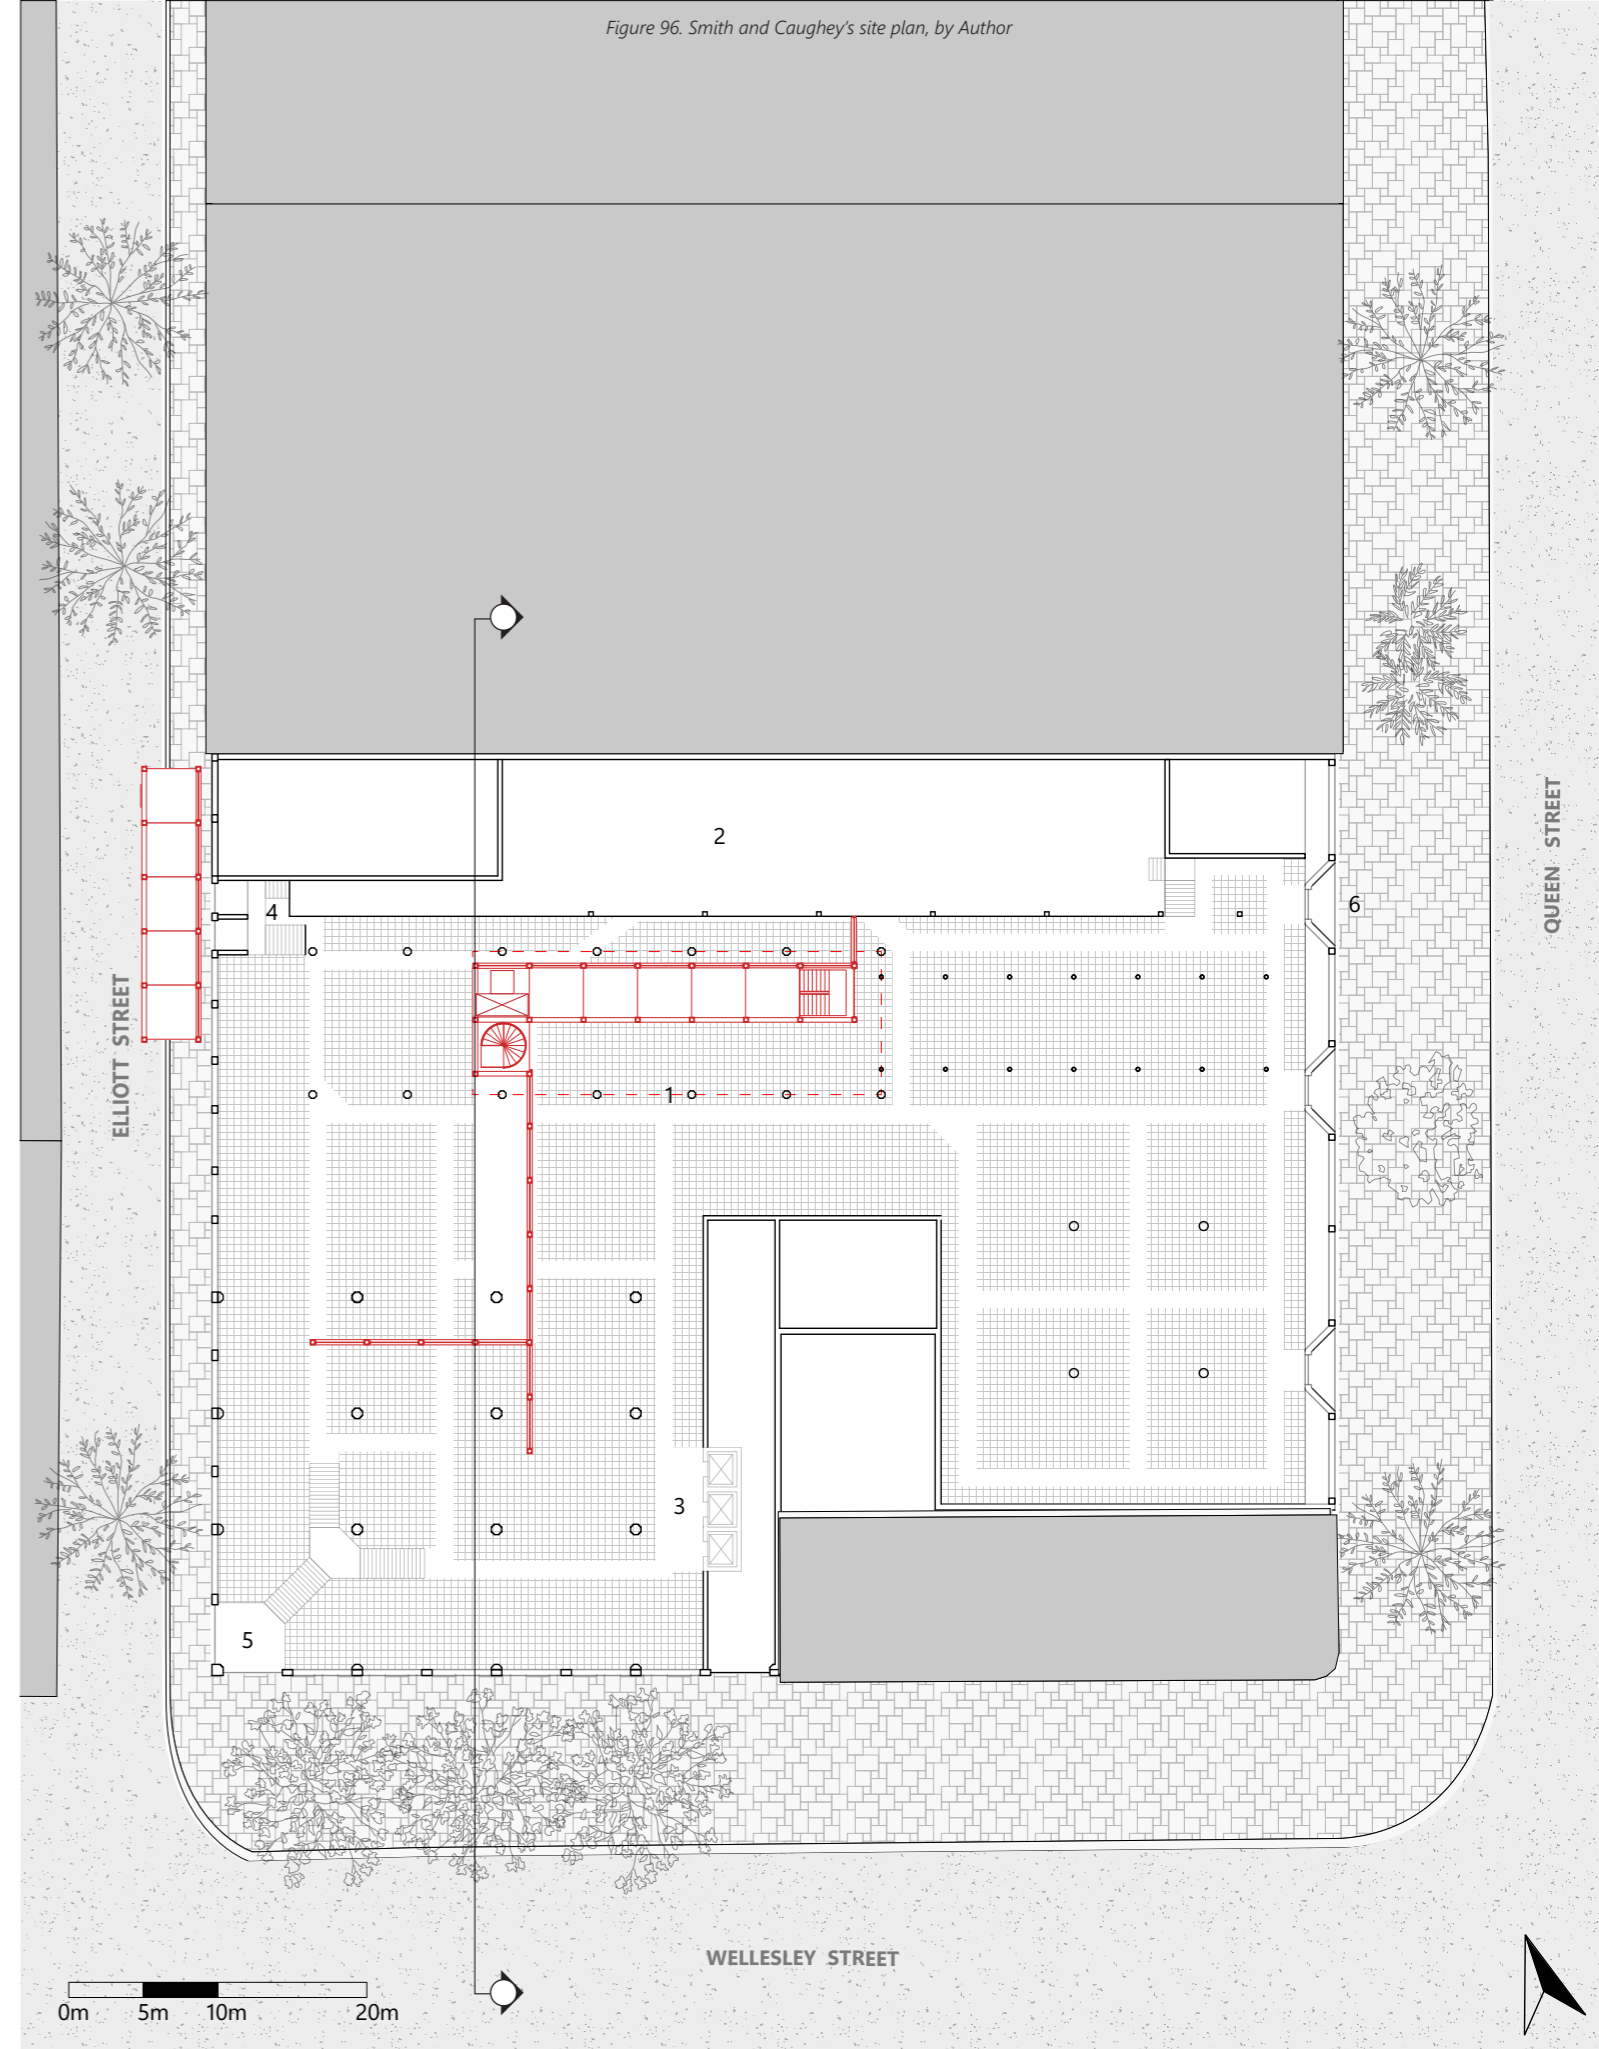
Figure 96. Smith and Caughey's site plan, by Author

- 1 Escalator Void - - - - -
- 2 Mezzanine
- 3 Existing Elevators
- 4 Elliot Street Entrance
- 5 Wellesley Street Entrance
- 6 Queen Street Entrance

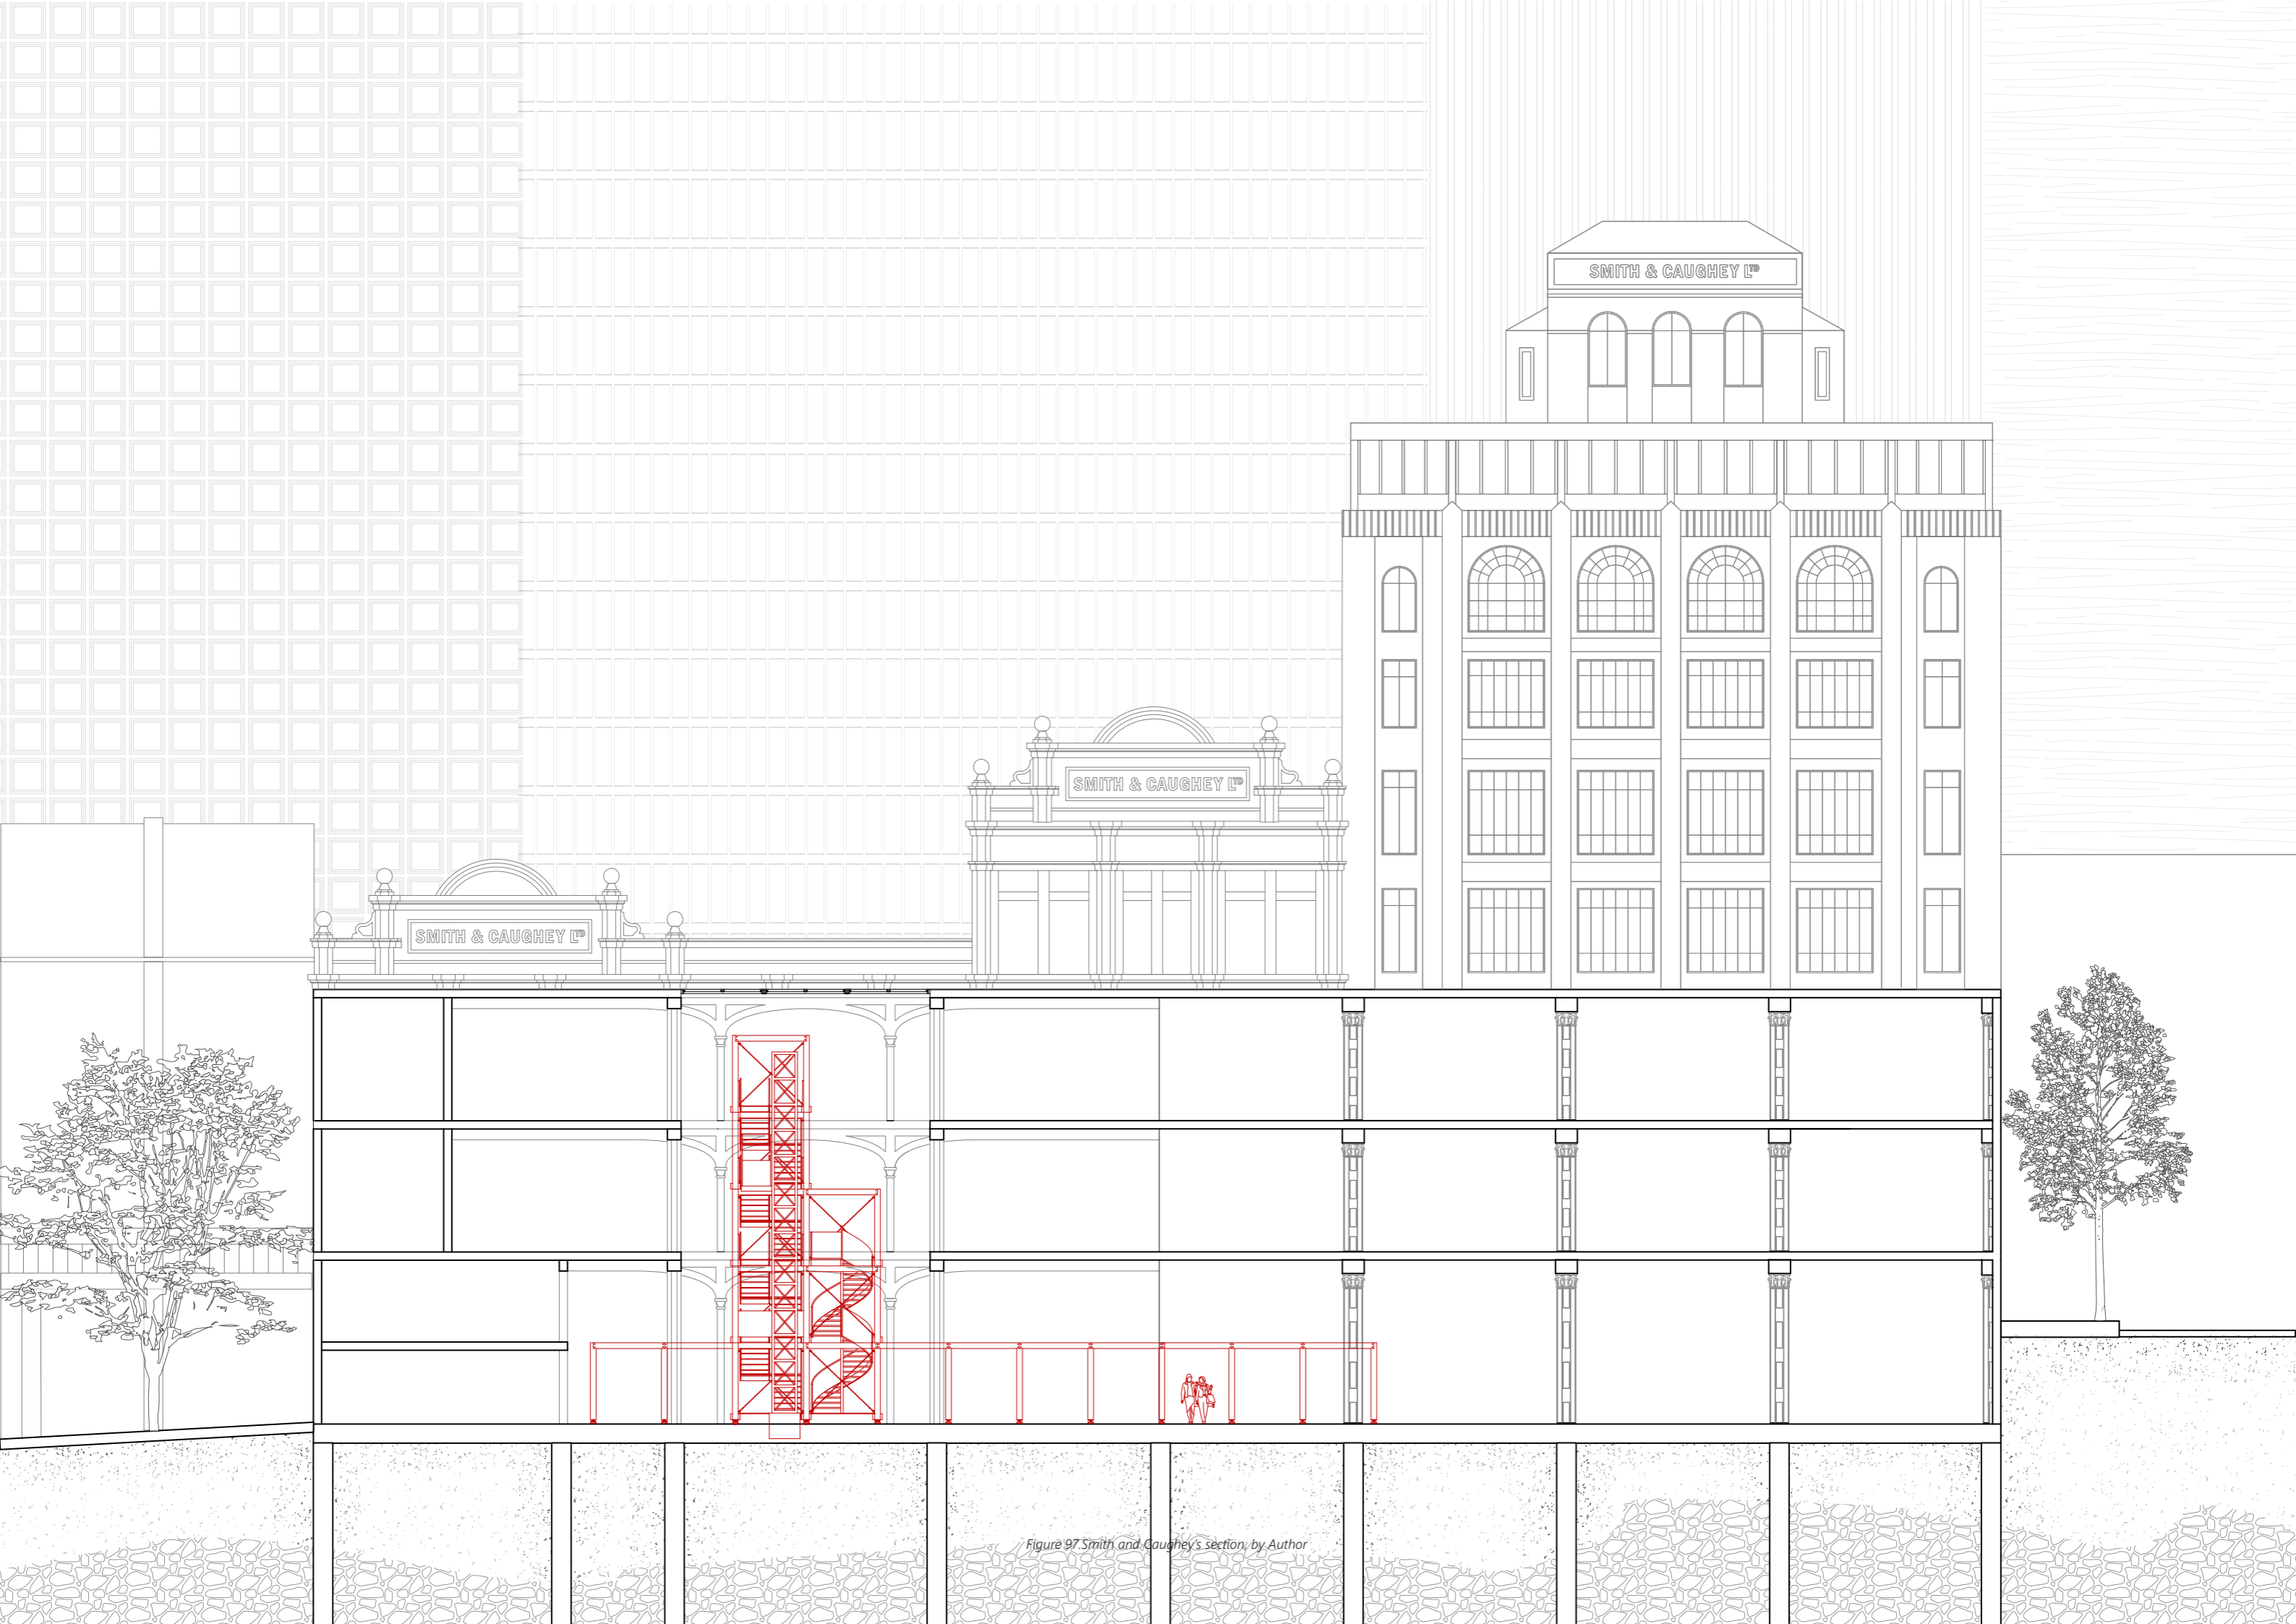
Figure 97. Smith and Caughey's section, by Author
