# Full-Scale Simulated Seismic Field-Testing of a Post-Tensioned Glue Laminated Timber Portal Frame Structure Deploying Traditional Māori Construction Techniques

Sonny Vercoe, Anthony Hōete, Jason Ingham & Sherif Beskhyroun

Testing was undertaken to investigate the viability of a traditional Māori post-tensioned construction technique that incorporated modern glue-lamination manufacturing to withstand seismic loadings. A feature of the form-fit connections was that the timber members were seated into pockets. A companion numerical model was developed to confirm aspects not readily measured in the field. Vertical loading was applied at the apex via water-filled containers. Seismic loading was simulated by applying a horizontal loading system at the apex via a winch and quick-release system, involving seven pseudo-static semi-cyclic tests followed by three snap-back tests. It was established that member demands remained within capacity, that apex vertical and horizontal displacements remained within code-defined deflection limits, and that the measured damping was 7.3%. Findings are also reported for mode shapes and joint rotational stiffness. Novel aspects of the reported research

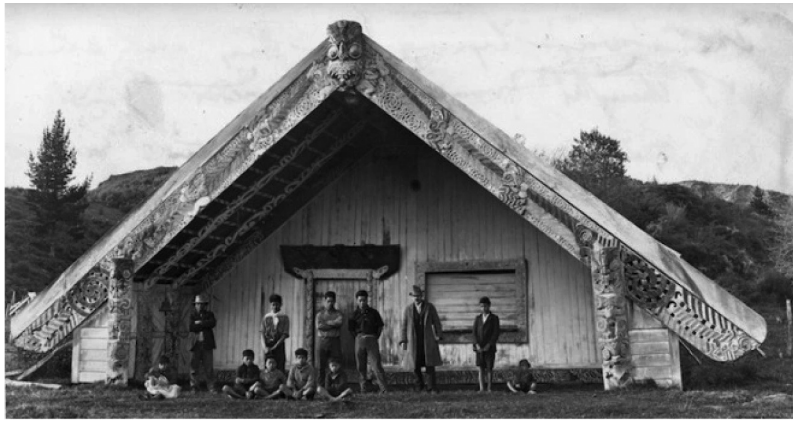
**Figure 1.** Tāne Whirinaki in 1920s. Photograph taken by Charles Troughton Clark circa 1913. Reproduced with permission of the National Library of New Zealand. Reference: PAColl-0477-01.

In 1874, this technique was deployed by Ngāti Ira for their own ancestral house, Tānewhirinaki (Figure 1). Located in the Waioweka, in the eastern Bay of Plenty region of New Zealand (Figure 2(b)), this is an area prone to a range of natural hazards. Following a series of reconstruction failures in its earlier years, coupled with the 1886 Mt Tarawera eruption (Ngāti Ira 2022; Wikipedia 2024a) and 1931 Hawkes Bay earthquake (Ngāti Ira 2022; Wikipedia 2024b), the structural

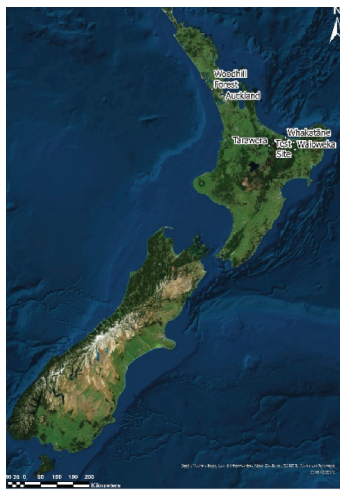
(a) Map of New Zealand showing locations of interest on the North Island

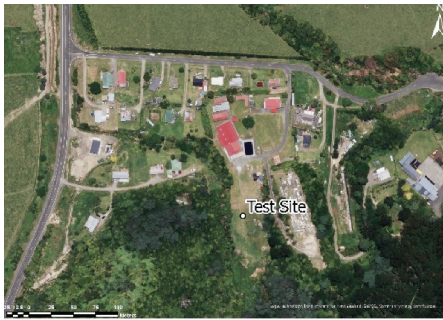
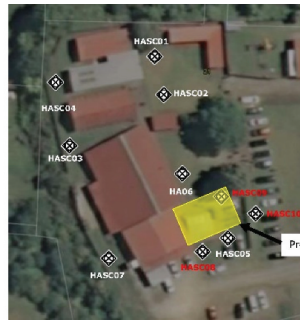
Figure 2. Site location and geotechnical investigation plan.

The testing was undertaken on a 2,700 m<sup>2</sup> land section near Ōpōtiki in the eastern Bay of Plenty region of New Zealand, as shown in Figure 2(c). It was positioned adjacent to Ōpeke marae (complex of Māori buildings), Waioweka Primary School (Te Kura o Waioweka, kura → school) and the surrounding village (papakāinga). A marae is a complex of Māori buildings that serves as a place of belonging (tūrangawaewae) for its tribe and that primarily include the meeting house (wharenui), dining hall (wharekai), and ablution blocks (wharepaku) among other buildings. Occupying approximately 1,400m<sup>2</sup>

Ground conditions were determined via a desktop investigation, hand shear vane testing, and results from existing geotechnical investigations. The desktop investigation involved assessing the interactive geological map of New Zealand (GNS Science 2024), which showed the surface distribution of geological units at scales of 1:250K and 1:1 M, indicating that the test site was likely comprised of gravel, sand, silt, mud, and clay, with local occurrences of peat. Hand shear vane testing was undertaken within the test operations area to determine the peak undrained shear strengths ( $s_u$ ). The ultimate bearing capacity ( $q_u$ ) was determined using the Verification Method B1/VM4 Foundations (Ministry of Business, Innovation & Employment 2023), which confirmed that the test site ground conditions complied with the NZS 3604 definition for good ground (Standards New Zealand 2011). An earlier geotechnical investigation by Engineering Design Consultants Limited (2023) had also been undertaken at the neighbouring complex of Māori buildings (marae) located within 100 m of the test site. As shown in Figure 2(d), this investigation included shallow intrusive hand augering at nine exploratory locations with the associated scalar penetrometer and shear vane testing undertaken up to a depth of 3.1 m. Similar to the result of hand shear vane testing, the findings from this earlier geotechnical investigation confirmed that the neighbouring complex of Māori buildings (marae) was also founded on good ground.

(c) Map of test site

(d) Locations of hand auger holes (Engineering Design Consultants Limited, 2023)

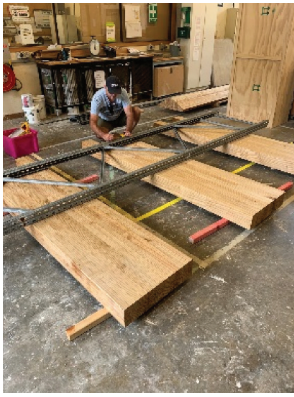
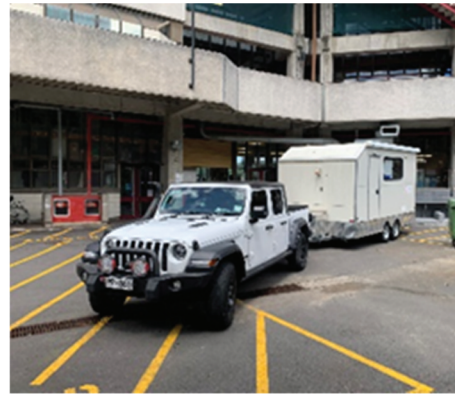
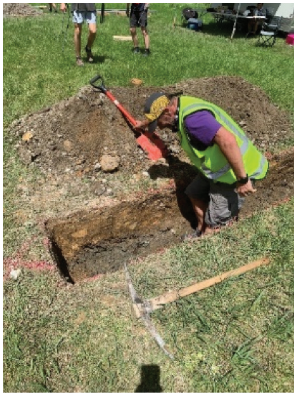
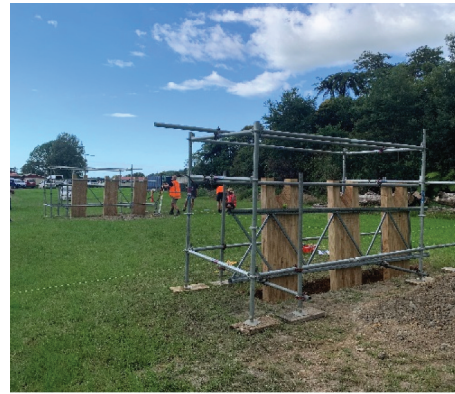
**Figure 4.** Preparation and positioning of columns (poupou) and foundations.

(a) Mounting columns (poupou) onto backing frames in UoA architectural laboratory

(b) Field-testing trailer used to transport columns (poupou) to test site

(c) Footings dug by hand

(d) Positioning of columns (poupou) prior to concrete placement

While positioned at their intended spacing, the columns (poupou) were fitted with a backing frame so that it could be readily reapplied at the test site (see Figure 6 (a)). All members were then disassembled and transported to the test site using the dedicated field-testing trailer (see Figure 6(b)).

intentionally using manual labour, installing the columns (poupou), and positioning the foundation reinforcement ready for concrete placement. A topographical site survey was undertaken to ensure the precise demarcation of the foundation boundary and accurate placement of the columns (poupou). After the footings were excavated by hand as shown in Figure 4(c), the columns (poupou) were remounted on the backing frames to ensure uniform spacing and were fixed to the scaffold support structure to ensure correct alignment and orientation (see Figure 4(d)). Once the columns (poupou) were positioned correctly the foundation reinforcement was placed, with the longitudinal reinforcement being held in position by temporary bars driven into the walls of the excavated footings that also

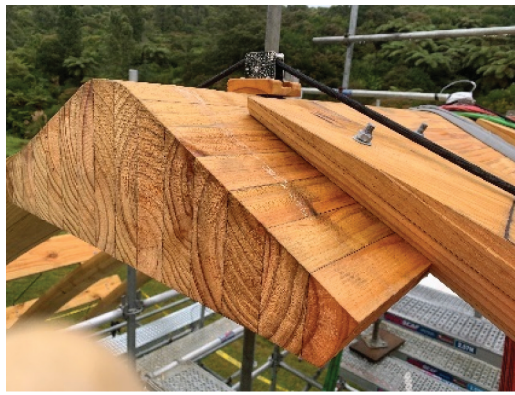
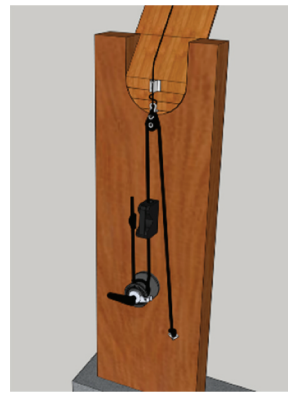
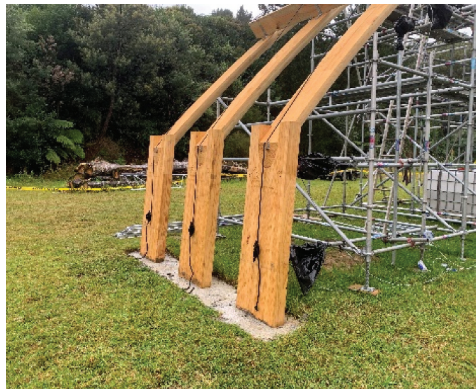
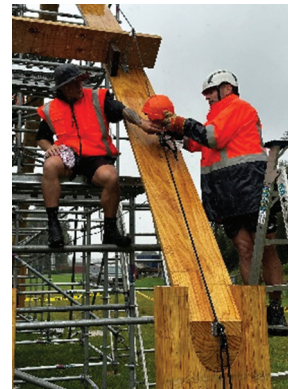
**Figure 5.** Post-tensioning (mimiro) system.

After all test unit members were assembled the components of the post-tensioning system were installed as shown in Figure 5. Mīmiro's seafaring origin was recognised by intentionally sourcing all-post-tensioning hardware from the maritime sailing industry;  $\varnothing 10$  mm double

braid rope (Fosters Chandlery 2024a) as the post-tensioning cable, high-load exit boxes (Ronstan International Pty Ltd 2024) for rope redirection, a swivel block (Harken New Zealand, Limited 2024b) to connect the dead end anchorage and live end and a rope clutch (Spinlock Limited 2024) to secure the post-tensioned cable. In addition, a single-speed winch (Harken New Zealand, Limited 2024a) and lock-in handle (Harken New Zealand, Limited 2024d) combined with pad eyes (Harken New Zealand, Limited 2024c) and horn cleats (Fosters Chandlery 2024b) were used for tension adjustment. The post-tensioning system was also equipped with load cells (VPG Force Sensors 2024) for data acquisition. The post-tensioning force of 2 kN was established after manually operating the winch with the maximum effort achievable by a member of the research team.

(a) High-load exit box mounted on ridge beam (tāhuhu)

(b) Rendered view of live end and clutch

(c) Dead end anchorage

(d) Waterproofing of compromised load cell

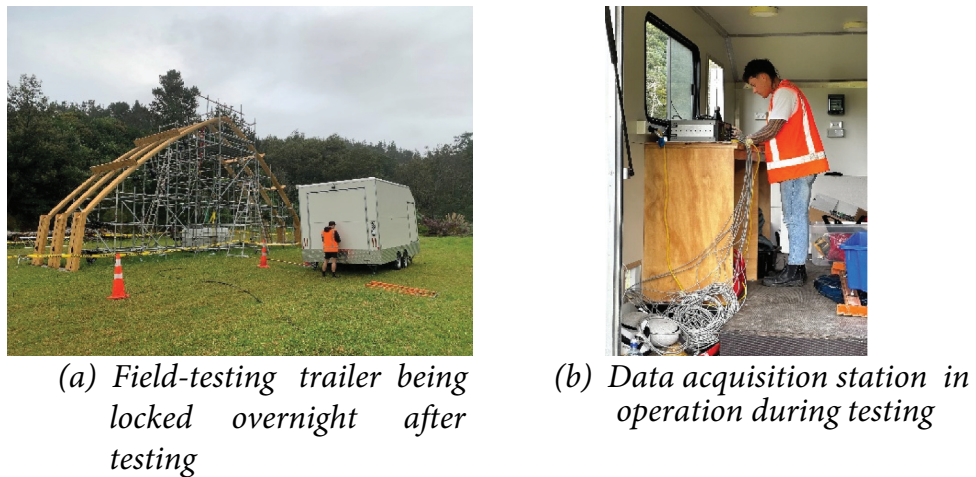
The field-testing trailer that was initially used to transport the columns (poupou) and backing frames during test unit assembly (see Figure 4(b)) acted as a mobile office during testing and was a safe lockable overnight storage facility for the data acquisition and test site equipment as shown in Figure 9(b). The field-testing trailer was generator-powered, had mobile Wi-Fi functionality and was equipped with sliding glass windows to allow visual monitoring as testing progressed. The field-testing trailer also featured a pass-through wall port that was used to run cables from the displacement sensors to the data acquisition station as shown in Figure 9(b).

**Figure 9.** Field-testing trailer used during testing.

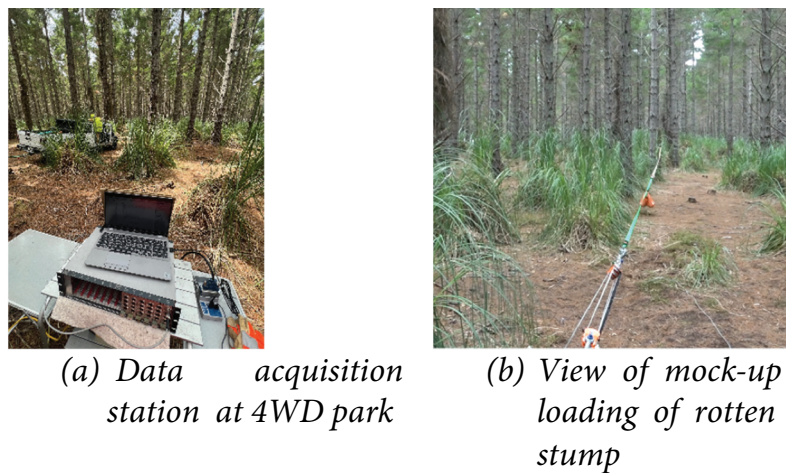
**Figure 11.** Verification testing at 4WD park.

A decision was also made to trial the installation procedure for the simulated seismic loading at the regional four-wheel drive (4WD) park in Woodhill Forest (Auckland Off Road Adventure 2024) on 4 February 2023. One reason for the trial was to check that all necessary equipment was considered and accounted for. Furthermore, some members of the

research team had limited experience with data acquisition and hence the trial allowed members of the research team to practise data capture with the data logger in the field as shown in [Figure 11\(a\)](#). Risk assessment and field activity plans were completed, and the park administrators were informed and approved the planned activity. Because it was unlawful to damage a living tree, a rotten stump located well away from other park users was selected as a suitable practice test unit as shown in

Figure 11(b). All equipment was carefully laid out, including safety signage on the approaches to the test site. The trial was successful, with no problems encountered.

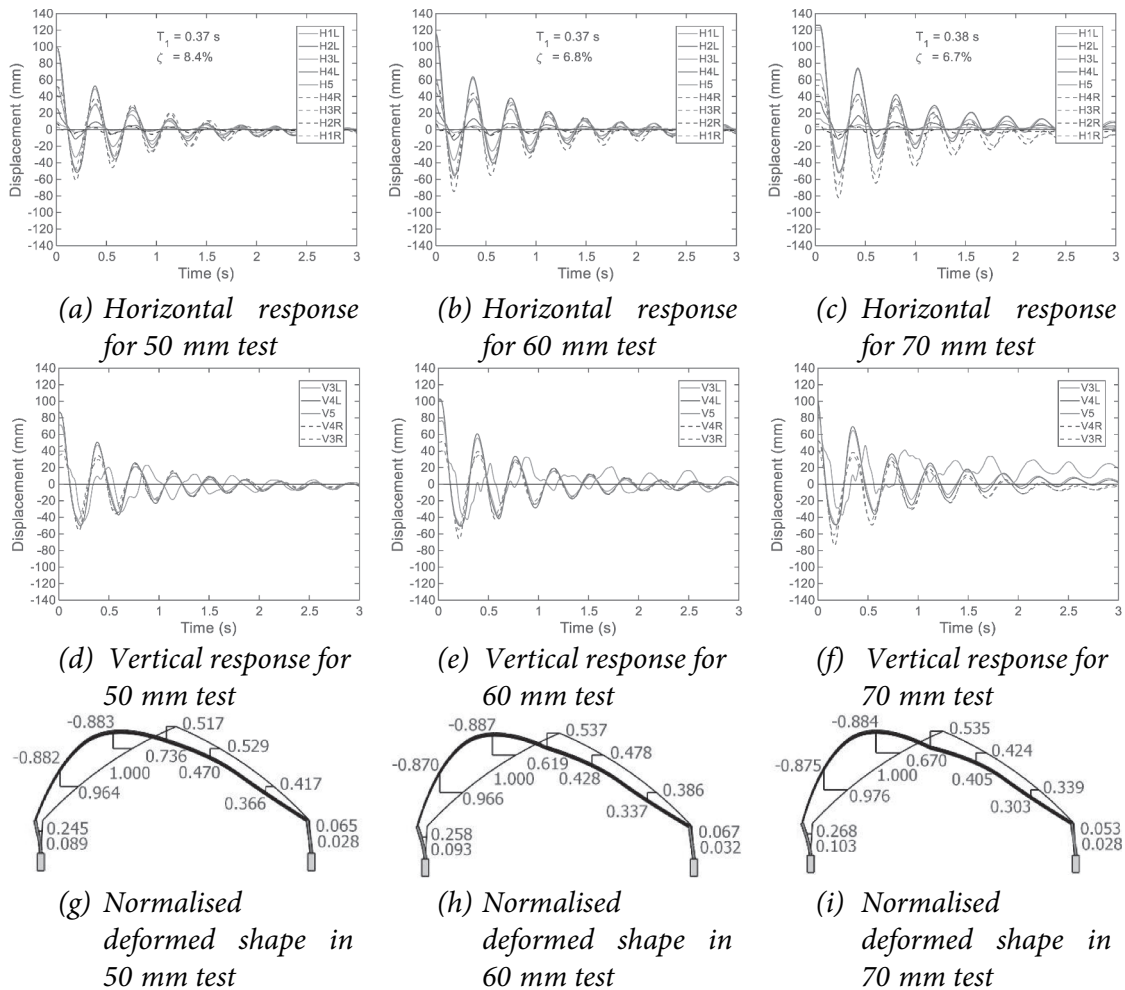
The snap-back simulated seismic response was consistent across all tests and all horizontal displacement gauges, as shown in Figure 14(a-c), confirming the high fidelity of the recorded horizontal data. The snap back vertical response was also consistent except for sensor V5 (located at the ridge beam (tāhuhu), see Figure 8(e)) as shown in Figure 14(d-f). It was suspected that because the IBCs were suspended from the ridge beam (tāhuhu), and because the simulated seismic loading system was fixed to the ridge beam (tāhuhu) and applied a minor vertical component of load ( $\tan(16.5^\circ) = 0.30F$ ) due to the non-horizontal orientation of the simulated seismic loading system, sensor V5 was likely disrupted by the vertical bouncing motion of the IBCs following the snap back quick release.

Figure 14. Snap back response (see Figure 8(e) for sensor locations; deformed shapes normalised with respect to sensor H4L).

The natural period  $T_1$  of each snap back test was evaluated as the average increment between the consecutive positive peaks beginning at the second peak  $Y_2$  and ending at the fifth peak  $Y_5$ , which resulted in measured first mode periods of  $T_1 = 0.37$  s in the 50 mm and 60 mm tests and  $T_1 = 0.38$  s in the 70 mm test. The increase in  $T_1 = 0.38$  s in the 70 mm test was likely due to the test structure softening from repeated testing. Damping was evaluated via the logarithmic decrement method (Miroslav et al. 2014) also using  $Y_2$  and  $Y_5$ , resulting in the logarithmic decrements  $\delta_{50} = 1/3 \times \ln(29.8/6.0) = 0.53$ ,  $\delta_{60} = 1/3 \times \ln(37.5/10.4) = 0.43$  and  $\delta_{70} = 1/3 \times \ln(42.8/12.1) = 0.42$  and corresponding damping ratios  $\zeta_{50} = 0.53 / \sqrt{(4\pi^2 + 0.53^2)} \times 100 = 8.4\%$ ,  $\zeta_{60} = 0.43 / \sqrt{(4\pi^2 + 0.43^2)} \times 100 = 6.8\%$  and  $\zeta_{70} = 0.42 / \sqrt{(4\pi^2 + 0.42^2)} \times 100 = 6.7\%$ . The damping of the test unit was averaged across the tests and therefore the adopted damping was  $\zeta = (8.4 + 6.8 + 6.7)/3 = 7.3\%$ . It is noteworthy that damping would be further increased as claddings were added (Devin and Fanning 2019; Ellis and Bougard 2001). Normalised deformed shapes for the first peak  $Y_1$  (corresponding to  $T = 0$  s in Figure 14) were established with respect to the largest measured displacement (recorded by sensor H4L) as shown in Figure 14(g-i) and it is evident that the shapes are consistent across all tests.

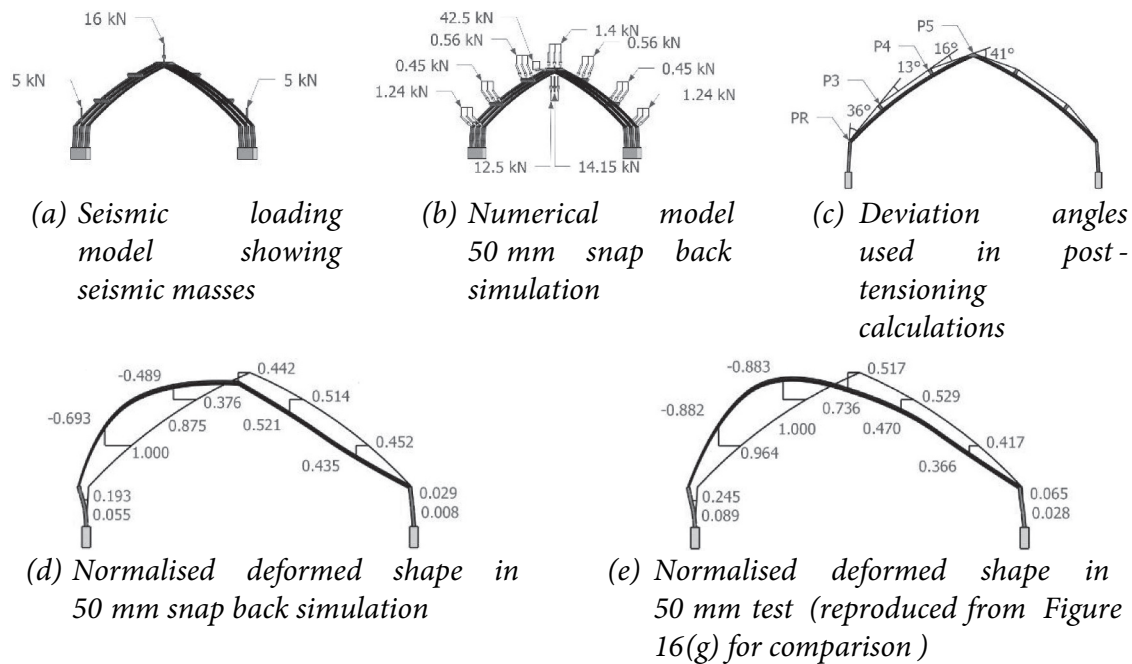
The model used to establish design seismic loading demands incorporated the seismic mass of the absent roof and carvings as shown in Figure 15(a). The proportion of dead and live load concentrated at the ridge beam (tāhuhu) was previously estimated to be  $G = 14.15$  kN and  $Q = 6.24$  kN and therefore the seismic mass applied at the tāhuhu was  $G + 0.3Q = 14.15 + 0.3 \times 6.24 = 16$  kN. Similarly, the proportion of dead and live load concentrated at the two semicircular knee joints (ruawhetū) were the loads acting over the remainder of the roof and were previously estimated to be 8.96 kN and 3.96 kN, respectively. The load was shared between the two semicircular knee joints (ruawhetū) and hence the seismic mass applied at each semicircular knee joints (ruawhetū) was  $(G + 0.3Q)/2 = (8.96 + 0.3 \times 3.96)/2 = 5$  kN. A modal analysis was undertaken and a fundamental period of  $T_1 = 0.37$  s was determined, closely matching the dynamic response measured during in-field testing as reported earlier

The 50 mm snap-back test was simulated using the companion numerical model replicating the as-tested configuration, as shown in Figure 15(b), with the 14.15 kN IBC supplementary vertical load incorporated as a point force acting beneath the centre of the ridge beam (tāhuhu). The post-tensioning was incorporated via a series of thrust forces ( $P$ ) acting at the semicircular knee joints (ruawhetū), purlins (kaho) and ridge beam (tāhuhu). These thrust forces were evaluated as force resultants using the simplified cosine rule  $p = \sqrt{(2F^2(1 - \cos\theta))}$  based on the applied post-tensioning force ( $F$ ) of 2 kN and the deviation angles ( $\theta$ ) shown in Figure 15(c). At the semicircular knee joints (ruawhetū)  $P_R = \sqrt{(2 \times 2^2 \times (1 - \cos 36^\circ))} = 1.24$  kN, at the lower purlins (kaho)  $P_3 = \sqrt{(2 \times 2^2 \times (1 - \cos 13^\circ))} = 0.45$  kN, at the upper purlins (kaho)  $P_4 = \sqrt{(2 \times 2^2 \times (1 - \cos 16^\circ))} = 0.56$  kN and at the ridge beam (tāhuhu)  $P_5 = \sqrt{(2 \times 2^2 \times (1 - \cos 41^\circ))} = 1.4$  kN. In order to generate the 50 mm release horizontal displacement, it was necessary to apply two  $16.5^\circ$  point forces at one-third and two-thirds along the ridge beam (tāhuhu). This combined force was determined to be 89 kN with the vertical and horizontal components being  $89 \times \sin 16.5^\circ/2 = 12.5$  kN and  $89 \times \cos 16.5^\circ/2 = 42.5$  kN, respectively. Consequently, the base shear force sustained by the test structure in conjunction with the 50 mm snap back test was  $42.5 \times 2 = 85.0$  kN, representing 246% of the design-level base shear force demand ( $V = 34.6$  kN). Consequently, it was concluded that the test structure had adequate strength to withstand design earthquake loading.

**Figure 15.** Fem details and response comparison of companion numerical model and test structure response.

The correlation between the simulated and the measured normalised deformed shapes (shown in Figure 15 (d,e)) was determined based on the average percentage error ( $E$ ) across all sensors, where  $E = (\Delta_s - \Delta_f)/\Delta_f$  and  $\Delta_s$  and  $\Delta_f$  are the simulated and field normalised displacements, respectively. This percentage error was evaluated to be 26% and therefore the correlation was  $100 - 26 = 74\%$ . As previously mentioned, considerable effort was made to align the field and simulated response, and while the match was not exact, the correlation was considered satisfactory to provide indicative values for the internal member actions of the test structure.

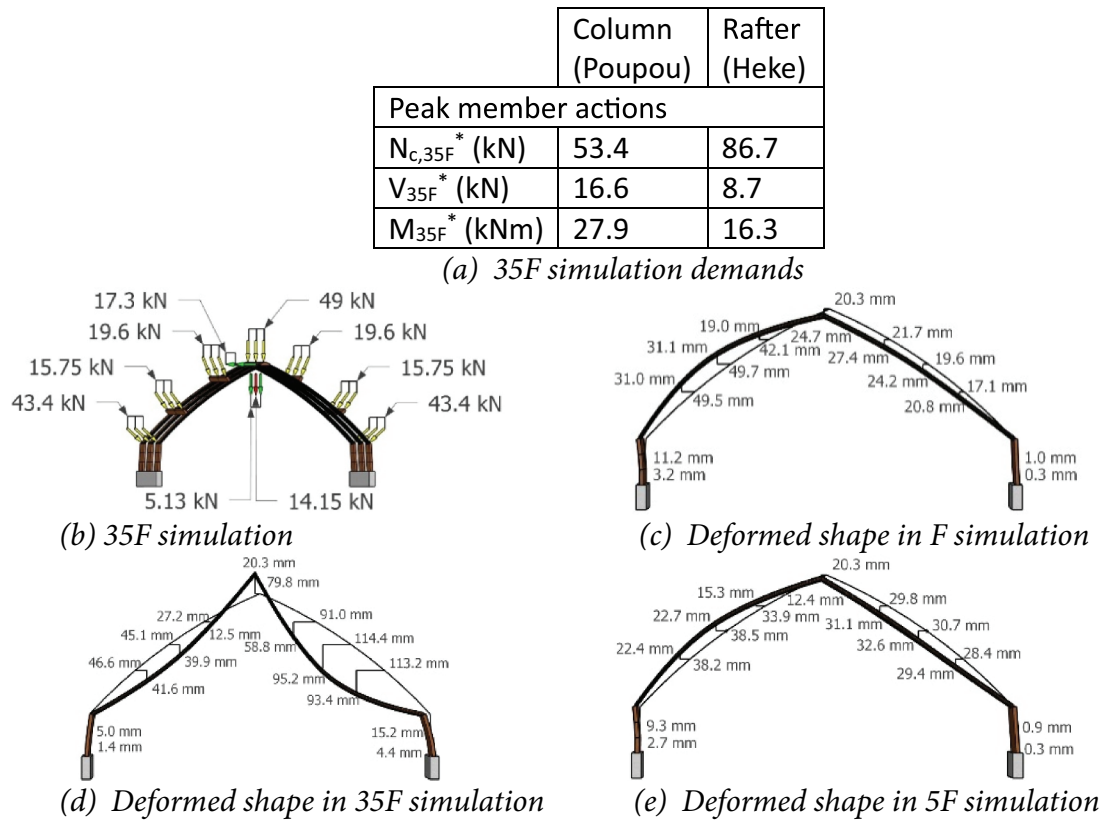
In the previously mentioned studies, the post-tensioning axial compressive stress was on average equivalent to approximately 7% of the characteristic compressive strength  $f_c$ . Based on  $f_c = 24$  MPa for GL8 as obtained from Techlam (2021) and the rafter (heke) cross-sectional area  $(\pi \times 165^2)/(2 \times 1000^2) = 0.043$  m<sup>2</sup> (dimensions shown in Figure 3(d)) the equivalent post-tensioning cable force for the test structure would be  $F = 0.07 \times 24 \times 0.043 \times 1000 = 72$  kN. Consequently, the design-level base shear demand ( $V = 34.6$  kN) was first applied to a model that incorporated a post-tensioning force of  $F = 70$  kN (referred to hereafter as the 35F simulation as shown in Figure 19(b) and the resulting member actions shown in Figure 19(a) were compared to those of the as-tested numerical model (hereafter referred to as F simulation) also previously reported in Figure 16(a). When subject to 35 F, it was concluded that the columns (poupou) demands increased by  $(N_{c,35F^*} - N_c^*)/N_c^* = (53.4 - 13.2)/13.2 = 305\%$  for axial compression,  $(V_{35F^*} - V^*)/V^* = (16.6 - 12.2)/12.2 = 37\%$  for shear and  $(M_{35F^*} - M^*)/M^* = (27.9 - 20.6)/20.6 = 36\%$  for bending. Similarly, it was concluded that the rafter (heke) demands increased by  $(N_{c,35F^*} - N_c^*)/N_c^* = (86.7 - 23.7)/23.7 = 266\%$  for axial compression,  $(V_{35F^*} - V^*)/V^* = (8.7 - 2.3)/2.3 = 279\%$  for shear and  $(M_{35F^*} - M^*)/M^* =$

$(16.3 - 4.6)/4.6 = 255\%$  for bending. Despite these elevated demands, the design member capacities of the columns (poupou) and rafters (heke) were not exceeded and hence it was concluded that the test structure had adequate strength to withstand design earthquake loading in conjunction with more conventional levels of post-tensioning. As shown in Figure 19 the apex horizontal displacement in all simulations remained 20.3 mm and therefore it was concluded that F had no significant influence on horizontal stiffness at the apex. The comparison between the F and 35 F deformed shapes shown in Figure 19(c) and (d) illustrated that increasing F caused progressive sag in the rafters (heke), occurring asymmetrically and disproportionately affecting the right rafters (heke) due to the design-level base shear force. When considering the centre of the rafters (heke) the resultant displacements in the F simulation were a  $\sqrt{(31.1^2 + 49.7^2)} = 58.6$  mm hog at the left rafters (heke) and a  $\sqrt{(24.2^2 + 19.6^2)} = 31.2$  mm sag at the right rafters (heke), corresponding to a total imbalance of  $58.6 + 31.2 = 89.8$  mm. Similarly, in the 35 F simulation, these displacements were a  $\sqrt{(39.9^2 + 45.1^2)} = 60.2$  mm sag at the left rafters (heke) and a  $\sqrt{(95.2^2 + 114.4^2)} = 148.8$  mm sag at right rafters (heke), corresponding to a total imbalance of  $148.8 - 60.2 = 88.6$  mm. The optimal post-tensioning force was determined to be the value that balanced these rafter (heke) midspan displacements. Consequently, parametric analysis was undertaken, and this value was determined to be 5 F (or alternatively 10 kN) where the resultant displacements were a  $\sqrt{(22.7^2 + 38.5^2)} = 44.7$  mm hog at the right rafters (heke) and a  $\sqrt{(32.6^2 + 30.7^2)} = 44.8$  mm sag at the right heke as shown in Figure 19(e).

Figure 19. 50 mm snap back test and 35F simulation demands and comparison of deformed shapes.
