caring for aging buildings:
a contextual study of adaptive reuse in aotearoa

A 90 point thesis submitted to Auckland University of
Technology in partial fulfilment of the requirements for
the degree of Master of Architecture (Professional), 2023

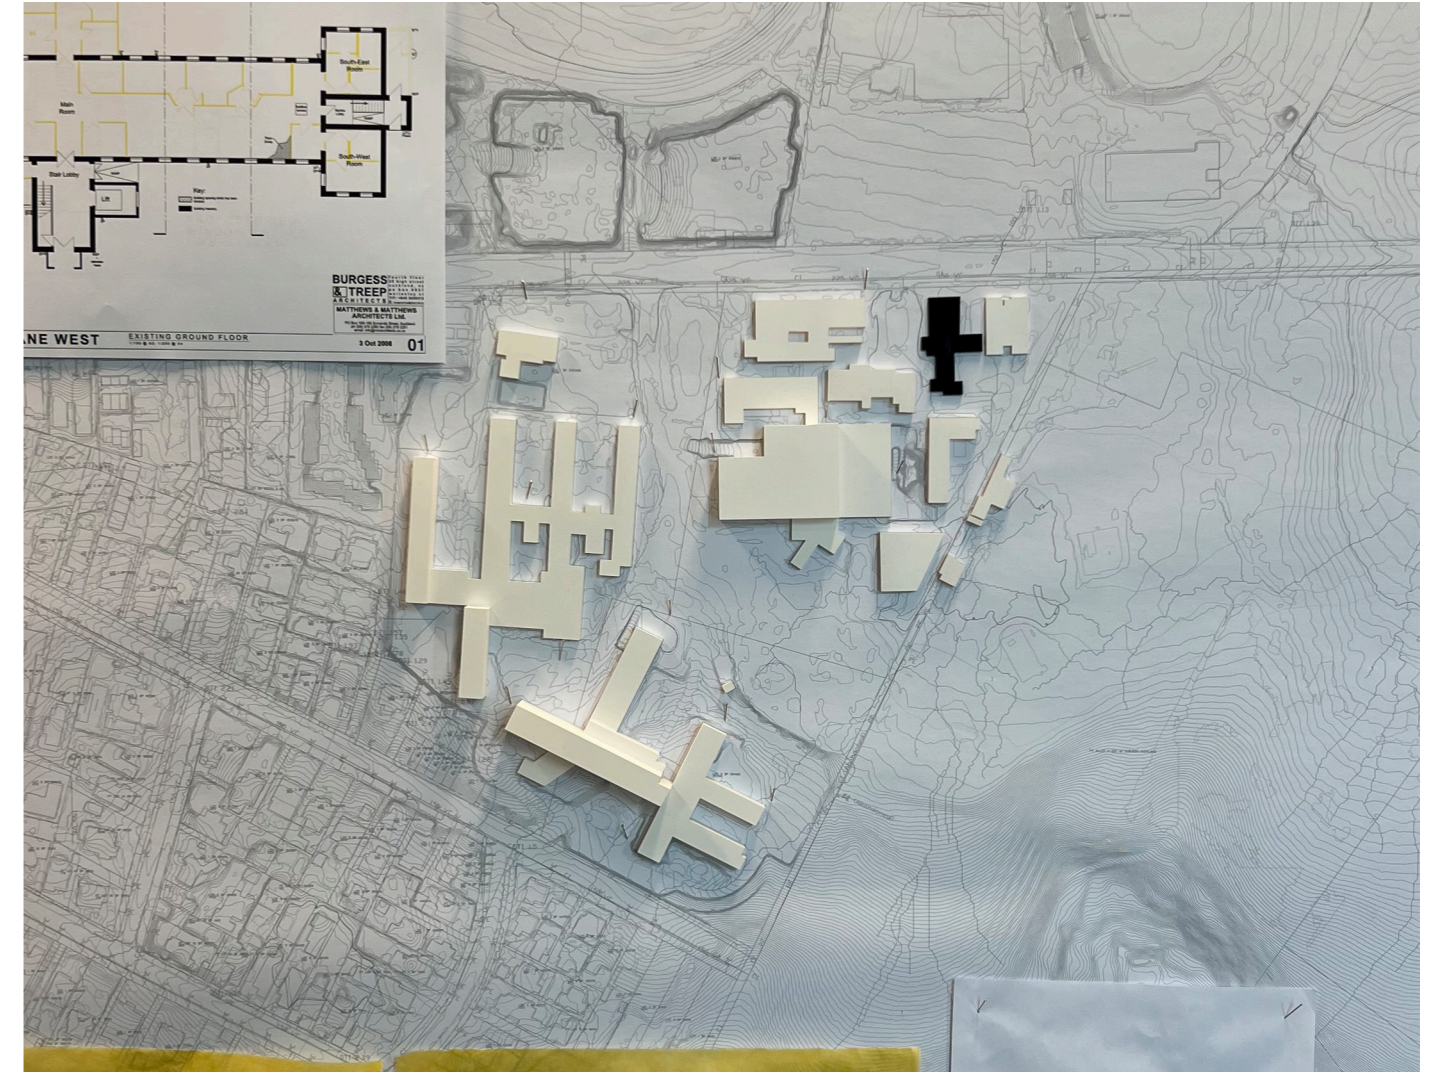
Figure 4 A physical massing model used to study the built infrastructure at Greenlane Clinical Centre. This model includes the 'E' shaped building to the West of the campus (former Nurses accommodation), which at the time of writing was the most recent building demolished. This follows a pattern of demolishing buildings considered not fit for use and replacing them with purpose built facilities, only to repeat the process just a few decades later. In subsequent figures the 'E' shaped building is shown as an outline before being removed entirely. Scale 1:1000

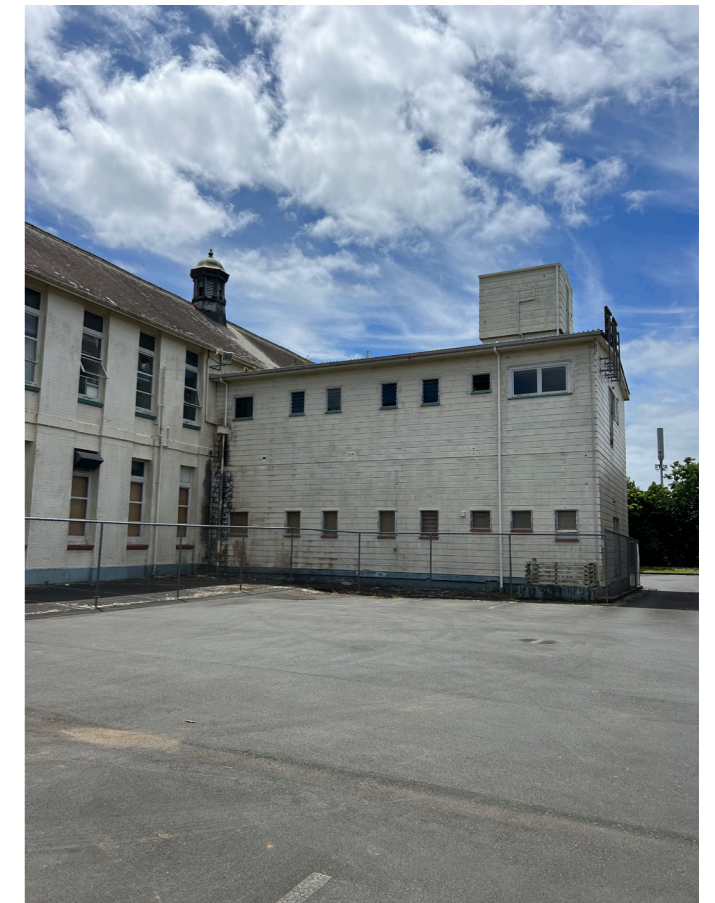
Figure 12 View of Building 5 1970s addition (Eastern Wing) looking Northwest. The cladding contains asbestos, the window openings are very small and do not relate to the original building. The junction between the addition and principal form roof is complicated.

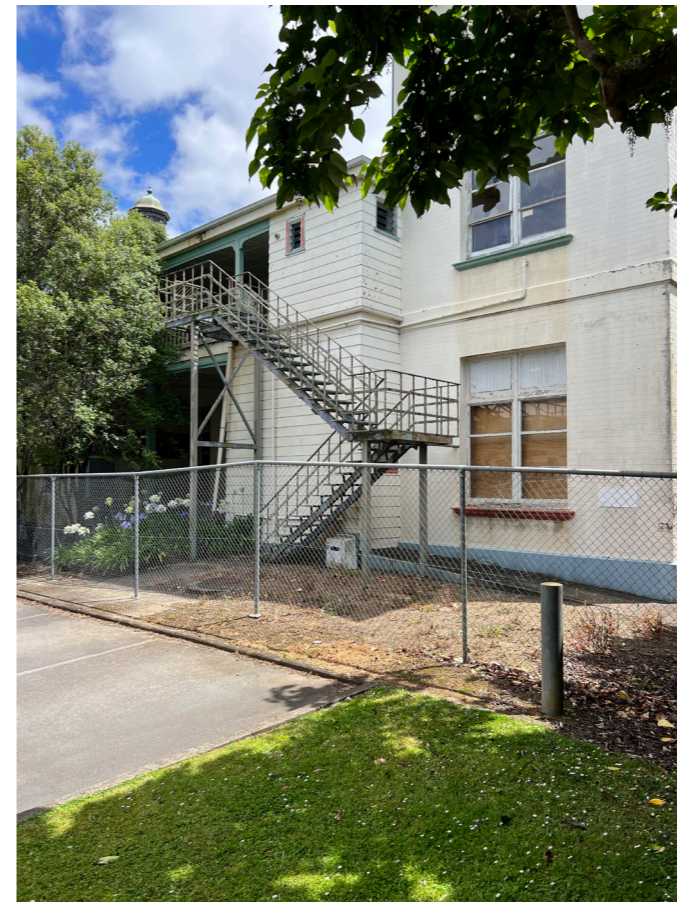
Figure 15 View of the northeast fire egress addition and partially walled-in verandas. A similar stair was removed from the Eastern Wing.

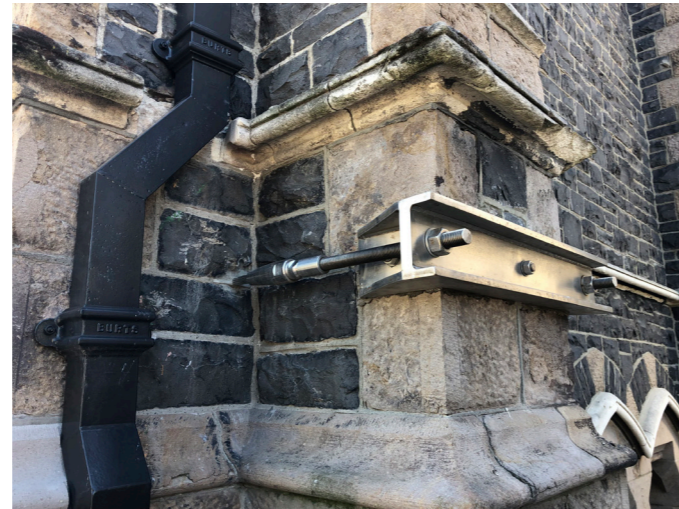
Figure 28 Christchurch Arts Centre Brick Tie Bracket detail (photo credit: Priscila Besen)

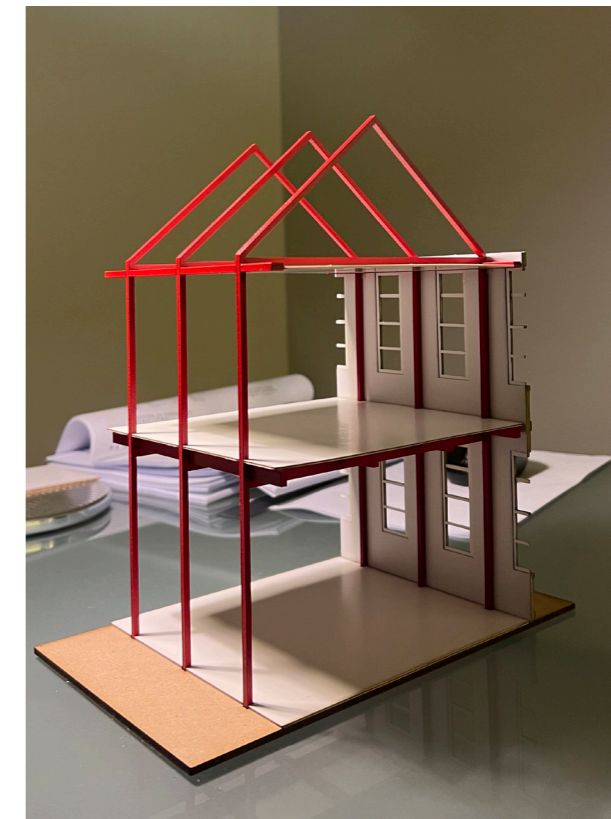
Figure 35 An early sketch model showing the proposed internal condition with structure

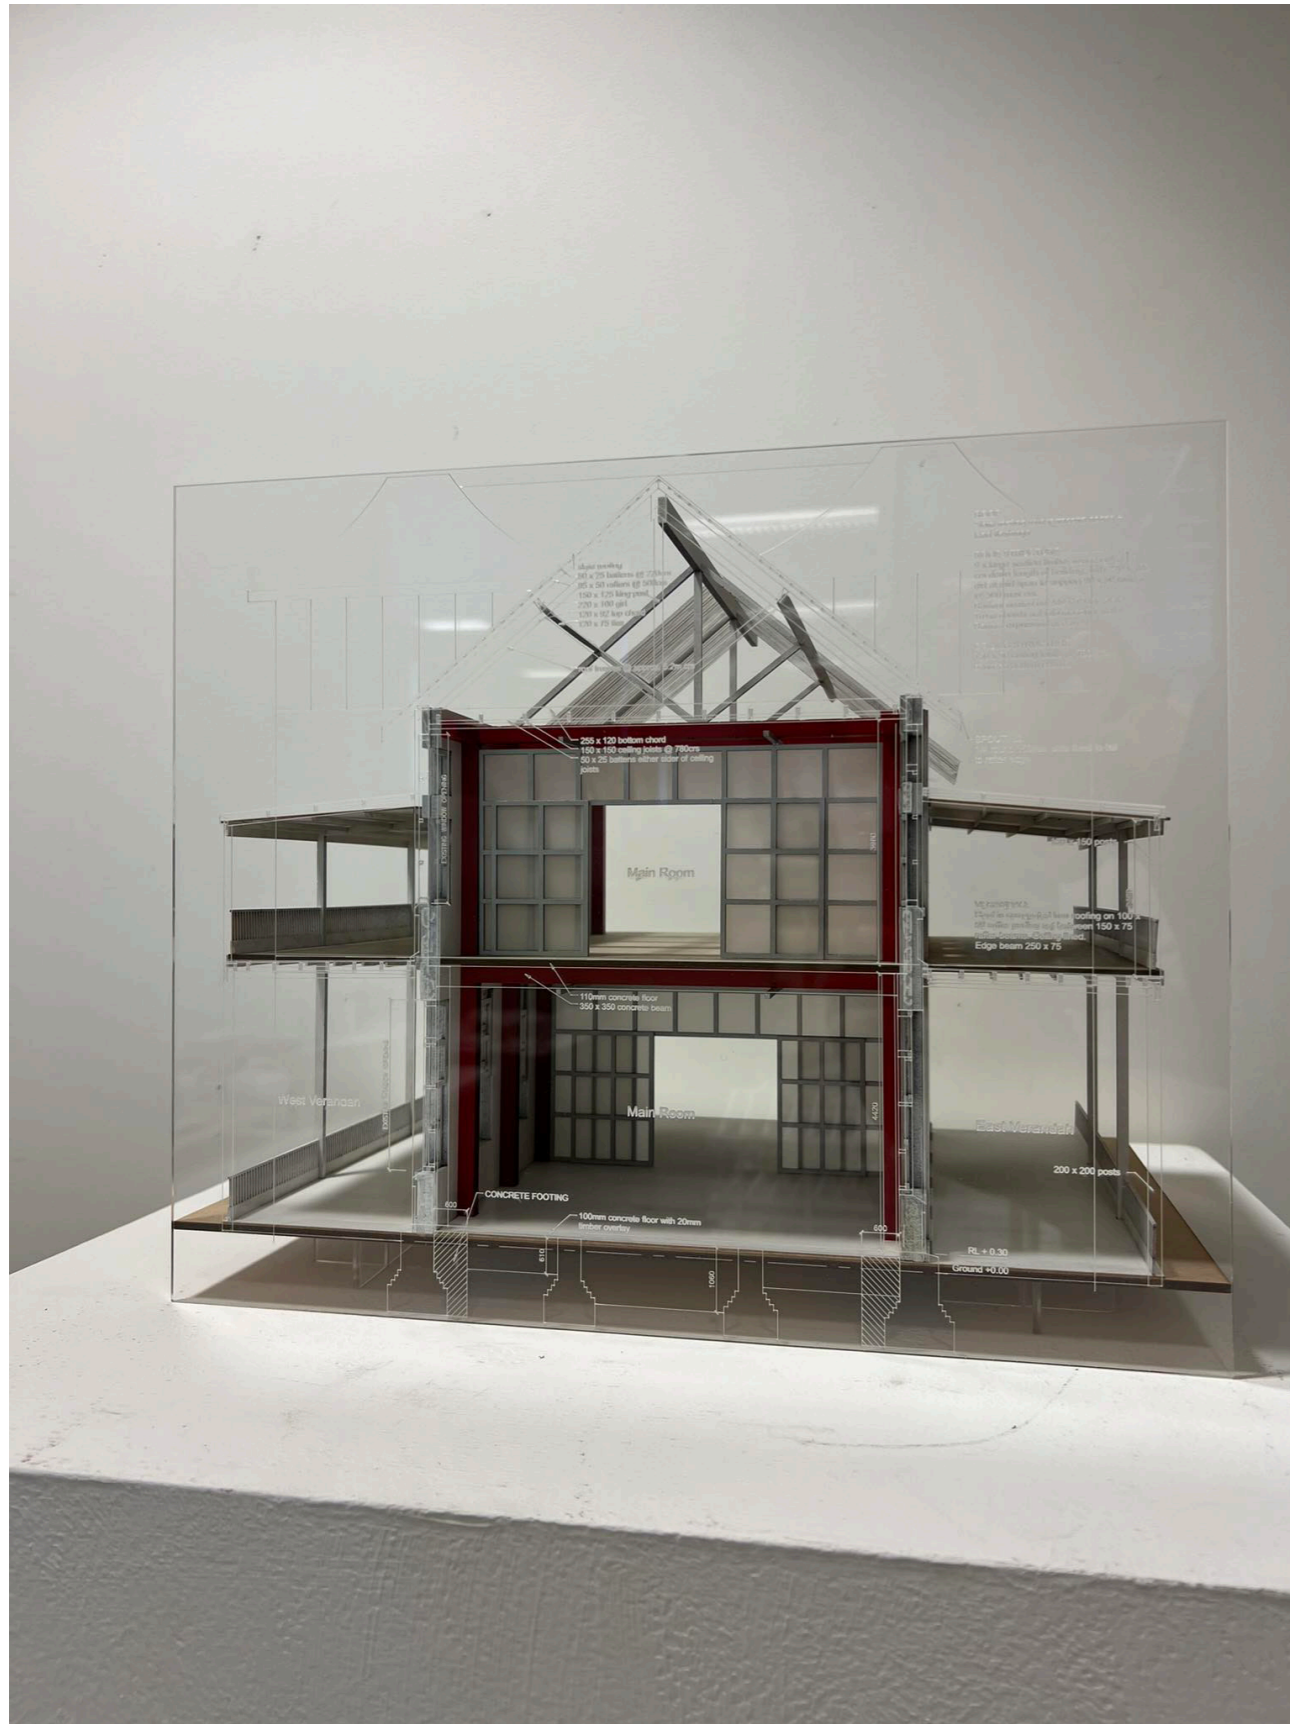
1:50 Sectional model of the principal building; section details, end 'towers', sub floor structure information and typical dimensions and materials etc engraved onto transparent material at point of section.
