# Authenticity and Change: A Framework for Examining Post-Earthquake Outcomes for the Christ Church Cathedral in Aotearoa New Zealand

RESEARCH ARTICLE

The Canterbury earthquake sequence (2010–2011) resulted in damage to historic unreinforced masonry cathedral and church precincts in Christchurch, Aotearoa New Zealand, where significant schemes of post-earthquake remediation have taken place. Public and church communities, government authorities, and conservation experts constitute decision-making stakeholders who are often, but not always, collectively motivated to retain historic architectural characteristics and religious traditions. International theories for conserving authenticity offer specialist guidance; however, there is a critical gap between institutional discourse and actual heritage outcomes shaped by the local decision-making. Using archival materials, local history records, and conservation planning documentation, we explore the construction of the city's Anglican cathedral, known as Christ Church Cathedral, and post-earthquake proposals and interventions from the 19th century to the present day. The novelty of this study lies in investigating tensions between heri

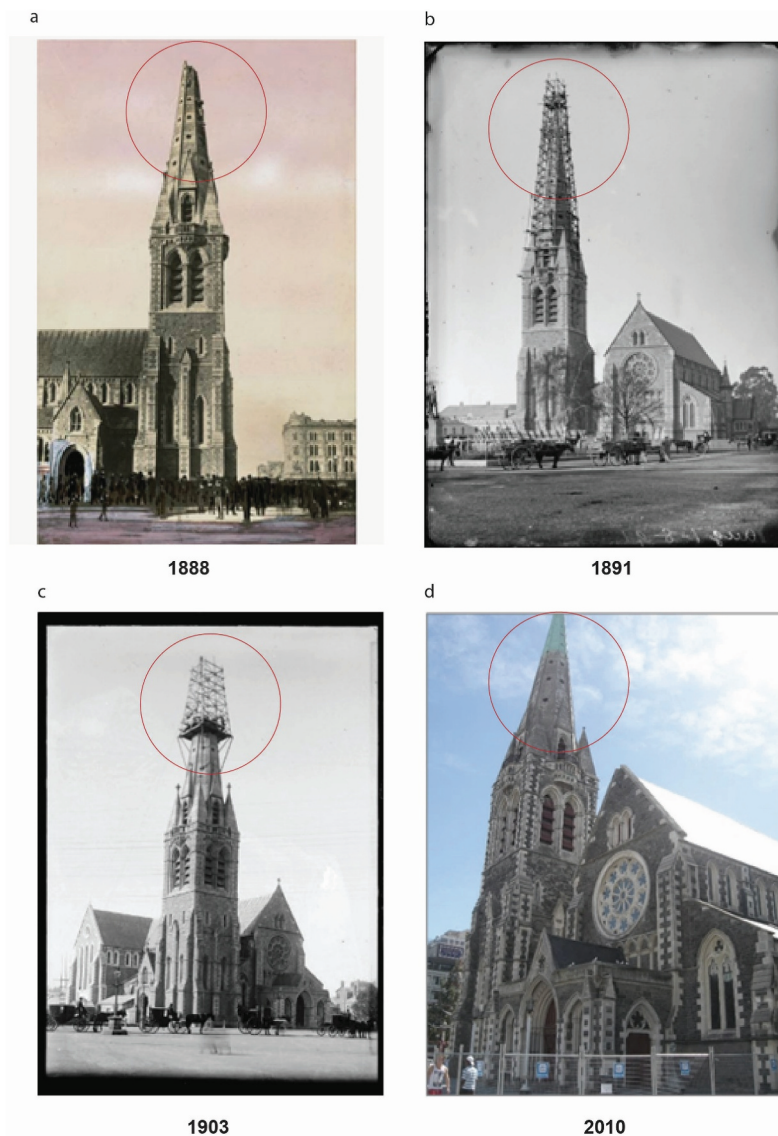
**Figure 4.** Christ Church Cathedral: material deliberations in rebuilding the spire. (a) 1888, Creator unknown: photograph of crowd outside Christ Church Cathedral with earthquake damage to spire, Christchurch. Original photographic prints and postcards from the File Print Collection, Box 19. Ref: PAColl-7985–72. Alexander Turnbull Library, Wellington, New Zealand. /records/22720273. (b) 1891, strengthening with masonry firebricks and view of the Cathedral Church steeple under repair from prior earthquake damage, with John Robert Godley statue and horse drawn wagons and coaches in foreground, with Warner's hotel beyond, Cathedral Square, Christchurch. Maclay, Adam Henry Pearson, 1873–1955: negatives. Ref: 1/2-163954-G. Alexander Turnbull Library, Wellington, New Zealand. /records/30111762. (c) Christ Church Cathedral, Christchurch, with spire being rebuilt. Ref: 1/2-018021-G. Alexander Turnbull Library, Wellington, New Zealand. /records/22614520. (d) Christ Church Cathedral, 2010, pre-2011 earthquake. Photograph by Stacy Vallis.

and apse (Lovell-Smith 2001). Earthquakes in 1881 loosened the Cathedral's stonework, and the upper parts of the tower were reconstructed after an earthquake in 1887. The tower was replaced with firebricks instead of the original stone masonry. An earthquake in 1901 caused further damage to the spire and required full reconstruction using the original design executed in timber and copper (Lovell-Smith 2001), which remained intact until the Canterbury earthquake sequence of 2010–2011 when the tower fully collapsed (Figure 4).

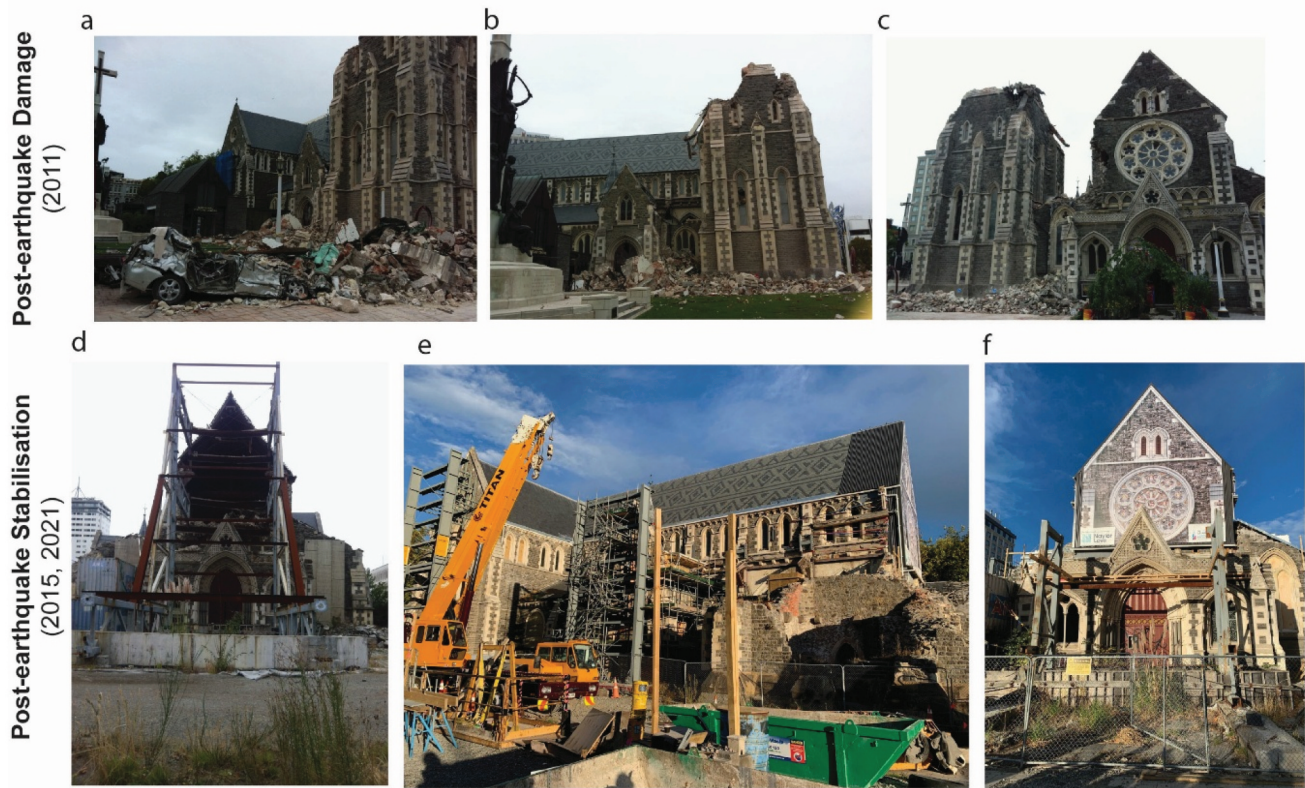
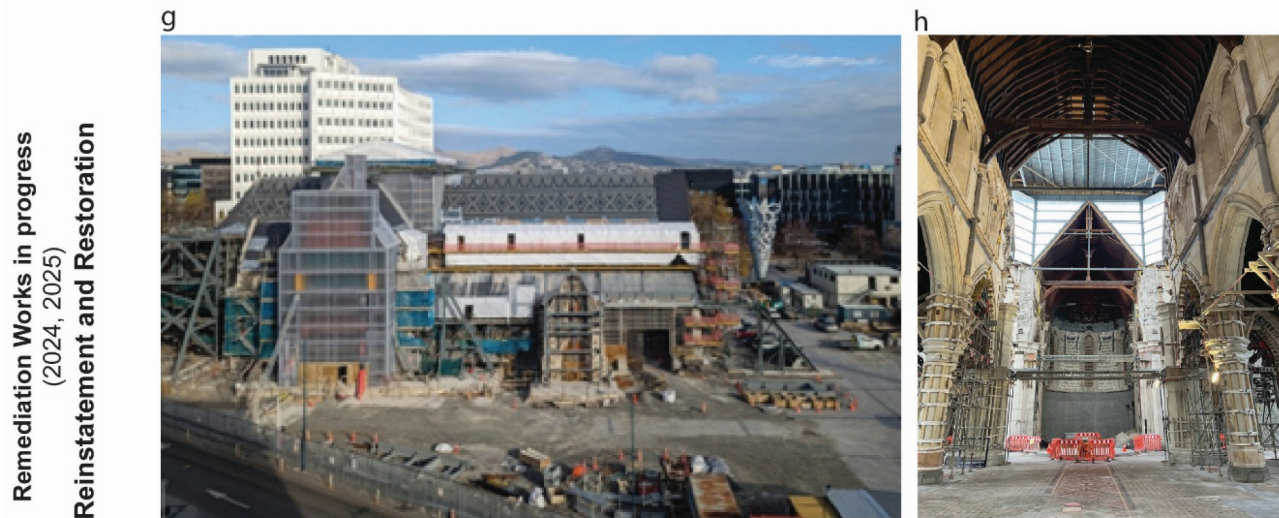
### POST-EARTHQUAKE DAMAGE AND INTERVENTIONS (Primary Building and Tower, Cathedral Square)

**Figure 5.** Post-earthquake damage, interventions, and remediation, Christ Church Cathedral. (a) Post-earthquake damage, seen from Cathedral Square, 2011. Photograph by Jason Ingham. (b) Post-earthquake damage to Cathedral tower, 2011, seen from Cathedral Square. Photograph by Jason Ingham. (c) Post-earthquake collapse of Cathedral tower and damage to primary façade 2011, seen from Cathedral Square. Photograph by Jason Ingham. (d) Emergency stabilisation for primary façade, 2015. Photograph by Jason Ingham. (e) Stabilisation works underway, 2021. Photograph by Jason Ingham. (f) Post-earthquake securing for primary façade, 2021. Photograph by Jason Ingham. (g) Post-earthquake external remediation works, 2024. Photograph by Stacy Vallis. (h) Post-earthquake internal remediation works, 2025. Photograph by Julia Gatley.

During the earthquake sequence, damage to the Cathedral was incremental. It survived the first major earthquake of September 2010 with superficial damage and was reopened to the public a few weeks later. Further damage occurred during the Boxing Day aftershock that same year. The building was closed and emergency stabilisation efforts to secure the primary façade and Rose Window included the use of a temporary brace made from disused steel lighting towers sourced from a sports stadium (Barrie, Anderson, and Goodenough 2014). Despite these works, subsequent aftershocks in June and December 2011 led to increasing instability and eventual collapse of much of the prominent west elevation, facing towards the main city square (Figure 5).
