Integrating energy retrofit with seismic upgrades to future-proof built heritage: Case studies of unreinforced masonry buildings in Aotearoa New Zealand

P. Besen, P. Boarin

To appear in: *Building and Environment*

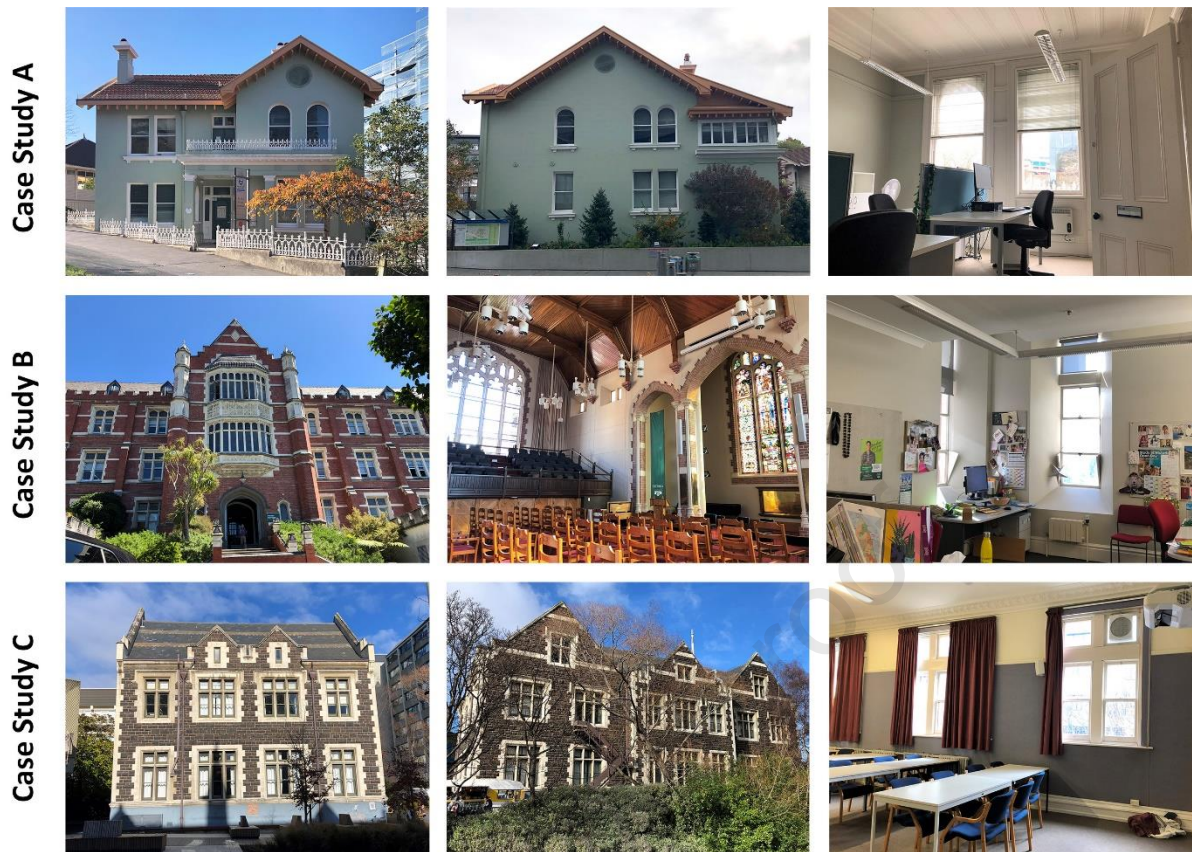
Figure 1 – External and internal photos of case study buildings A, B, and C.

The three buildings were selected because they share many common characteristics. The main current use in all case studies is offices for universities, with similar occupation patterns, allowing for a fair comparison of energy consumption in the three cases. Additional uses, such as lecture theatres in building B and laboratories in building C, occupy a minor portion of the buildings’ floor areas. Window types are similar in all buildings, consisting of single-glazed sash windows with timber frames, with similar window module sizes. They also have similar window-to-wall-ratios, with an average of 20.9%. All buildings have similar wall thicknesses ranging from 510-540 mm, but wall build-up layers differ amongst the three buildings. Case studies A and C have compact building shapes, with simple rectangular building footprints and a surface area to volume ratio of 0.81 and 0.49 respectively. Case study B presents a more elongated and complex building form, with additional façade features, including bay windows; it still achieves a low S/V ratio of 0.65 due to being a multi-storey building. Figure 1 shows selected views of the buildings, illustrating the different configurations of façades and the similarities in typical indoor spaces and window sizes. In building B, walls had already been retrofitted with an internal layer of sprayed concrete, and the photo on the right shows the increased depth of window reveals resulting from this upgrade.

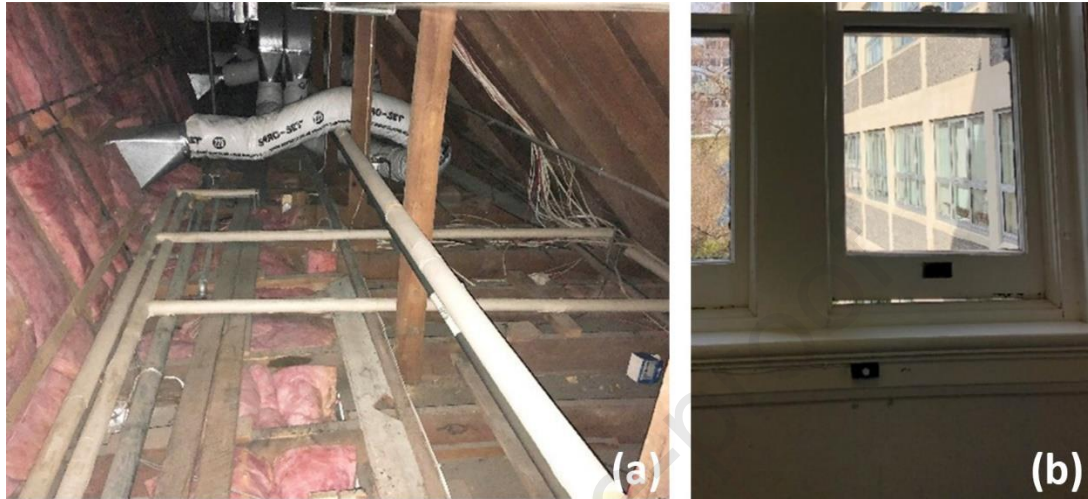
Visual inspection was documented with photographs of critical aspects found in the three buildings. The main findings were related to decay, lack of maintenance, modifications, and occupants' preferences. Following the identification of issues in ceiling insulation through thermography in case study C, an inspection of roof space revealed that insulation was only installed in half of the ceiling

space: Figure 4 (a) shows that the areas on the right-hand side remain uninsulated, causing significant heat losses. Also, air draughts through windows were common in all buildings due to lack of maintenance, as per Figure 4 (b) showing how the original sash windows do not close properly and leave a visible gap at the bottom in building C.

Figure 4 – Photos of case study C showing key issues. Photo credit: Priscila Besen.

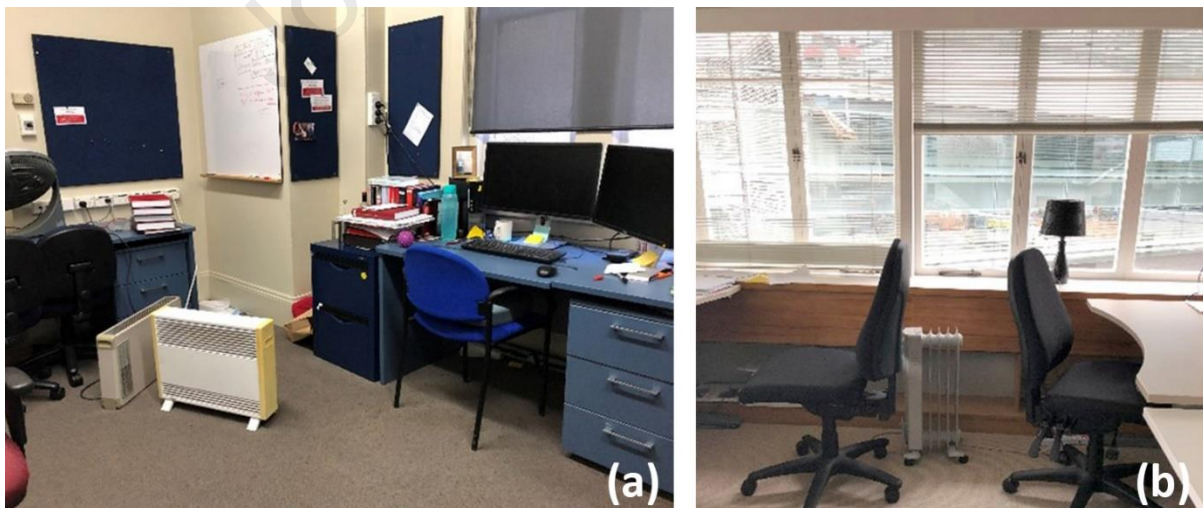
To maintain building occupants' thermal comfort, many portable electric heaters were used in office spaces, which were brought from home by the occupants (Figure 5). This practice, found in all case studies, clearly indicates that the fixed heating devices installed in the buildings are not enough to ensure comfortable conditions in winter.

Figure 5 – Use of personal portable heaters by building occupants in case studies C (a) and A (b). Photo credit: Priscila Besen.

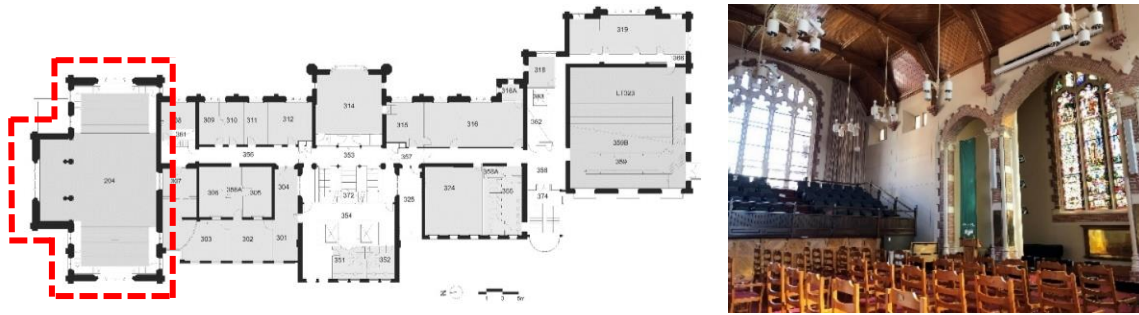
Values shown for building B do not apply to the Council Chamber room, as it needed to be carefully assessed for retrofit. This room is a triple-height space that is utilised for occasional events. There is significant original detailing in the timber, walls, and ceilings, and heritage significant stained glass windows, which are a memorial for staff and students who died in the world wars. These windows had already been upgraded with secondary glazing applied to the outside to provide protection from decay. The addition of secondary internal glazing and wall insulation would have a significant impact on this important space. The ceiling and floor of the room could possibly be insulated, if insulation could be added to existing cavities (this would be subject to confirmation through further investigations such as through the use of endoscope cameras). Therefore, given its heritage significance and its occasional occupancy pattern, no interventions are proposed for this room because any changes could have a significant visual impact. In addition, there are no significant requirements from occupants' comfort point of view since it is only used for occasional short meetings and gatherings. Figure 10 shows the location of the Council Chamber room and the extent of the building that will be excluded from retrofit interventions, as well as an internal view of the configuration of the space and the stained-glass memorial windows.

Figure 10 – Case study B: Floor plan and photo showing the Council Chambers room, which will be subject to minimal energy retrofit interventions due to its heritage significance.

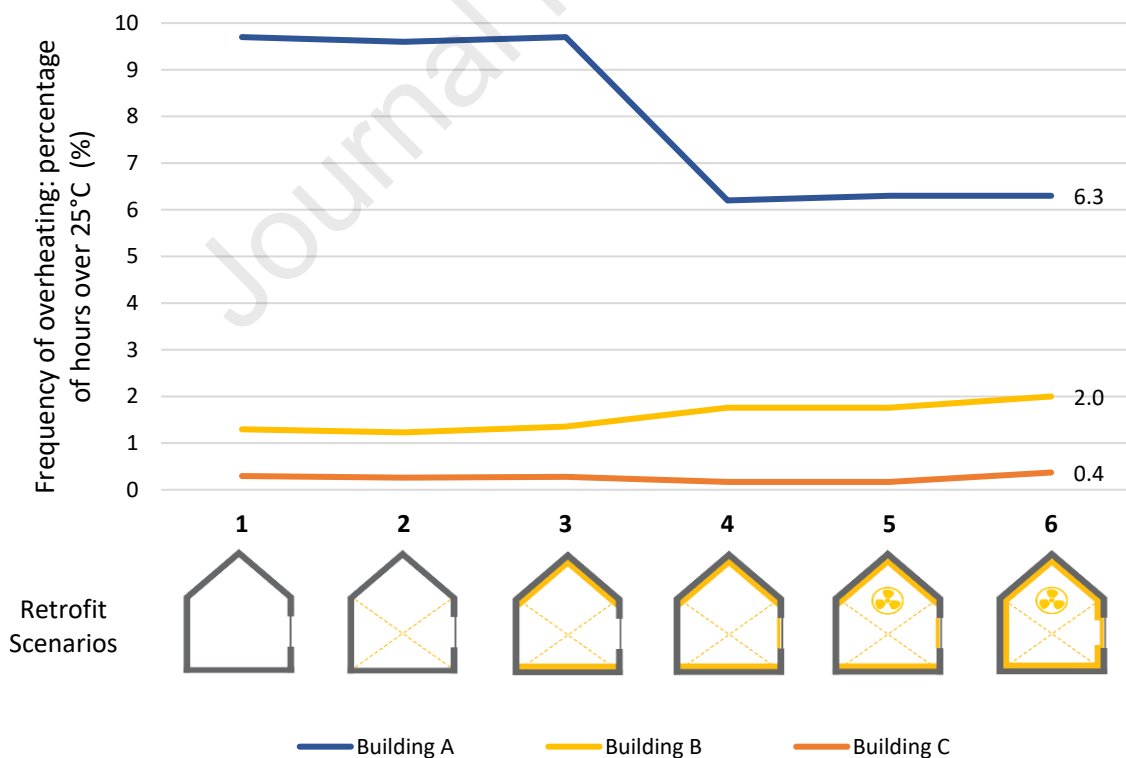
Figure 12 shows the results from energy simulation, demonstrating the effect of the proposed retrofit scenarios on heating demand, while Figure 13 illustrates the frequency of overheating. The frequency of overheating was calculated in PHPP and represents the number of hours in a year where the indoor temperature exceeds 25°C, considering that these buildings would not utilise active cooling. The resulting overheating percentage is the number of hours above 25°C divided by the total number of hours of occupancy. All results were obtained from PHPP models, which included input from thermal bridging calculations developed in the software THERM.

Figure 13 – Cumulative retrofit scenarios 1-6: frequency of overheating (%) results for case studies A, B, and C.
