## FATIGUE OF COMMERCIALLY PURE TITANIUM DENTAL IMPLANTS

**Abstract.** Failure of two commercially pure titanium dental implants was analysed. The implants fractured at the abutments after only three years use. One abutment failed at the junction of the threaded and unthreaded areas, the other failed within the threaded area. Both failures were by reversed bending fatigue, whereby fatigue cracks began from relatively coarse machining marks on the abutments. The final fracture areas were less than 10 % of the total fracture surfaces, indicating that the abutments had not been abnormally loaded. However, bone resorption would have increased the abutment bending stresses by causing an increased moment arm of the acting forces and misalignment of the abutments in the maxilla. The effect of misalignment was investigated by finite element modelling, which showed that even a slight misalignment could double the bending stresses. This unanticipated large effect, combined with the coarse machining marks, explains the premature failure of the implants.

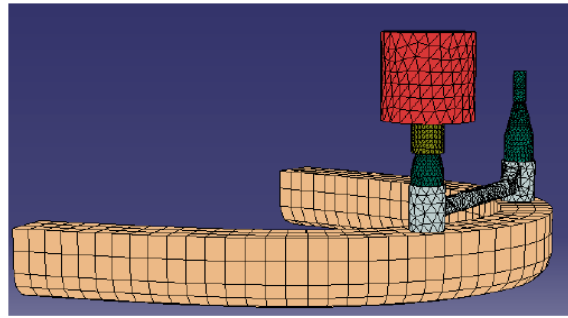
- (1) The two implants were joined by the connecting bar (gold alloy) as well as the resin-based full denture, see Figs. 2 and 9. These connecting members have different mechanical properties, which are difficult, if not impossible, to model otherwise. In particular, the denture's compliance (lack of rigidity) is important, since this increases the loads transferred to the implants [6].
- (2) The misalignment of the implants should be accounted for.

To fully capture the effects of these factors a finite element model was developed using the commercial finite elements software ABAQUS. The undeformed model is shown in Fig. 9.

**Fig. 9.** The undeformed finite element model. The model components include the denture, connecting bar, abutments, fixtures, and bone. The shorter abutment A is shown in the foreground. The fixture and bone have been removed schematically from abutment B to highlight the notch between the tapered and threaded sections.
