# FATIGUE OF COMMERCIALY PURE TITANIUM DENTAL IMPLANTS

**Abstract.** Failure of two commercially pure titanium dental implants was analysed. The implants fractured at the abutments after only three years use. One abutment failed at the junction of the threaded and unthreaded areas, the other failed within the threaded area. Both failures were by reversed bending fatigue, whereby fatigue cracks began from relatively coarse machining marks on the abutments. The final fracture areas were less than 10 % of the total fracture surfaces, indicating that the abutments had not been abnormally loaded. However, bone resorption would have increased the abutment bending stresses by causing an increased moment arm of the acting forces and misalignment of the abutments in the maxilla. The effect of misalignment was investigated by finite element modelling, which showed that even a slight misalignment could double the bending stresses. This unanticipated large effect, combined with the coarse machining marks, explains the premature failure of the implants.

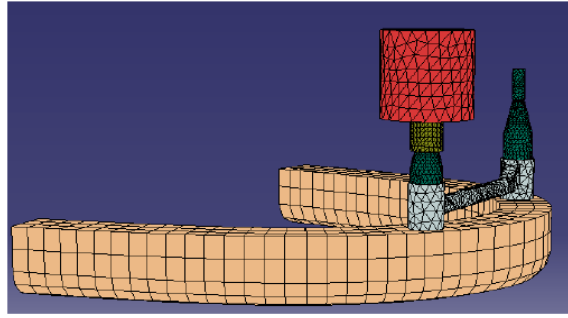
- (1) The two implants were joined by the connecting bar (gold alloy) as well as the resin-based full denture, see Figs. 2 and 9. These connecting members have different mechanical properties, which are difficult, if not impossible, to model otherwise. In particular, the denture's compliance (lack of rigidity) is important, since this increases the loads transferred to the implants [6].
- (2) The misalignment of the implants should be accounted for.

To fully capture the effects of these factors a finite element model was developed using the commercial finite elements software ABAQUS. The undeformed model is shown in Fig. 9.

**Fig. 9.** The undeformed finite element model. The model components include the denture, connecting bar, abutments, fixtures, and bone. The shorter abutment A is shown in the foreground. The fixture and bone have been removed schematically from abutment B to highlight the notch between the tapered and threaded sections.
