## Seismic Performance Evaluation of Rocking Plasterboard Partition Walls Via Full-Scale Shake Table Tests

# Seismic Performance Evaluation of Rocking Plasterboard Partition Walls Via Full-Scale Shake Table Tests

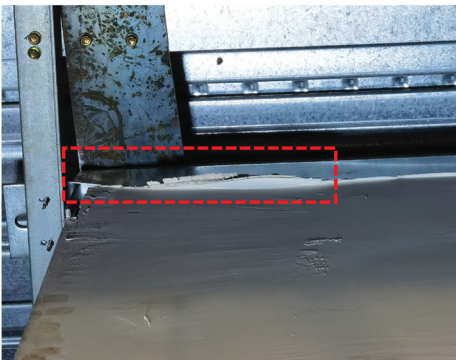
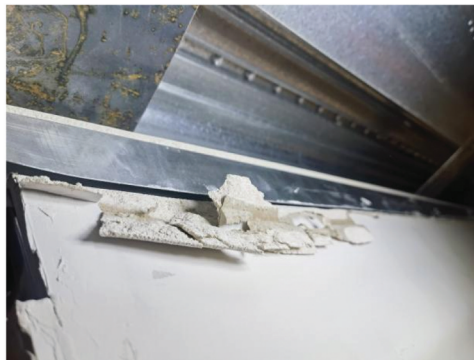
(a) Scraping off the plasterboard and  
deformation of the top DST flange  
(1.49%)

(b) Localised plasterboard damage with  
spalling and detachment (2.12%)

**Figure 15.** Localised damage observed at the top edge of L2X wall and corresponding peak inter-storey drifts.

After the 0.49 g longitudinal (NS/X) shaking (1.49% PIDR), localized wear of the plasterboard surface at the top of the L2X wall and deformation of the top DST flange were observed (Fig. 15a). Due to a construction error, the overlap of the plasterboard within the DST was approximately 5 mm, and

the preceding 0.40 g bidirectional shaking prevented the plasterboard from fully returning to its original position within the DST. During subsequent rocking motions, the plasterboard repeatedly pressed against the sharp edge of the DST flange and slid against it, generating frictional wear and causing localized plasterboard damage (extending over an area of approximately 200 mm × 35 mm), as shown in Fig. 15b. This unintended damage was not directly related to inter-story drift demand but was instead construction-related; it has, therefore, been excluded from the damage state classification. Such plasterboard damage would be concealed within the plenum space in commercial buildings.
